## Village of Lions Bay

Final Report

Bridge Inspection Program

June, 2018

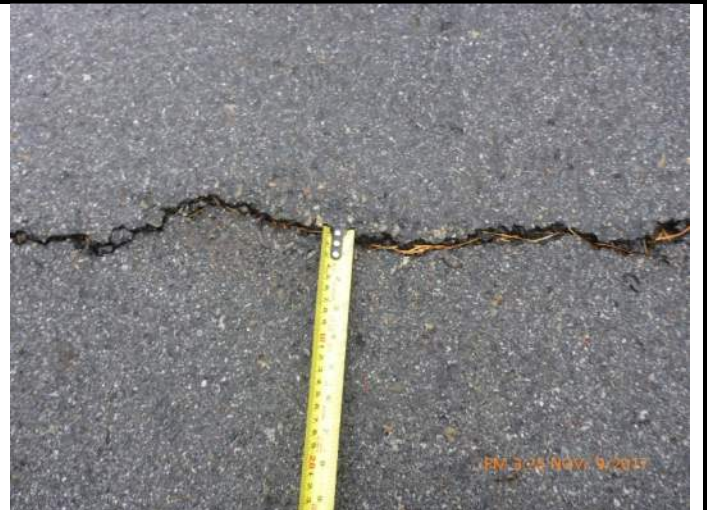
004 – Typical asphalt crack at joints

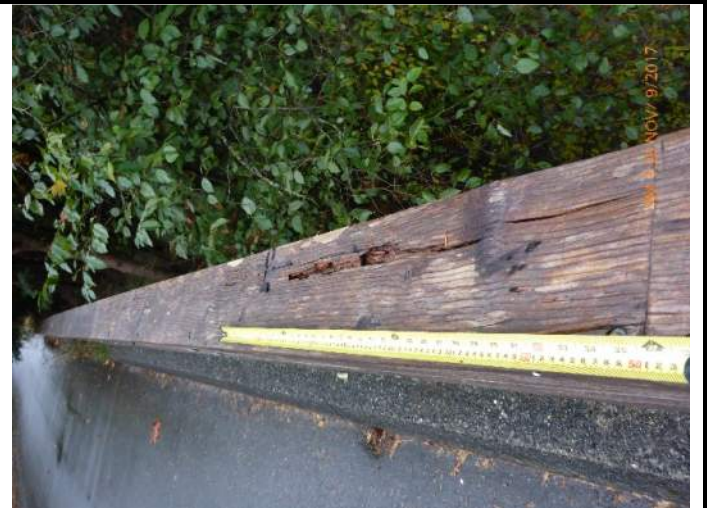
006 – Typical decay at the top rail

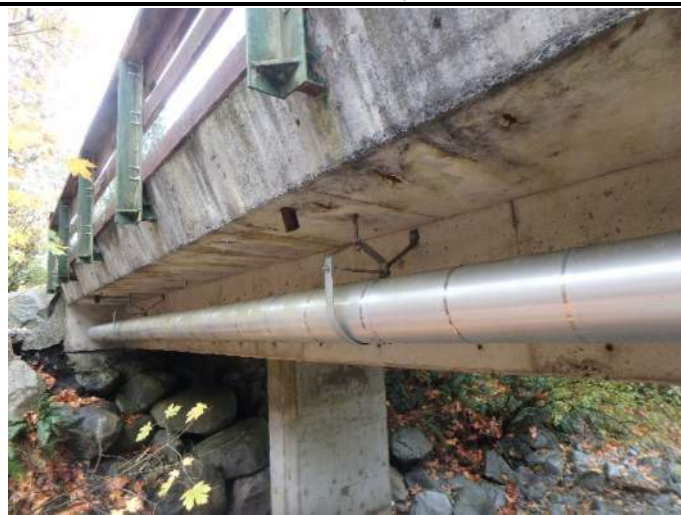
009 – Watermain on East side; spalling and exposed reinforcement bars typical throughout

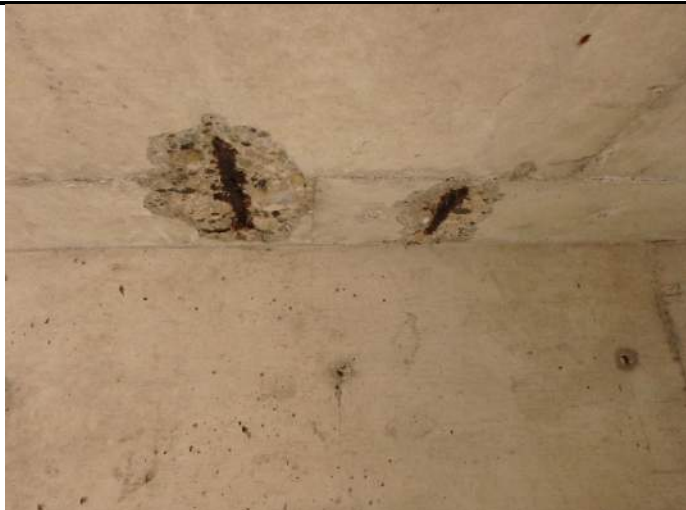
012 – Spalling with exposed corroded reinforcing on soffit, typical

- Repair delaminated and spalled concrete on deck soffit and girder units

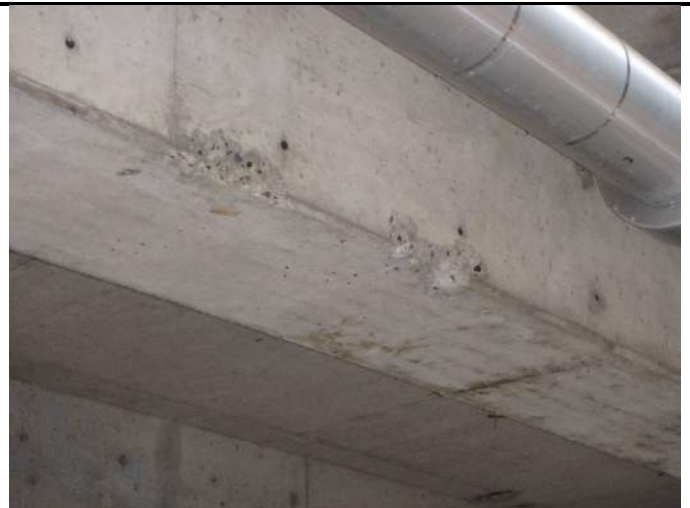
014 – Light Spalling from impact damage on Girder 1 midspan

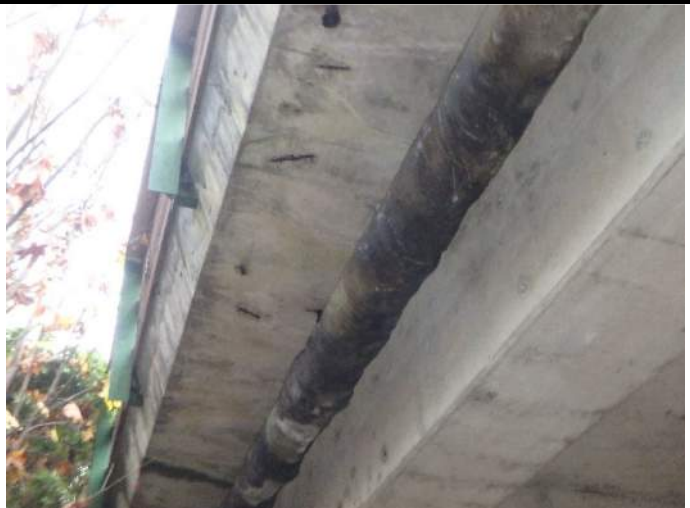
016 – Main at West side, typical exposed rebars

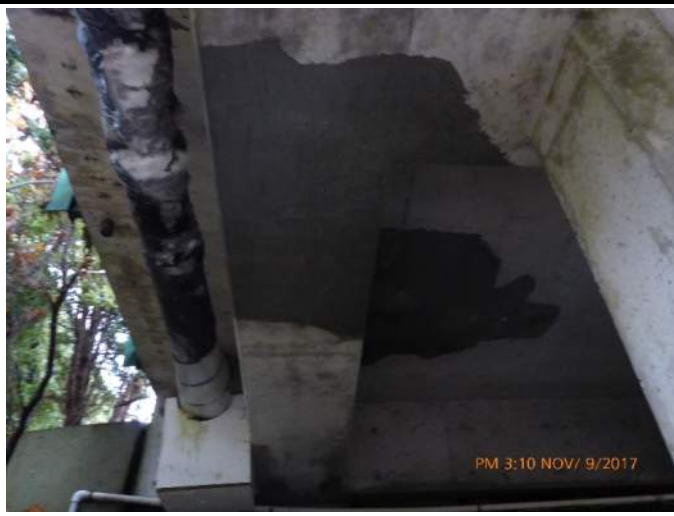
019 – Previous repairs at the soffit and Girder 2

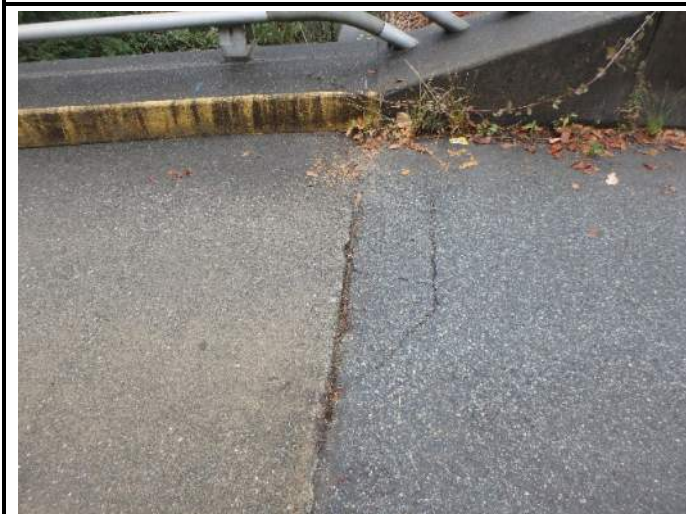
003 – Cracks at North Approach

- Repair spall at the North end of deck and repair cracked North approach section.

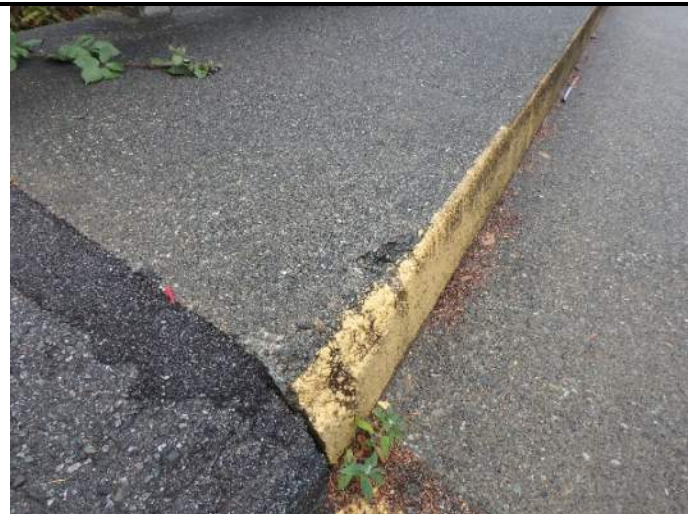
004 – Minor spall at sidewalk edge on North side

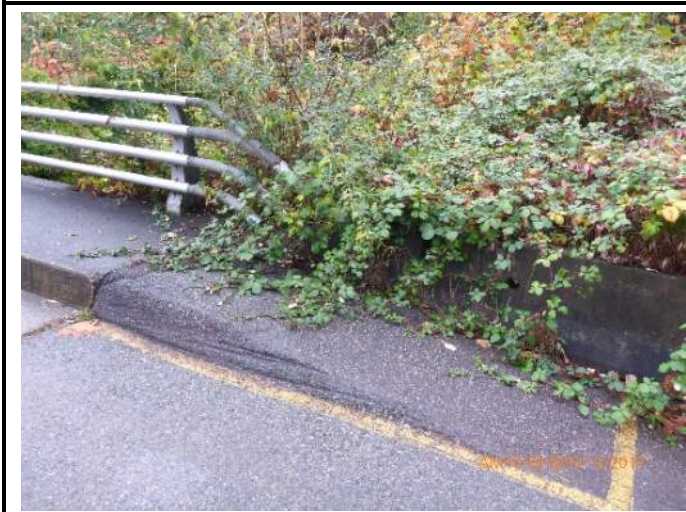
005 – Vegetation growth over sidewalk, typical

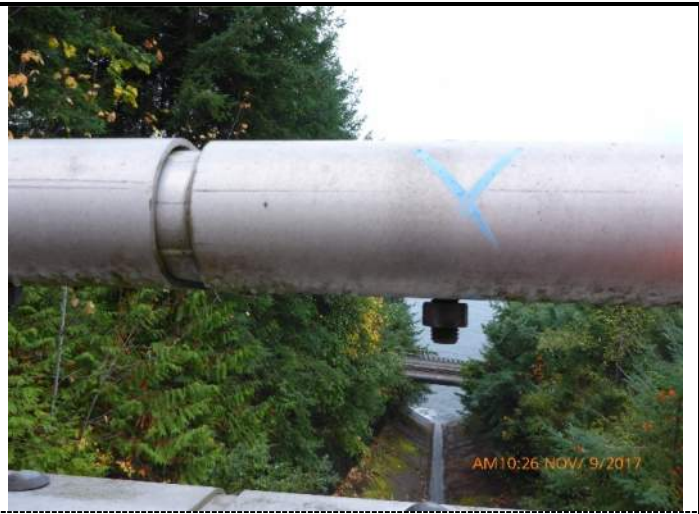
008 – Loose splice bolt at West side railing

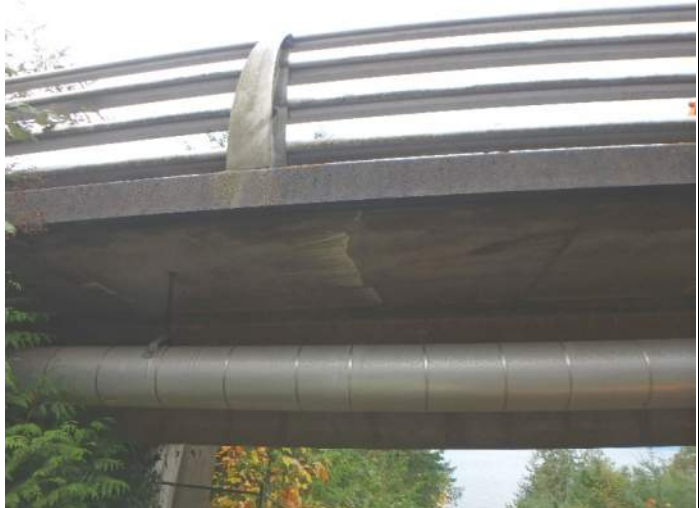
012 – Typical transverse cracks with efflorescence at the underside of sidewalks

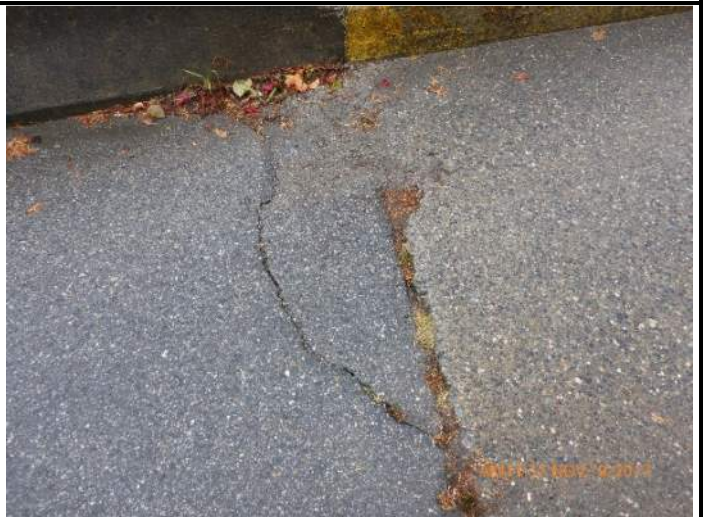
004 – Crack in asphalt at South approach, West side

- Repair debonded asphalt and seal the crack at approaches.

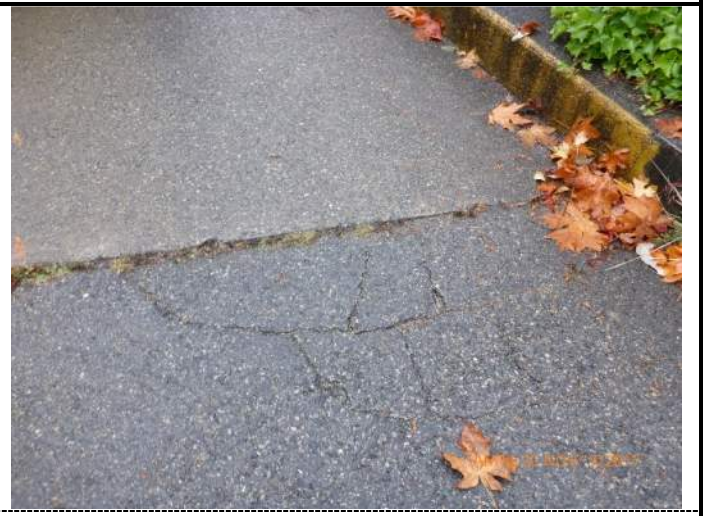
006 – Crack in asphalt at North Approach, West side

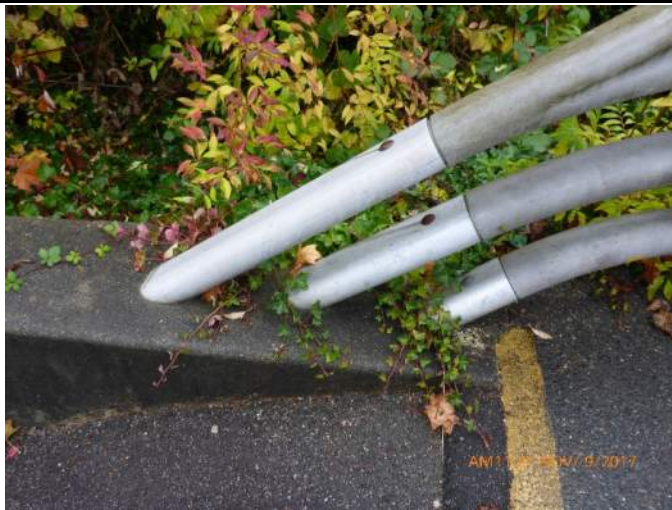
009 – Rusty bolts at the railing, typical

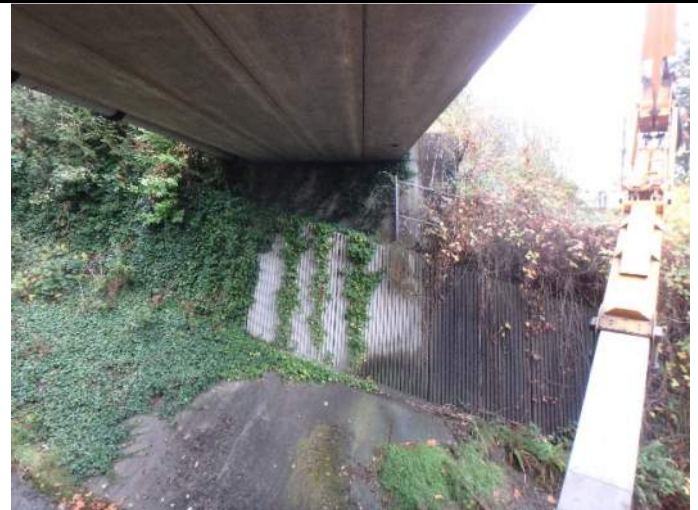
010 – South Abutment. Note vegetation growth.

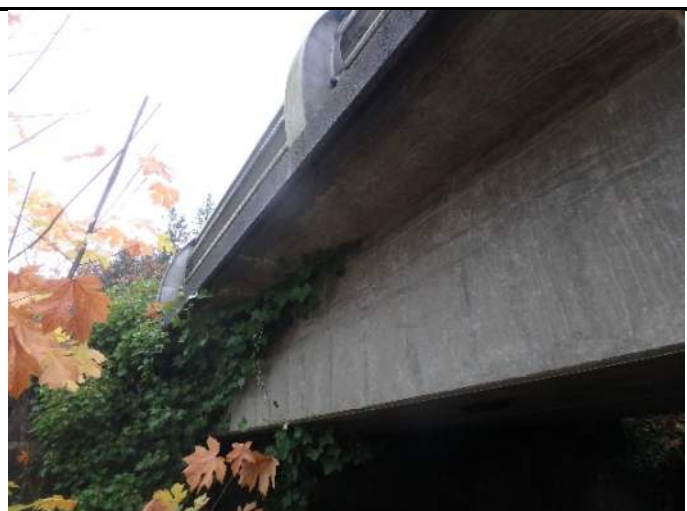
018 – Vegetation growth onto the curb

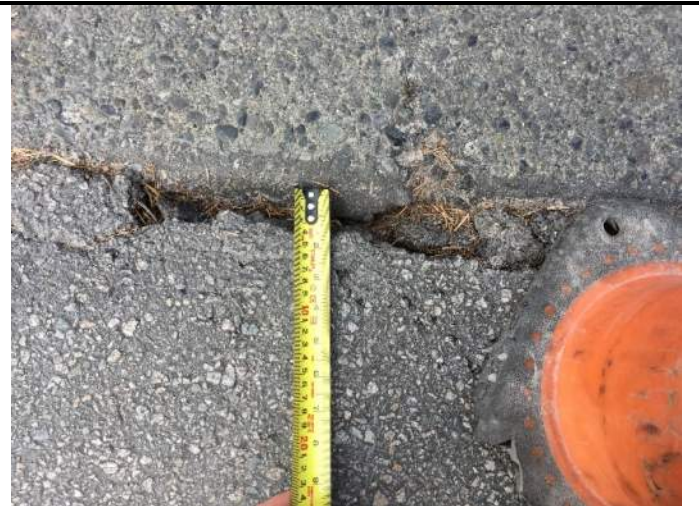
006 – Spalls in asphalt on South approach

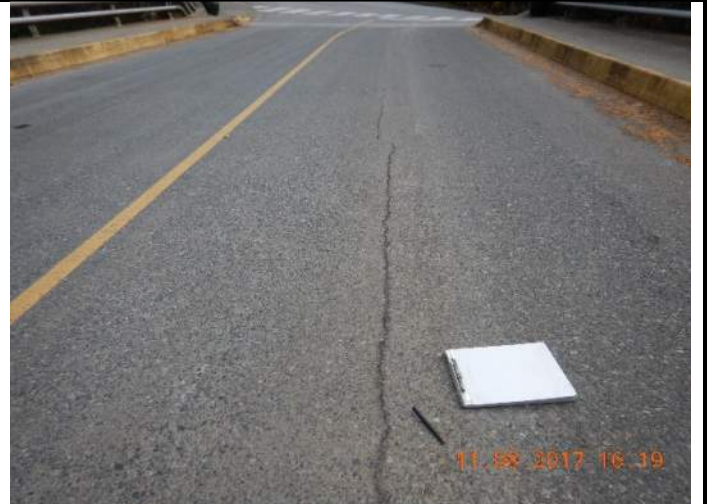
016 – Longitudinal crack at SB lane

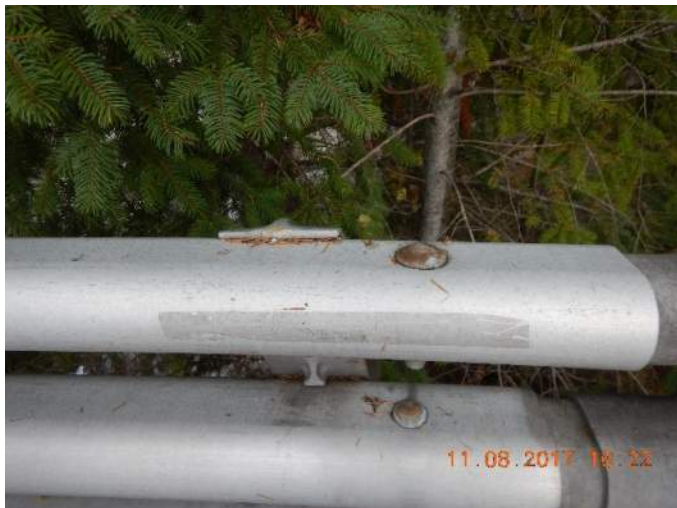
017 – Rusty bolts at railing, typical

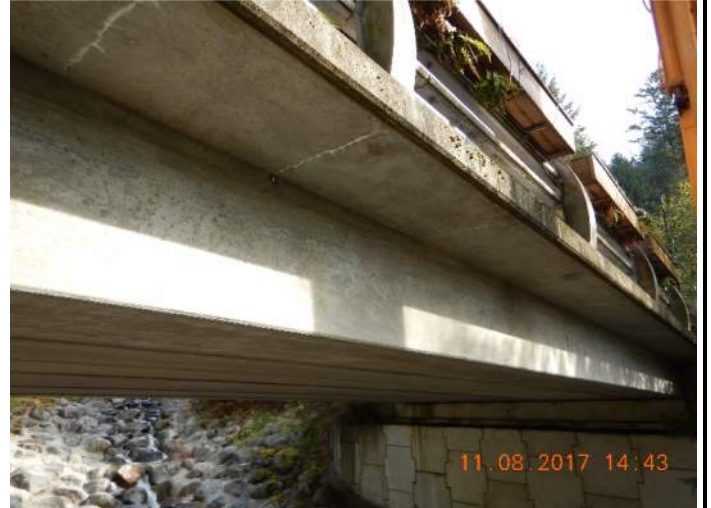
018 – Transverse cracks with efflorescence on underside of West sidewalk, similar observed at East sidewalk

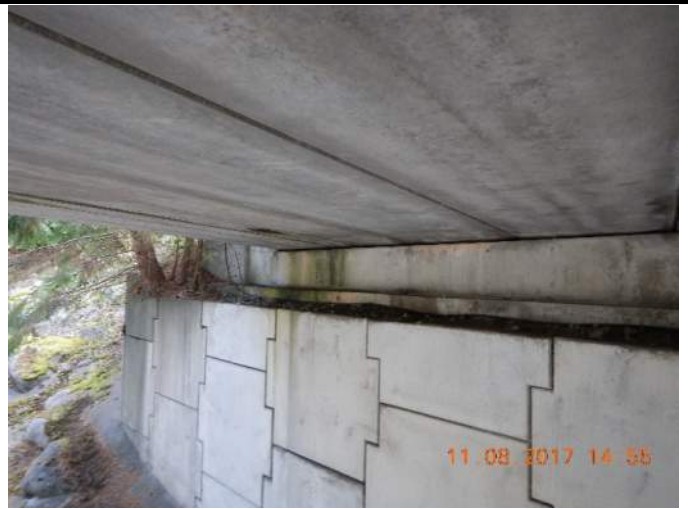
024 – South Abutment: efflorescence deposits, water leaking signs, horizontal cracks with rusting

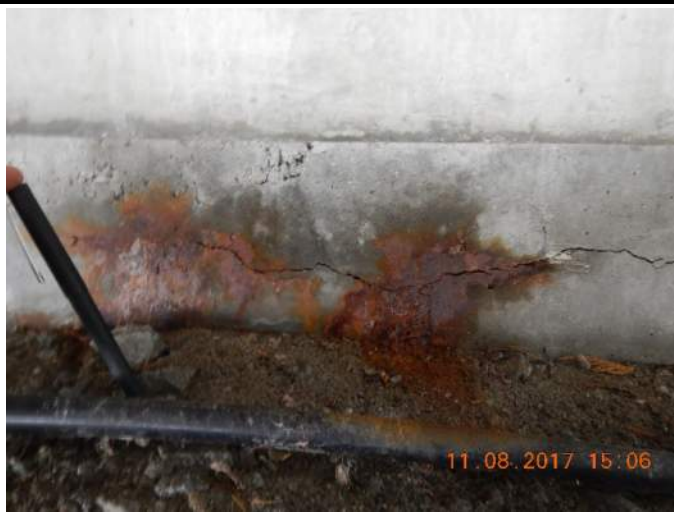
025 – South Abutment: horizontal cracks with rust staining

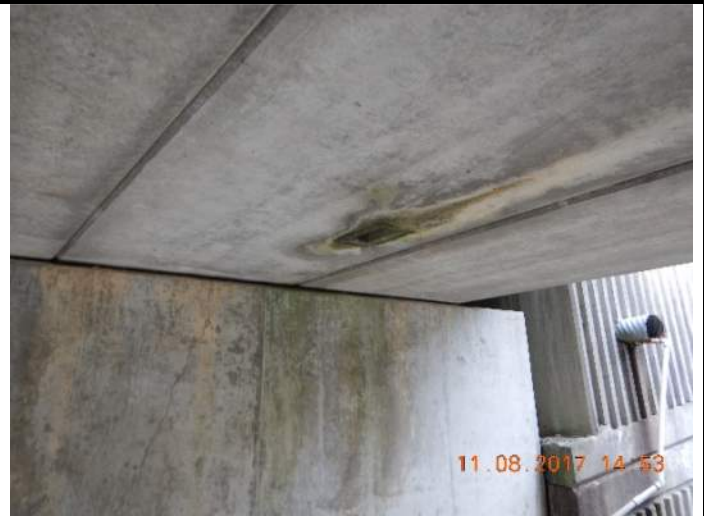
026 – Drains are flush with girders

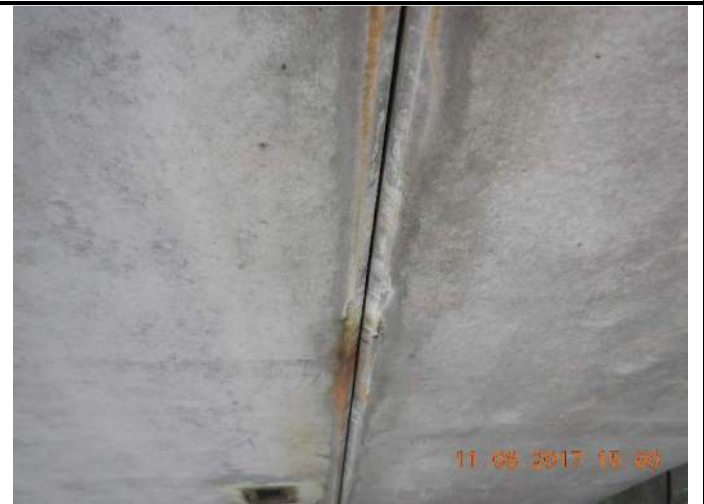
028 - Leaking between girders

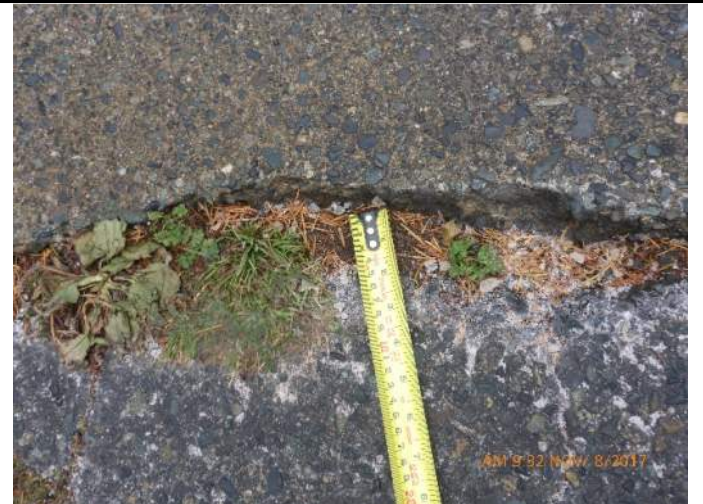
004 – Gap between deck and asphalt at South Approach

Urgency Rating Notes:  
- Remove vegetation from abutment. Repair delaminated concrete.  
- Seal sidewalk, curb, and deck  
- Repair broken up asphalt at South approach, regrade to eliminate grade differential.

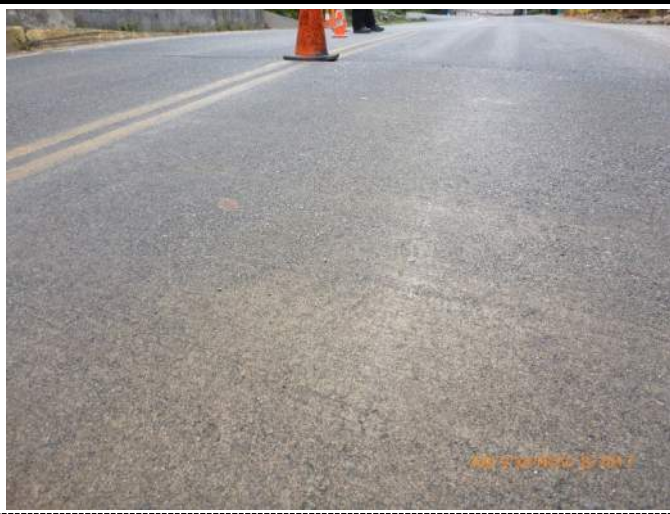
007 – Longitudinal hairline crack at SB lane (similar at NB lane)

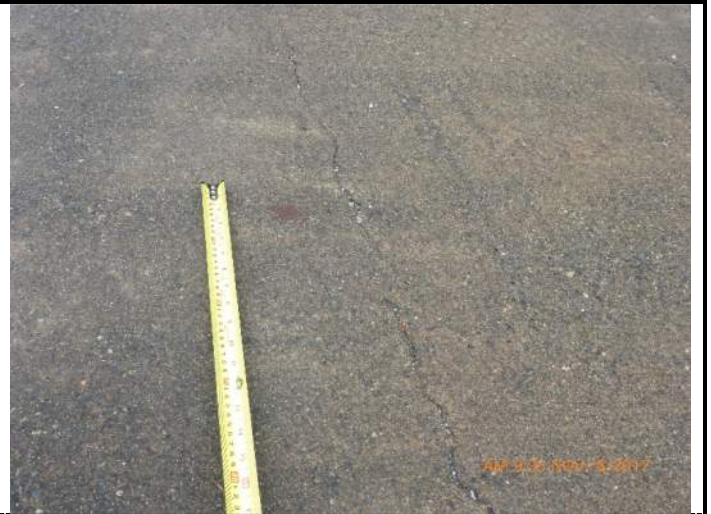
008 – Hairline crack at SB lane on Deck

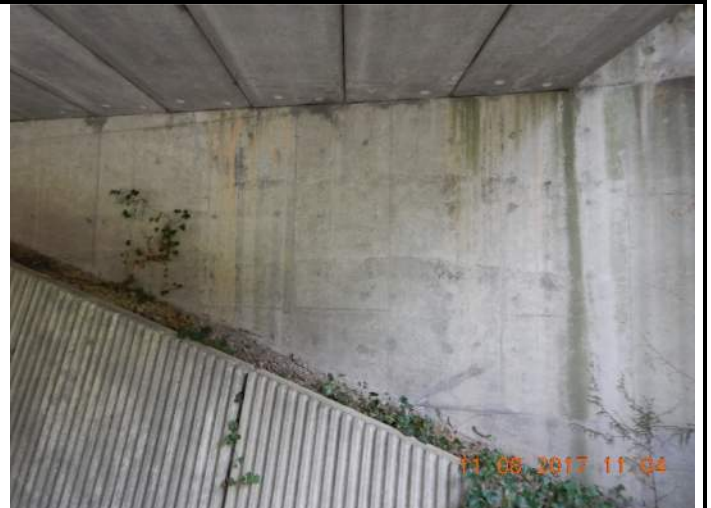
012 – South Abutment: evidence of leaking at West side, localized medium delamination under Girders 4 and 5

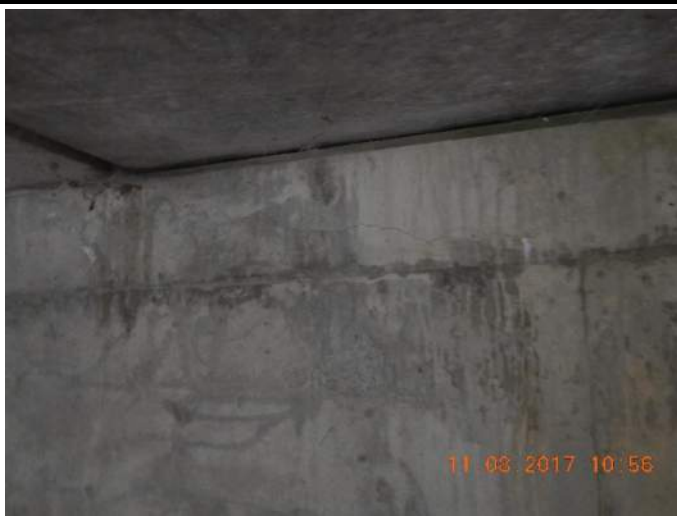
013 – South Abutment: medium hairline crack under Girder 4

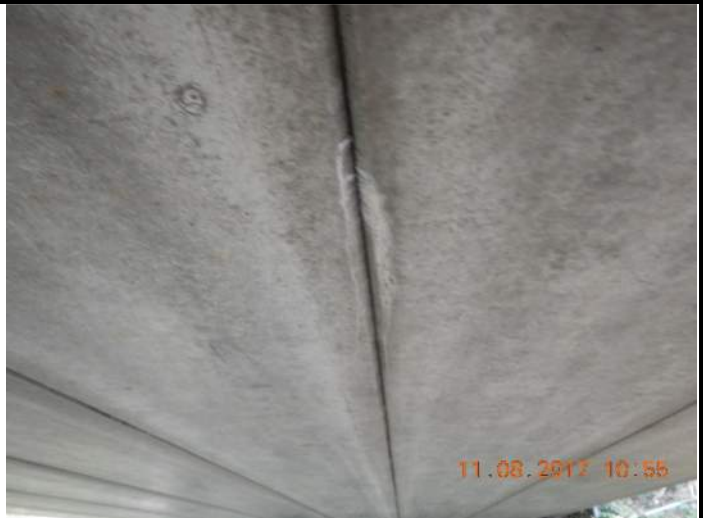
014 – Localized efflorescence between girders

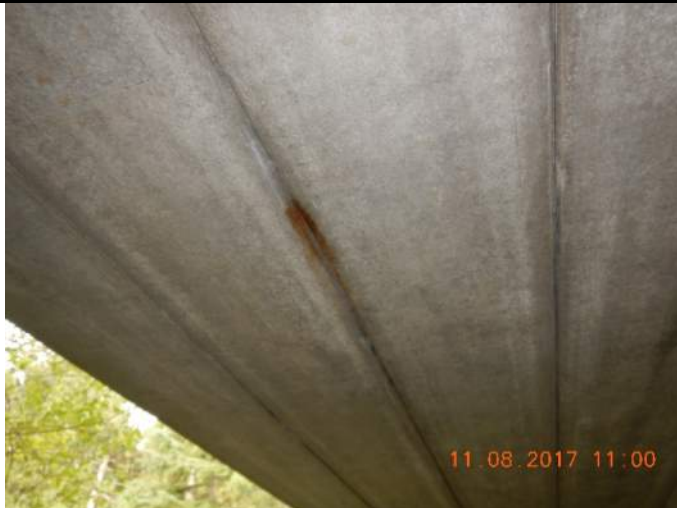
015 – Localized staining between girders

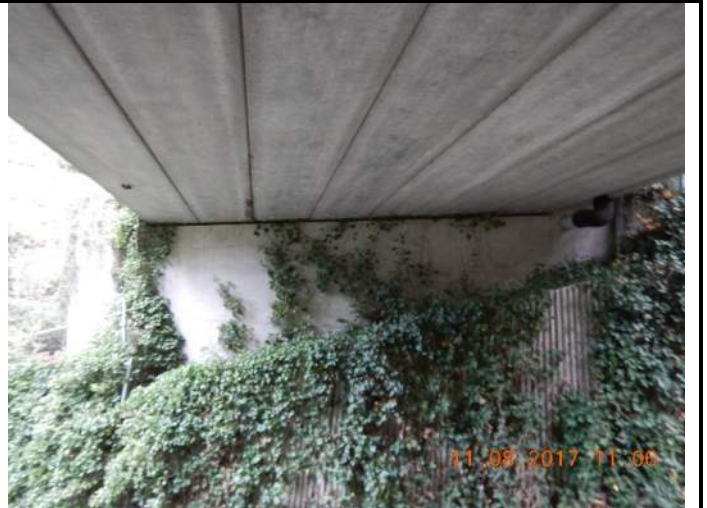
016 – Vegetation growth on North Abutment

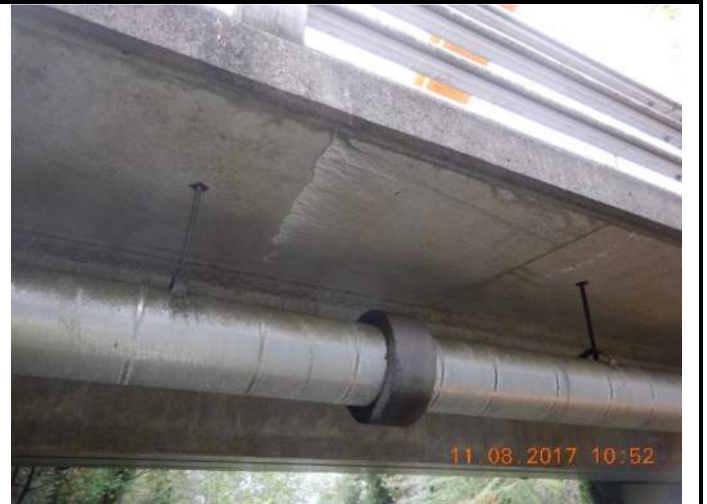
018 – Typical transverse cracks with efflorescence on the underside of sidewalk

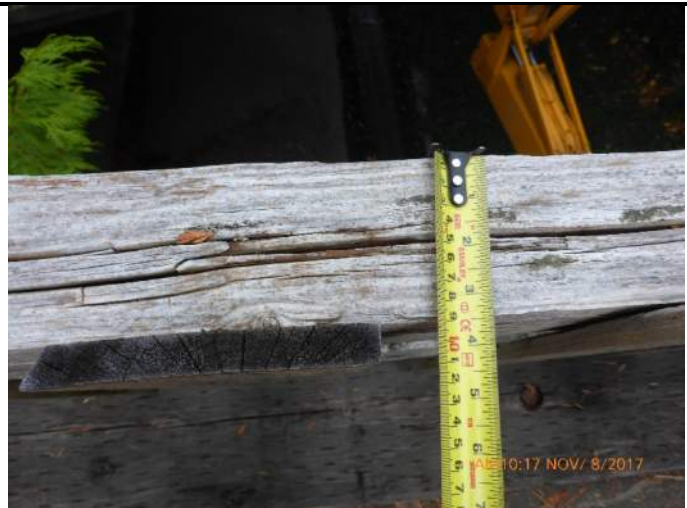
004 – Typical Railing condition – significant checks, signs of decay

- Recommend replacing guardrail system.

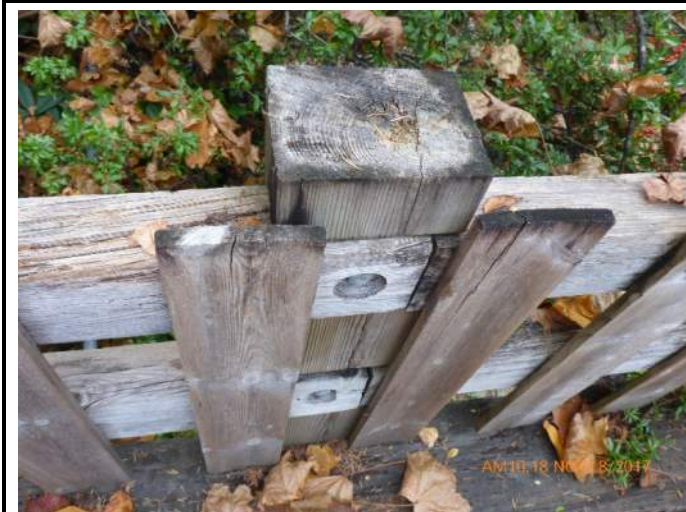
005 – Typical Post: soft timber, splits

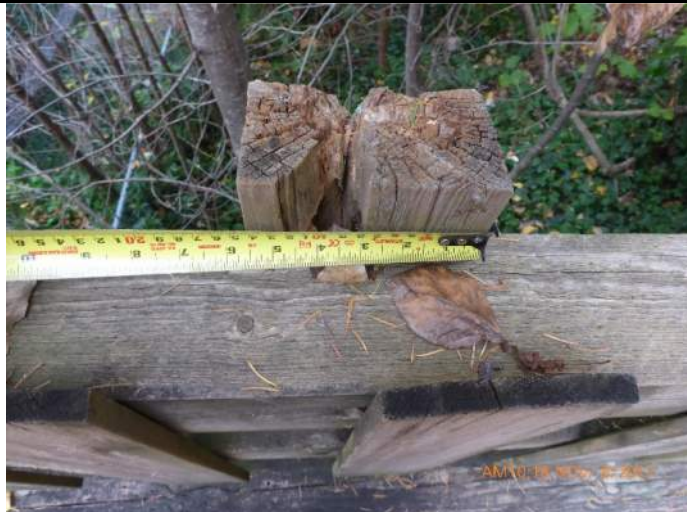
006 – 8 posts are failing (significant crushing)

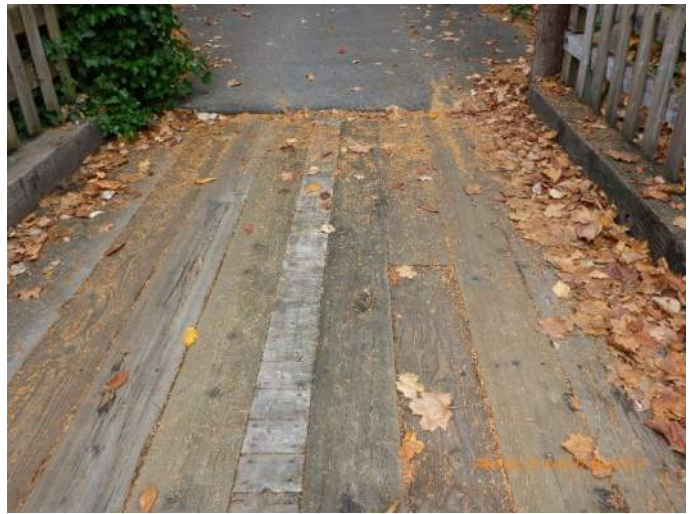
008 – Normal wearing at deck with minor checking

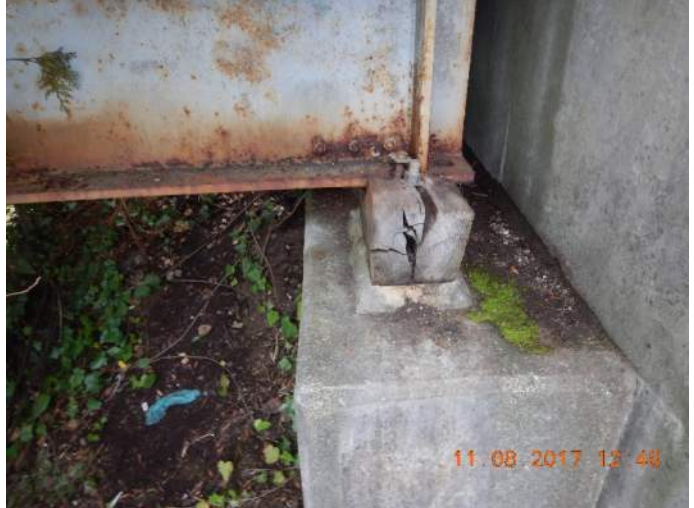
010 – South Abutment Bearing. Note severe cracks and crushing.

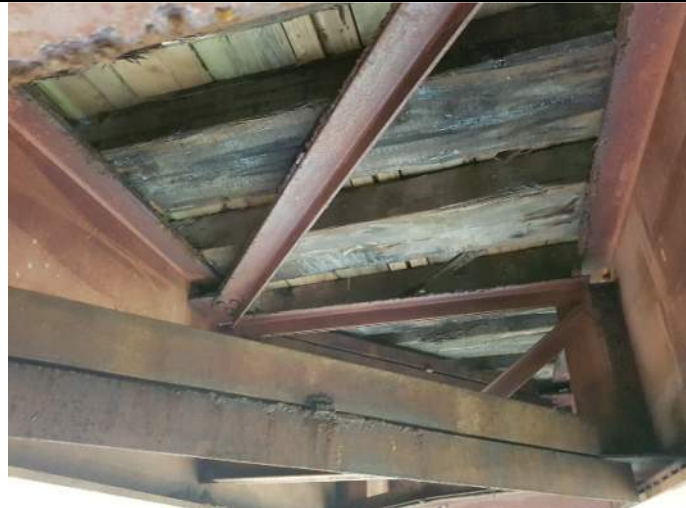
016 – Floor beams with extensive checks/splits typical.

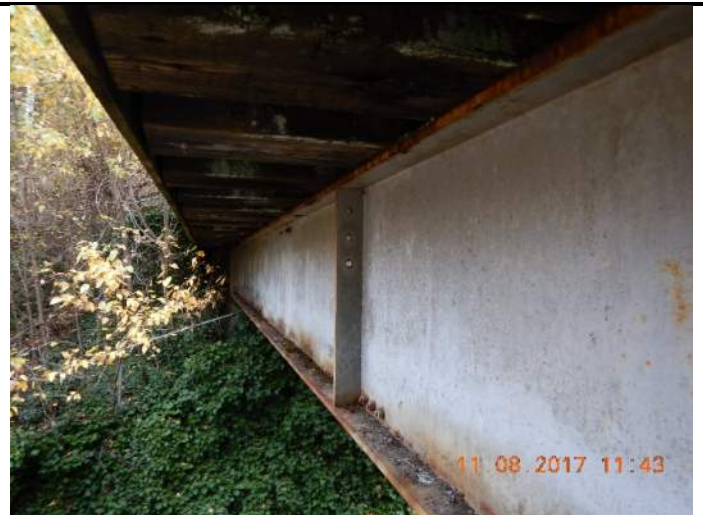
020 – Girder Exterior typical. Note surface rusting through coating.

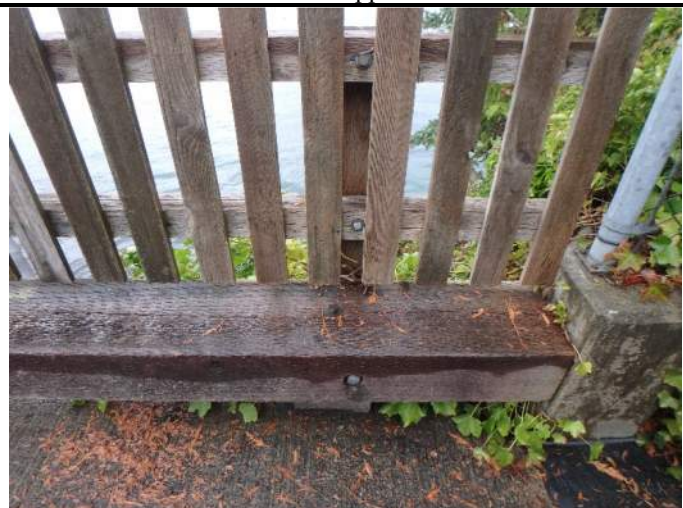
006 – Vertical plans in fair condition, all connections are poor (not adequate for load)

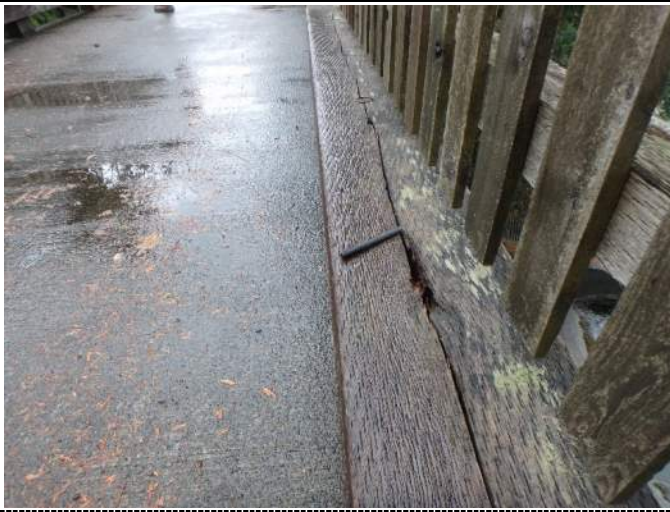
007 – Deep splits/checks, rot throughout wheel guard

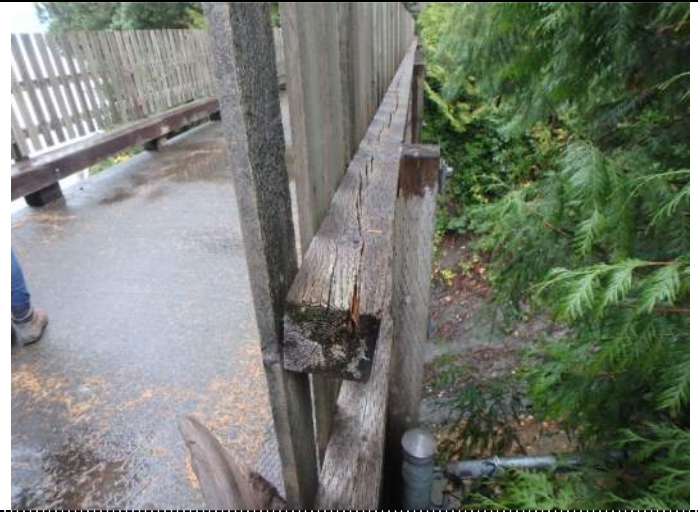
008 – Significant splits/checks, signs of decay at horizontal rails

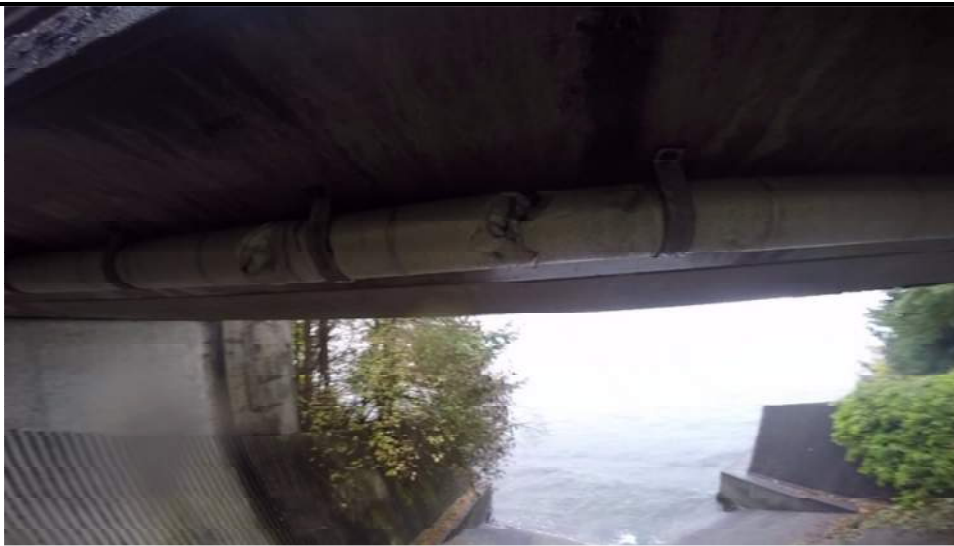
011 – Water main is damaged in several sections

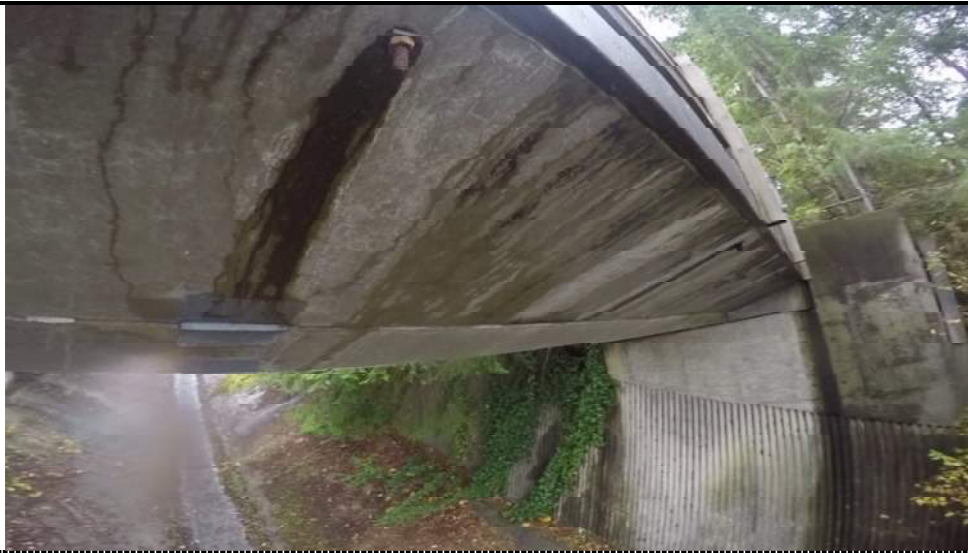
012 - Soffit overview, leakage through the bolts (hold down wheel guard)
