Project name:
Water Reservoirs Replacement

Technical Memorandum

Subject: Harvey Water Reservoir – Preliminary Structural Condition Assessment

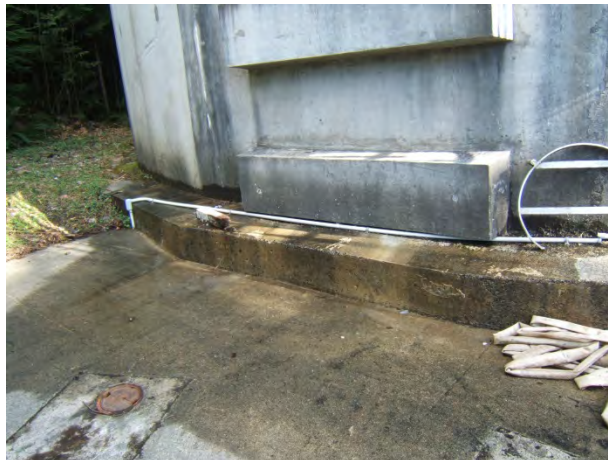
In 2004, AECOM (formerly Earth Tech) noted that the structure has some critical defects, such as extensive water leakage, which require urgent attention. The leaking between the wall panels is a concern because it could cause rapid deterioration of the post-tensioning steel. In 2006, a preliminary structural assessment was completed to determine the cause of the cracks and leakage which found that the foundation ring beam appears to be inadequate to support the hoop tension at the base of the wall. It is understood that internal rehabilitation works were attempted in early 2006 to seal both the vertical and horizontal joints (see Figure 2) and were only partially successful (see Figure 1) and that the full recommendations of the report were not implemented.

Figure 1: Record Photo of Horizontal Seam Leakage (March 20, 2006)

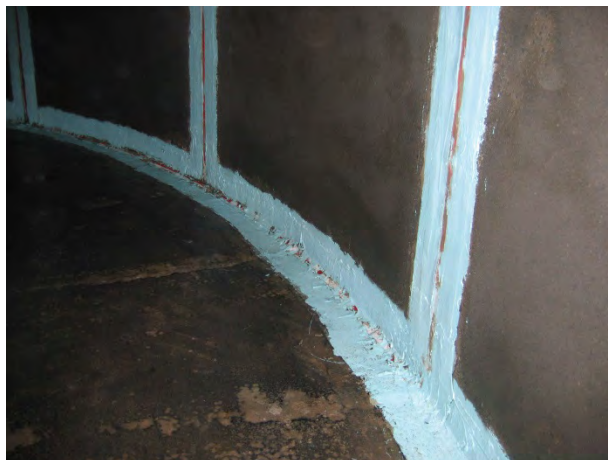
Figure 2: Record Photo of Internal Tank Joint Sealant (Feb 27, 2006)

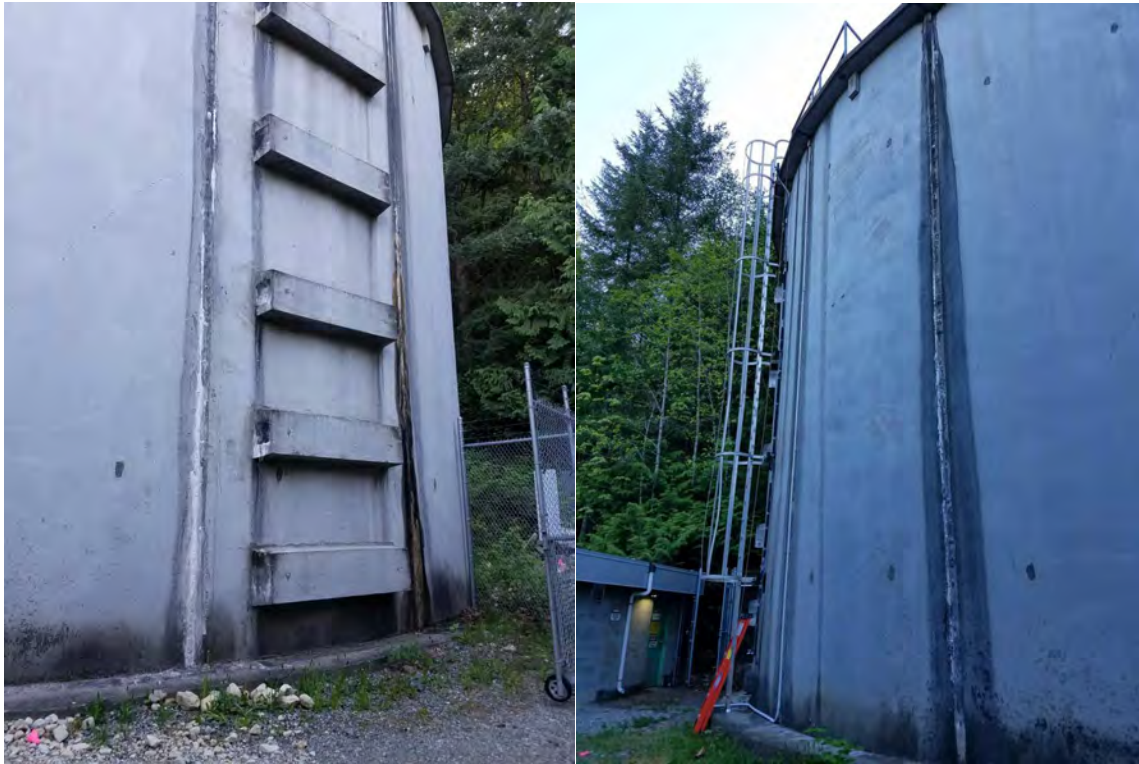
- One vertical joint between tank precast wall panels displaying leakage from the bottom to 2/3 of the tank height. There was a small amount of water dripping down along the joint with white efflorescence deposit along the joint. Similar white efflorescence deposits were observed at other wall panel joint locations, however the joints are dry upon touch.

Figure A2.1.1: Wall panel leakage facing southwest (left) and northwest (right)

In addition to seismic upgrades, repair and resealing of vertical joints is required. Repairing the vertical joints between precast wall panels includes: removing current interior repairs; routing out interior joints and patching with a waterproof patching mortar; repair exterior failed joints where required and inject leaks (as required); install exterior tensioning and shotcrete the entire exterior surface. The roof will require repair and resealing after installation of walls. Following vertical joint repair, resealing of the base joint between the wall and base slab including removal of existing repair is recommended.

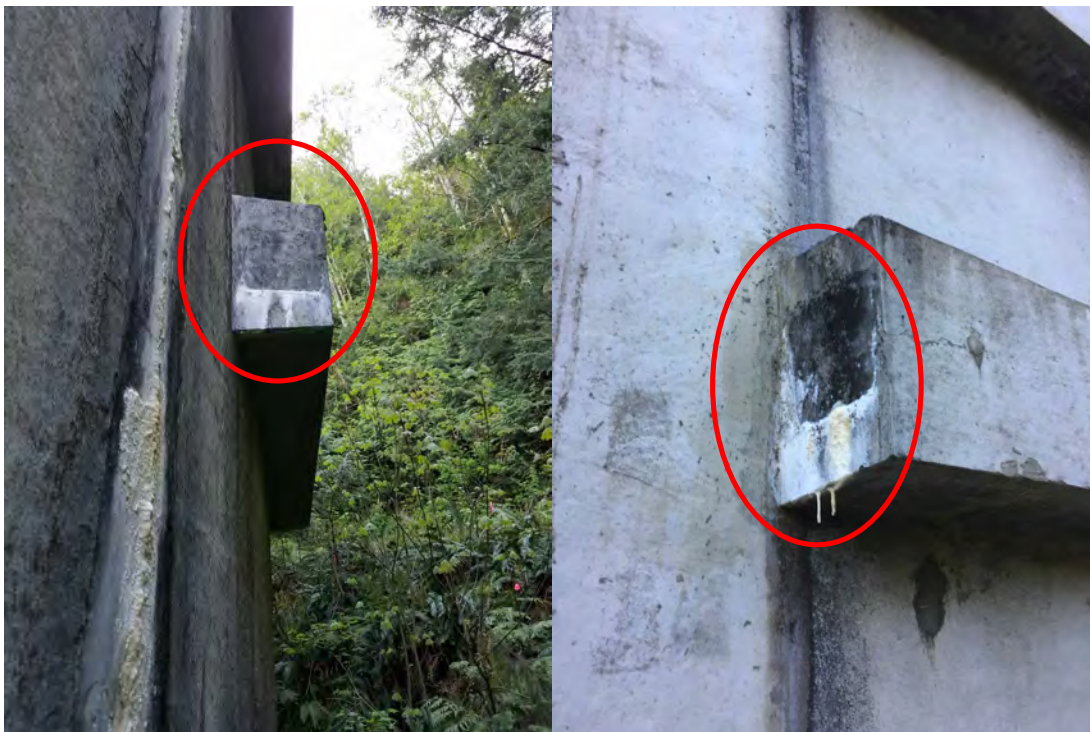
- Nearly all buttresses are showing white efflorescence deposit at the post tension grouted pockets at each end. This provides evidence that water has infiltrated the tensioning steel strands which will lead to corrosion and deterioration. It also indicates weakened tension stresses in the steel stand cables, which comprise the structural function of the post tensioned tank wall panels.

Figure A2.1.2: White efflorescence deposits at grout filled pockets on each end of the post tension buttress

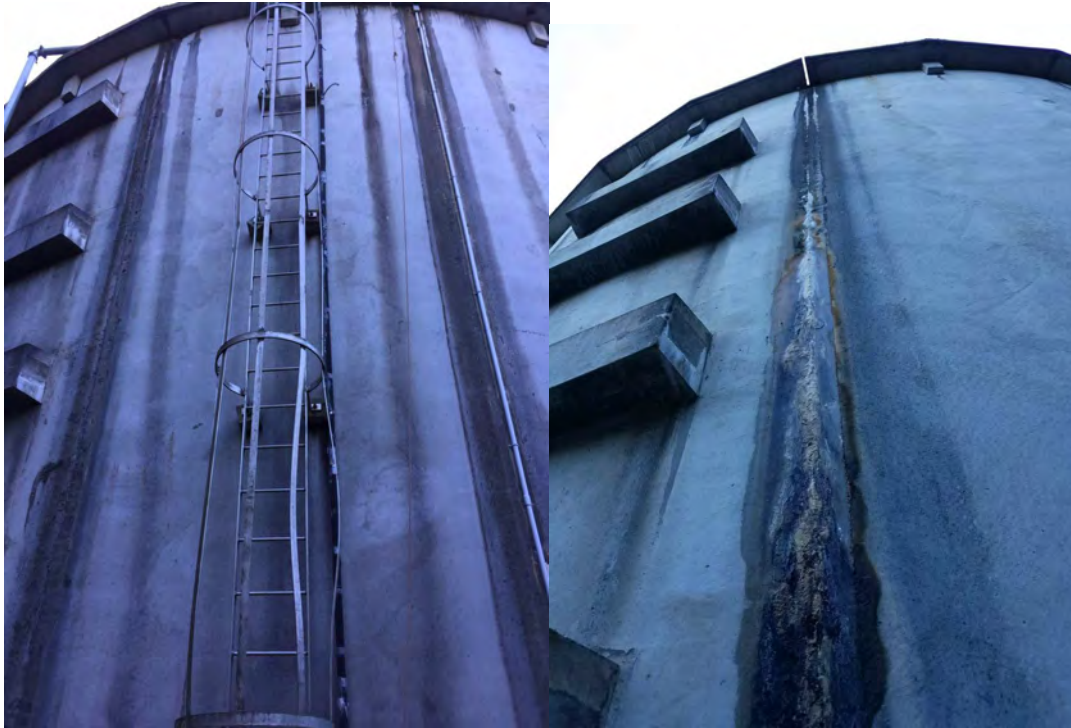
Figure A2.1.3: External access ladder cage (left) and wall panel leakage (right)

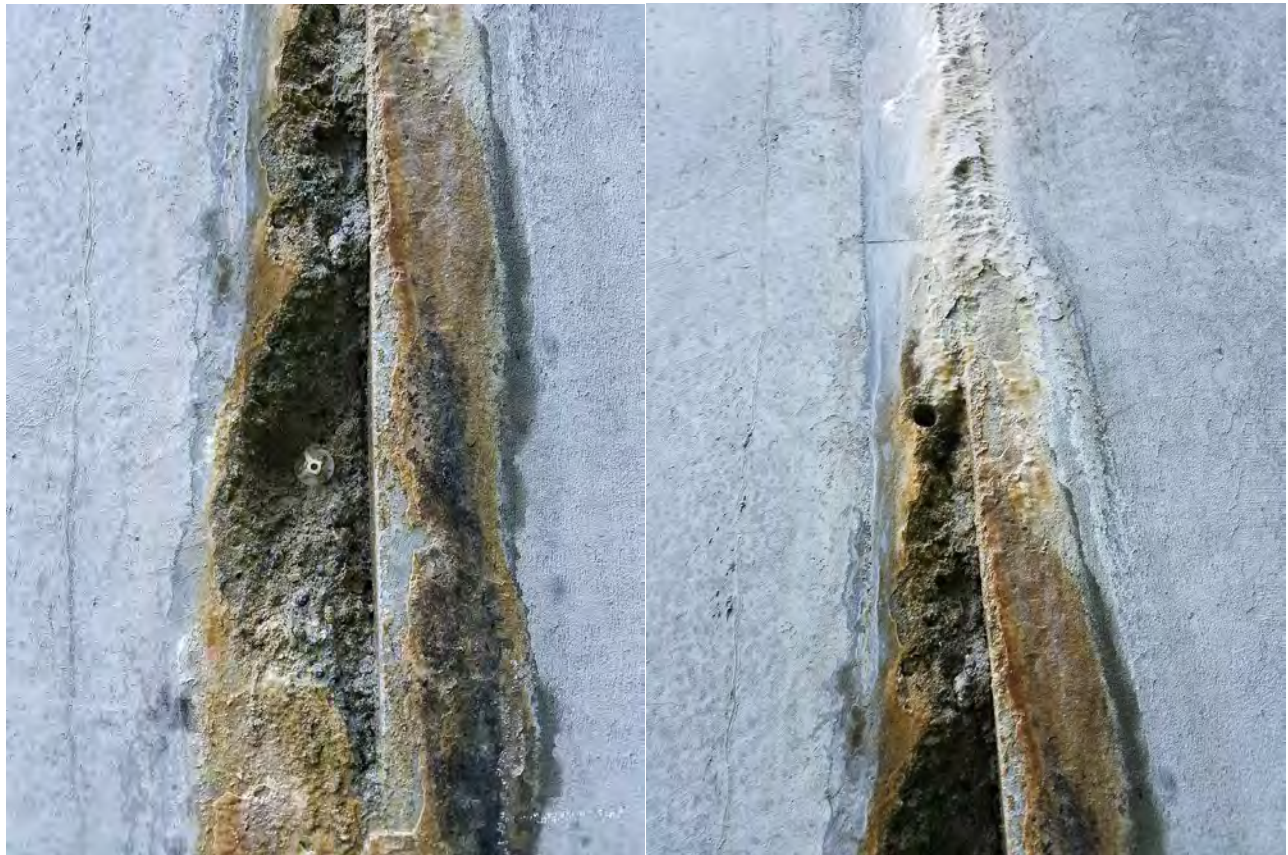
- Evidence that external joint repair by injection has failed, particularly on southwest of tank approximately 1.5 metres above grade, see Figure A.2.1.4.

Figure A2.1.4: Wall panel material deterioration and evidence from previous repairs

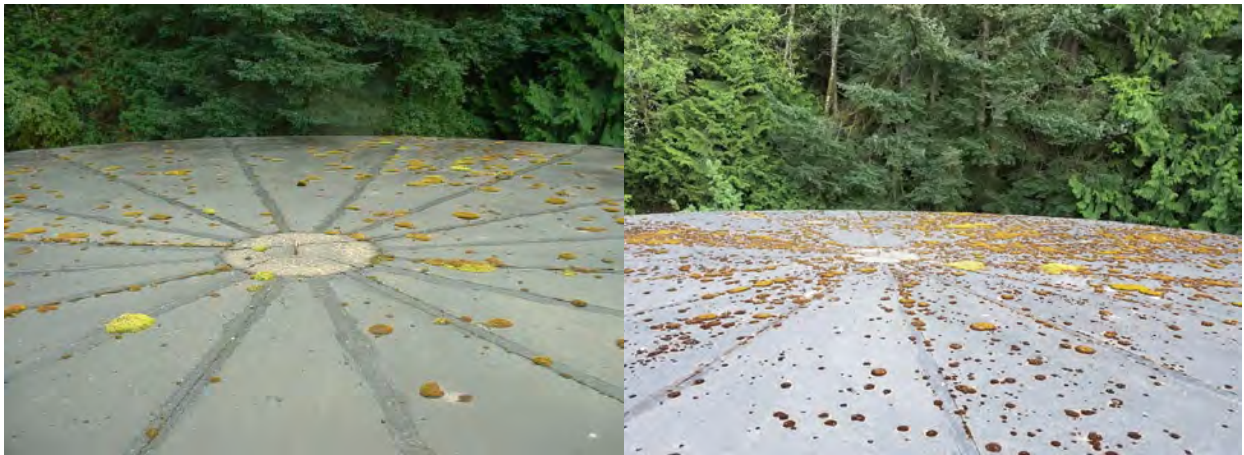
- The recommended ring beam upgrades do not appear to have been completed.
- Growth of green moss and vegetation continuing to progress on the roof of the tank.

Figure A2.2.4: More green moss/vegetation growing on the roof, left picture from 2005, right picture from 2018

Lastly, due to the inadequate crack control of the reservoir roof, it is recommended that a waterproofing membrane be installed over the entire roof area. This will prevent contaminants from entering the reservoir through cracks which may form in the roof slab.

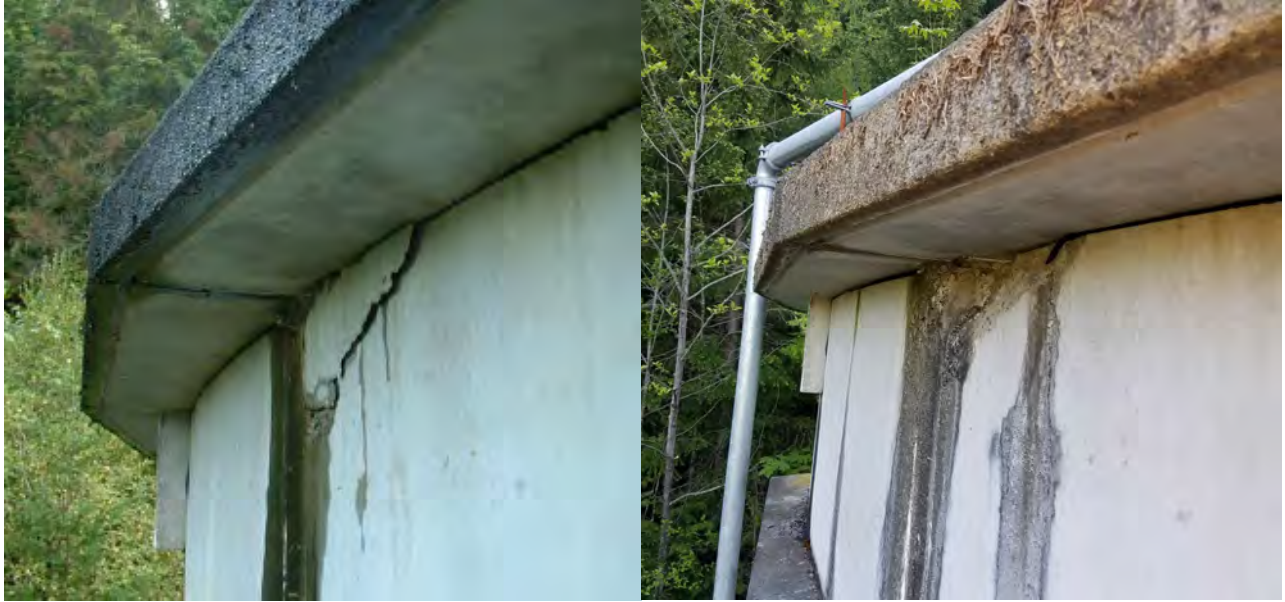
- One precast wall panel shown diagonal crack at the top in one corner near the ladder in 2005. This corner piece was partially missing during this site investigation. The waterstop at the top between the wall and roof was exposed and discontinued at this location, see Figure A2.2.5. Comparison of photos taken in the 2005 inspection to current status, all joints between wall panels show progressed deterioration, however there was less wet leakage observed during the 2018 site visit. The leaking joints indicate that the joint detail at the interior of the wall has failed.

Figure A2.2.5: Wall/roof connection damage on north panels, left picture from 2005, right picture from 2018

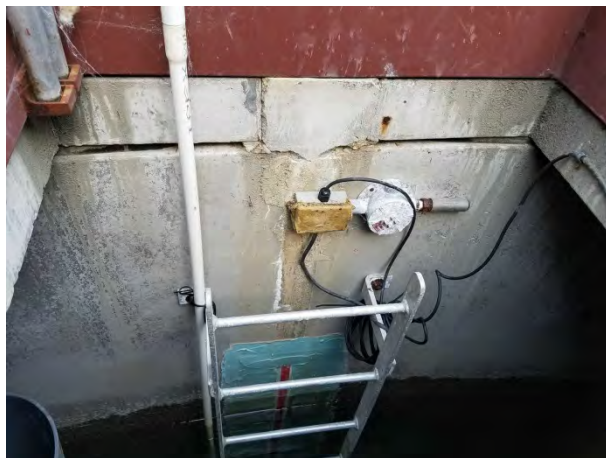
Figure A2.3.2: Internal access ladder and instrumentation. Evidence of previous rehabilitation on vertical panel seam observed behind ladder.
