Village of Lions Bay

Water Storage Facilities Replacement

Contract Documents
Issued for Tender

Volume 3 of 3
Appendices

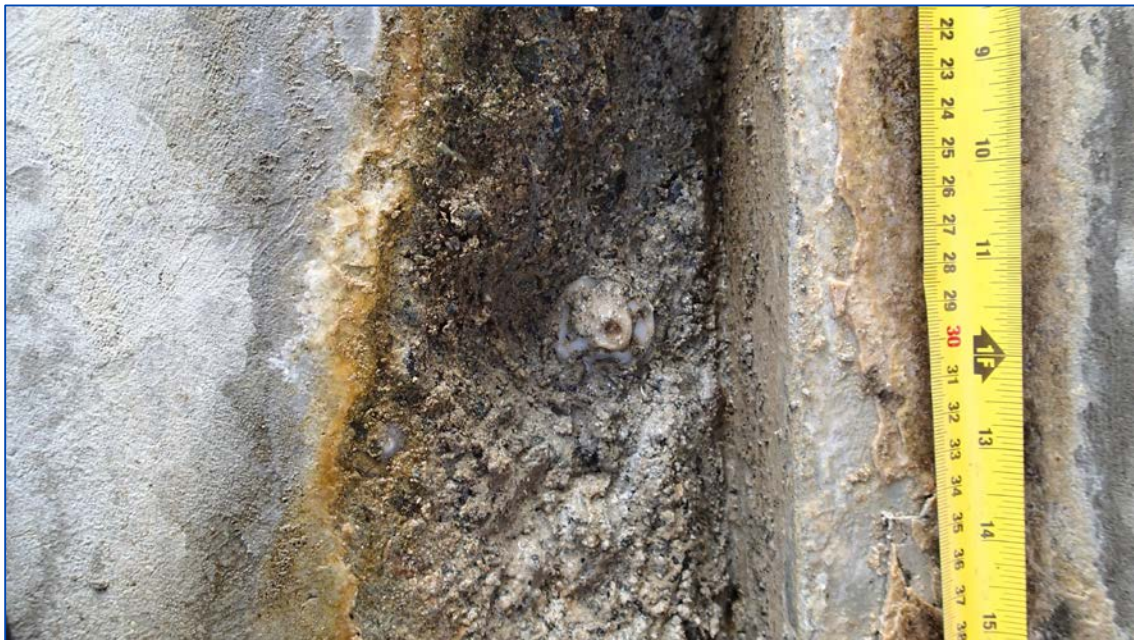
Photo 6: Close-up of Photo 5 showing deterioration of the joint.

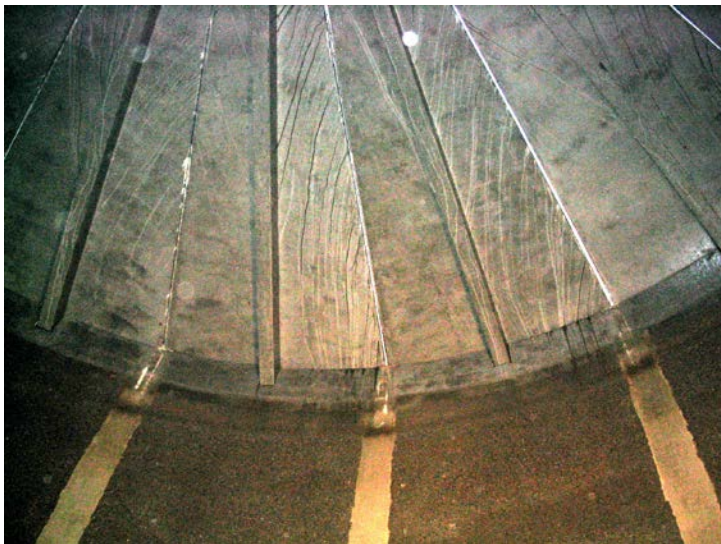
143. Note water leaking through roof panel joints

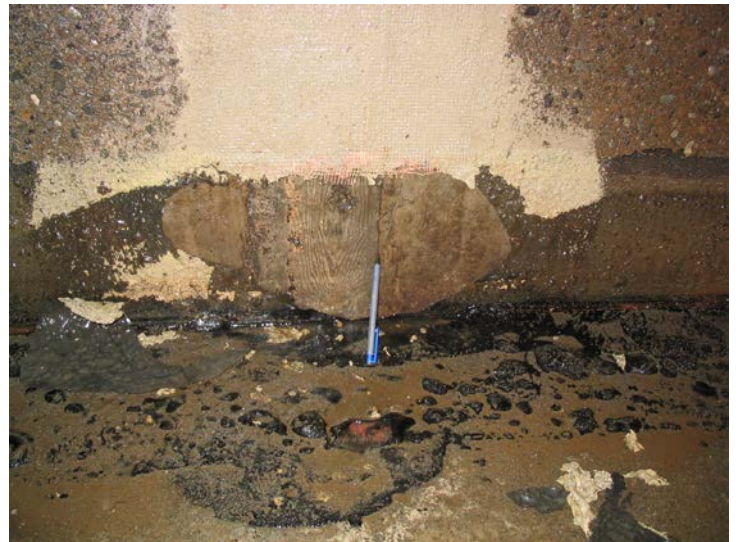
150. The rubberized material was easily pulled away from the wall and revealed vertical joints between wall panels. Water was seen to be leaking through this joint from the outside of the tank.

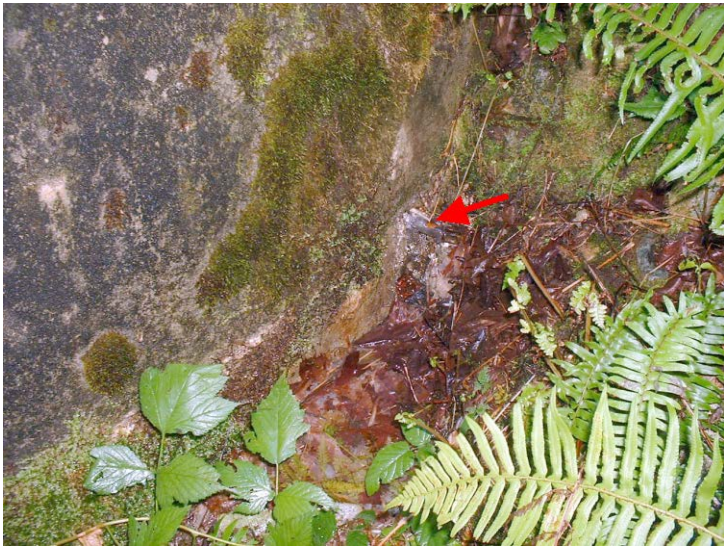
84. Hole at bottom of wall where water was observed to pouring out similar to water out of a tap

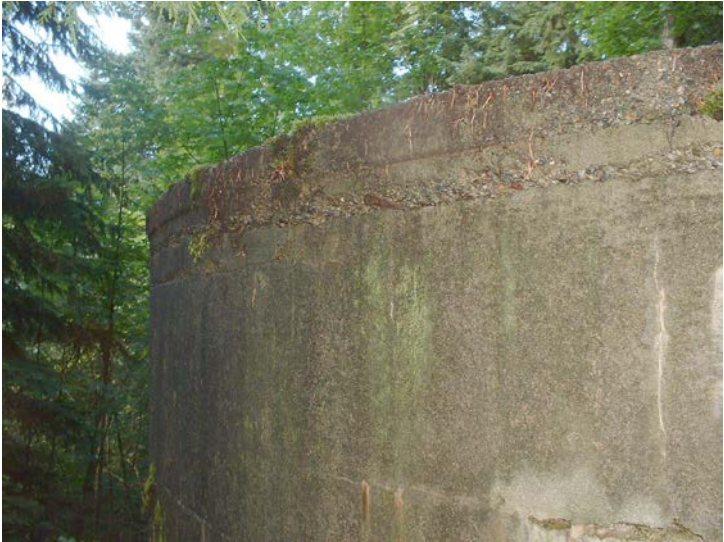
86. Horizontal crack at roof level on wall

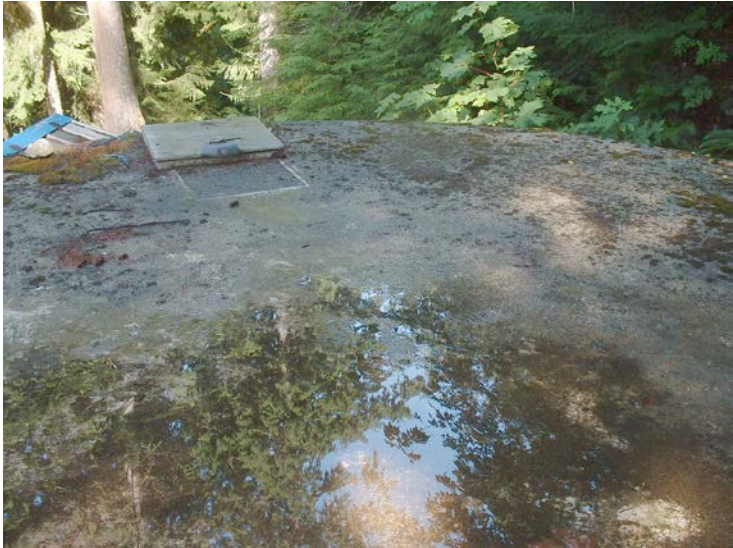
87. Water pooling on roof

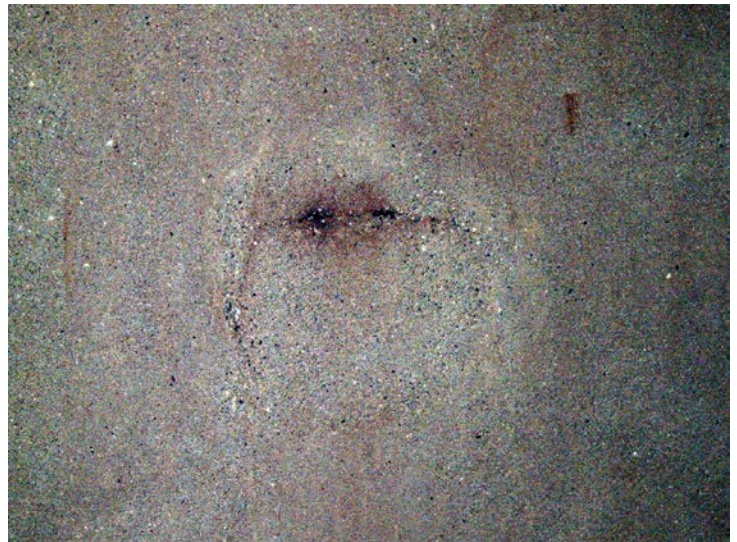
164. Cracked and delaminated concrete at east side of reservoir interior wall.
