The Village of Lions Bay: A Natural Hazards Assessment Area Strategy for Coastal, Creek and Hillslope Hazards.

Submitted by
Cordilleran Geoscience
PO Box 612,
Squamish, BC
V8B 0A5

V1: November 30, 2017; V2 December 19, 2017; V3 January 4, 2018; Final V4 January 18, 2018; Final V5 June 25, 2018

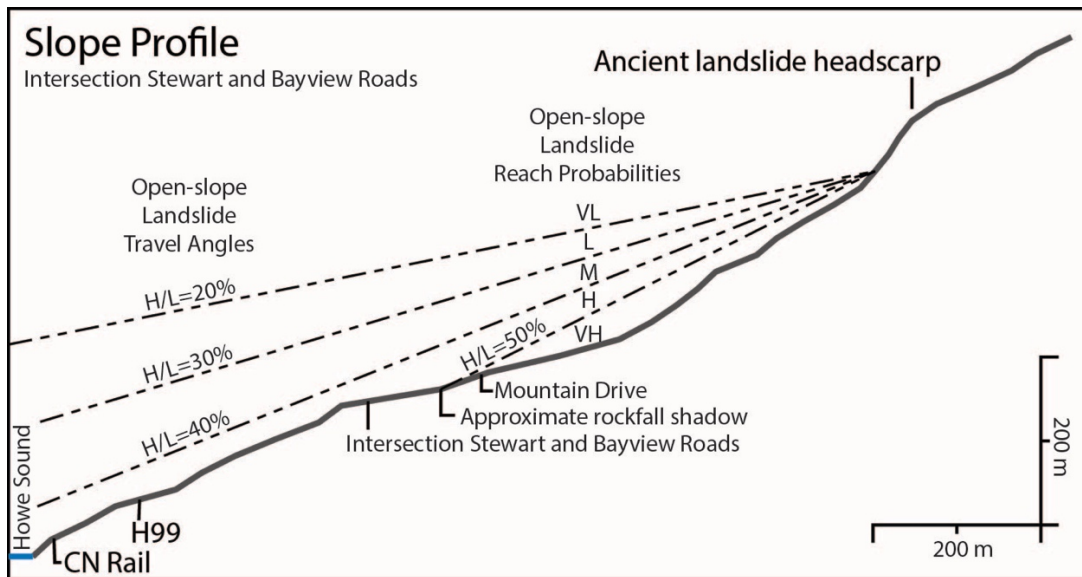
On the basis of the analysis above, to reduce the probability to no less than tolerable (1:10,000 per annum) of Type 1 error, that is, declaring a site free of hazard when in fact hazard exists, it was determined that the lower boundary for the open-slope NHAA 3A should be established using the lower limit of the Low reach probability category, equating to an H/L of 20% (11⁰). Projecting this slope from some potential start zone high on the slope above the subject property captures essentially the entire municipality (Figure 4).

Figure 4. Topographic slope profile through the intersection of Stewart and Bayview Roads. Open-slope travel angles are plotted from a hypothetical start zone on the slope below the cliff and show that runouts can extend very far down the slope.

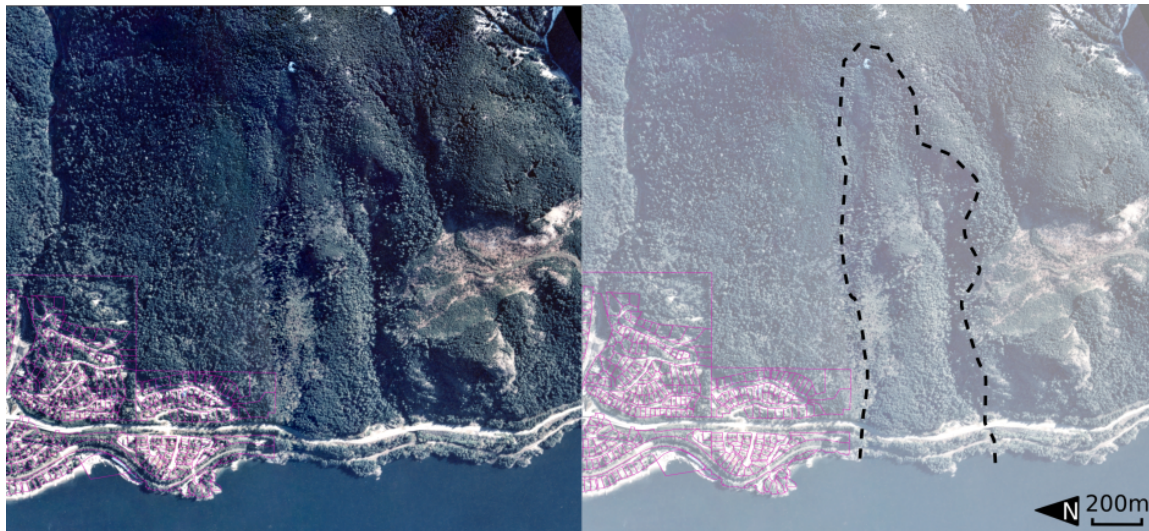
Just 100 m south of the Village of Lions Bay, the whole slope from sea level to 1100 m elevation shows signs of weakness. The area is sided by two linear depressions defining an area about 500 m width and delimited by a horseshoe-shaped headscarp at the top and by a convex toe at sea level (Figure 5). The convex toe dictates the highway path. The stability of this feature is unknown. This area is outside the LIDAR coverage but it has been recognized and mapped on the historic orthophotos. In personal communication, this area was previously identified to Cordilleran Geoscience by Karen Savage, P.Eng., of Horizon Engineering. Even if this feature might not directly affect Village of Lions Bay, it affects the highway and may pose significant hazard to the access to the Village of Lions Bay.

Figure 5. Potential sacking slope identified just south of Village of Lions Bay.

These examples of potential deep-seated instability require characterisation and assessment by a qualified geological engineer.

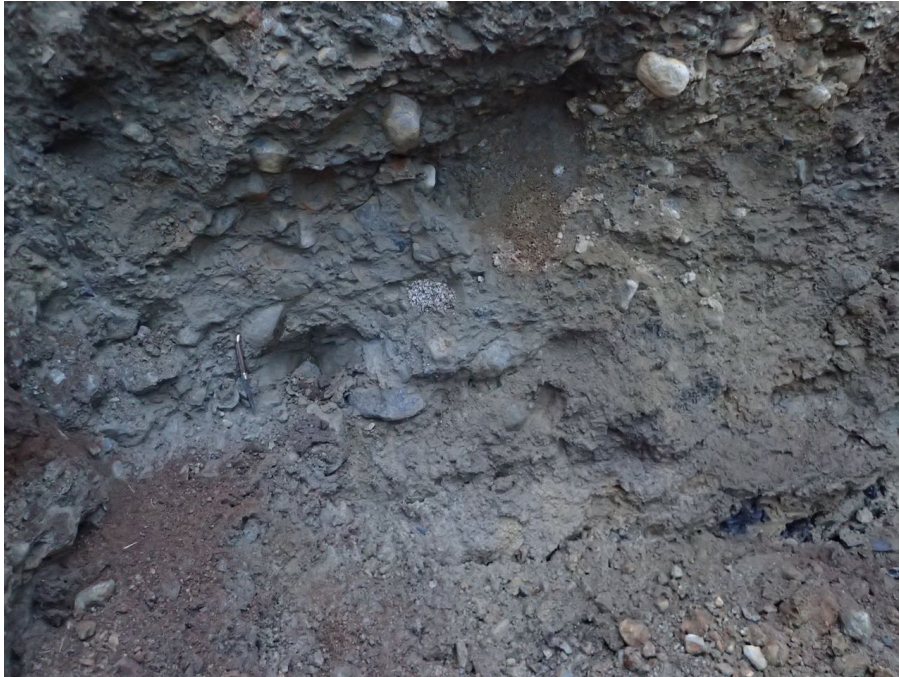
Morainal materials deposited during the last glaciation are known as Vashon Drift (a complex of till, glaciofluvial and glaciolacustrine sediments) (Photo 1). Glaciofluvial deltaic and glaciomarine sediments were deposited up to an elevation of 220 m (Photo 2). These sediments are known as Capilano Formation. Glaciofluvial deltaic sediments are found in the gravel quarry at Magnesia Creek (120-140 m elevation) and the fan-delta morphology extends upslope to its apex at 280 m elevation, while bouldery fan-delta sediments at Harvey Creek extend up to 220 m elevation. Fine grained marine sediments are typically found on benchlands, such as the east point of Anvil Island where clays were mined for manufacturing of brick.

Photo 1. Till in house excavation, Lot 60 Oceanview Road.

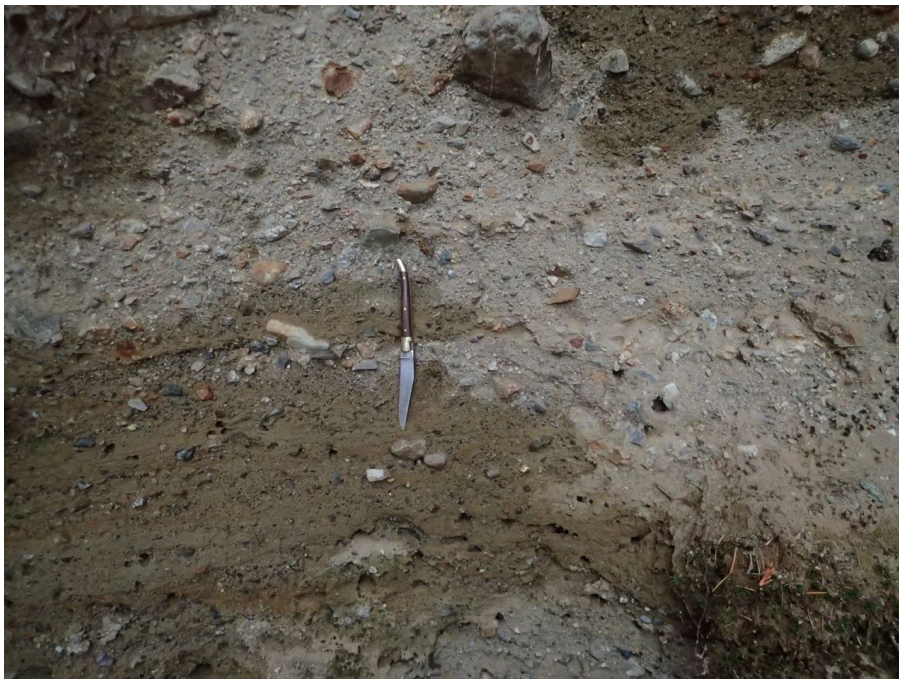
Photo 2. Glaciofluvial fan-delta sediments, 160 m elevation, Lot 22 Highview Place.

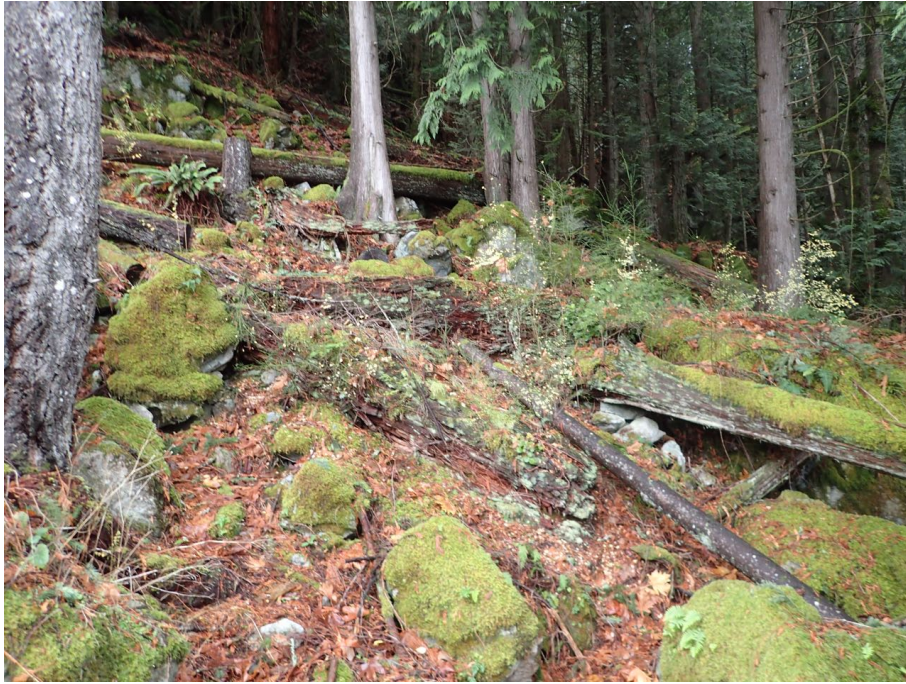
Photo 3. Blocky talus slope on Lots 60-61, Kelvin Grove Way.

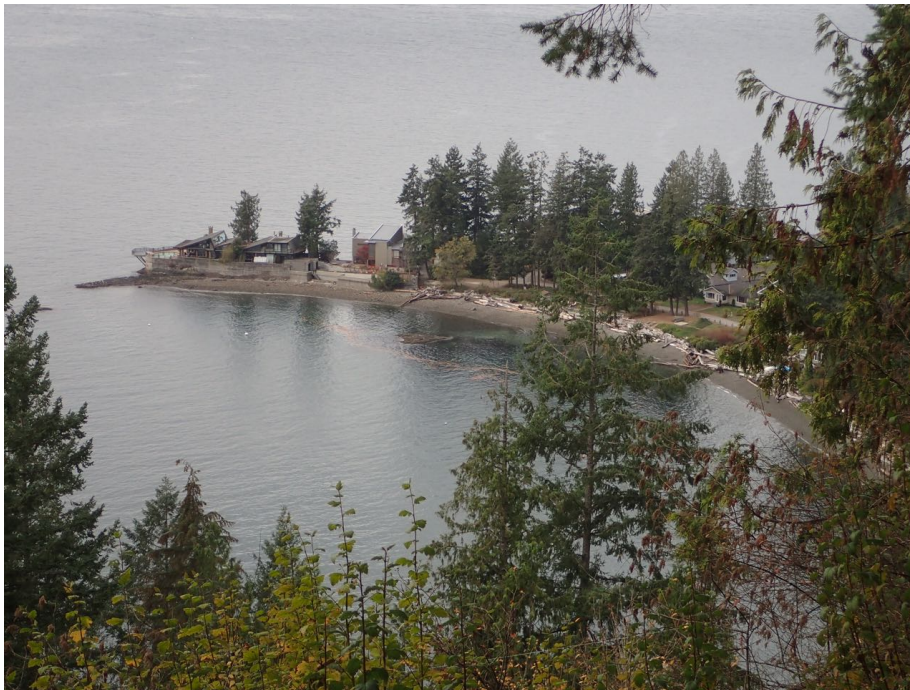
Photo 4. View of the tombolo spit, Brunswick Beach. Low lying land is subject to flooding and erosion given sea level rise.

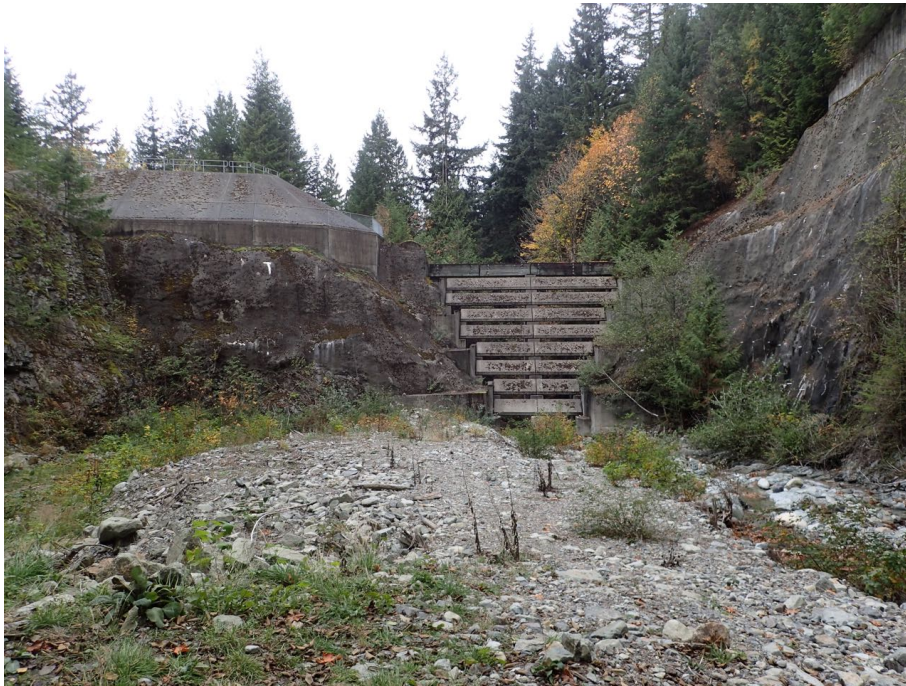
Design of mitigation for Harvey, Alberta and Magnesia (Photo 5) creek hazards in the 1980s was based on the Design Event (Table 7). Since there was no data available to prepare a debris flow frequency analysis, the Design Event was based on the “largest volume that could reasonably occur during the life of the structure” (Hung et al. 1984). The method assigned an estimated channel yield rate (m³/m) to the total channel length in the watershed; 10% might have been added to account for point sources. The storage structure volume was then made 15-25% larger than the design debris flow (Table 7). The channel works downstream of catchments were sized to accommodate twice the design event.

Photo 5. Magnesia Creek catch basin.

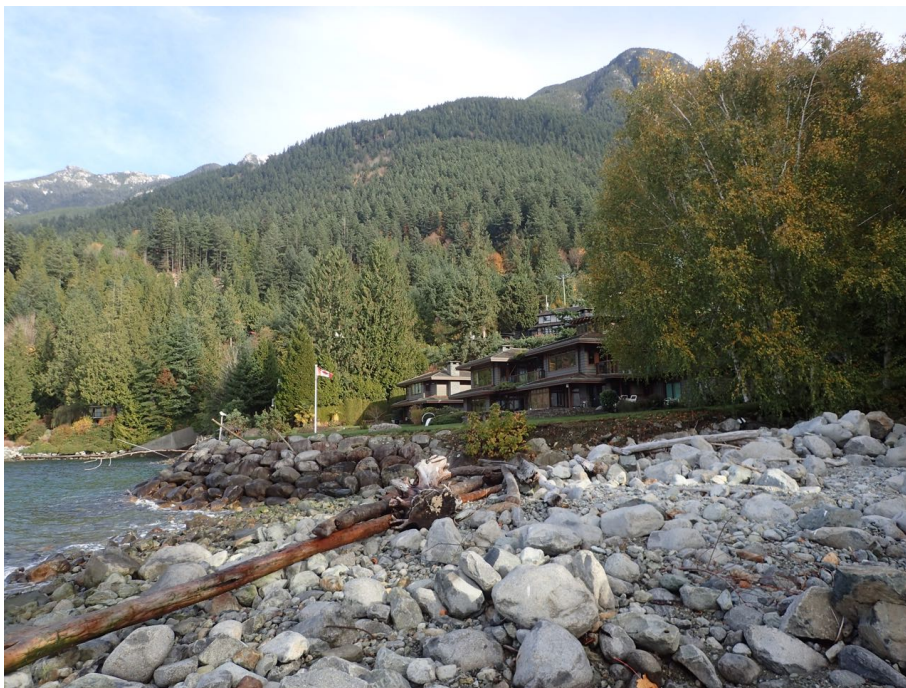
Water flood and debris flood hazard may present downstream of catchment structures as well. Where an engineered flume is present it has more than enough capacity to accommodate water floods and bulked debris floods. However, it was noted that for example on Harvey Creek, the engineered flume does not extend right to the beach, so in that area lots may be vulnerable to floods and debris floods (Photo 6).

Photo 6. Lots 21 & A Lions Bay Avenue have natural banks not significantly raised above Harvey Creek, and could be vulnerable to flood hazard.

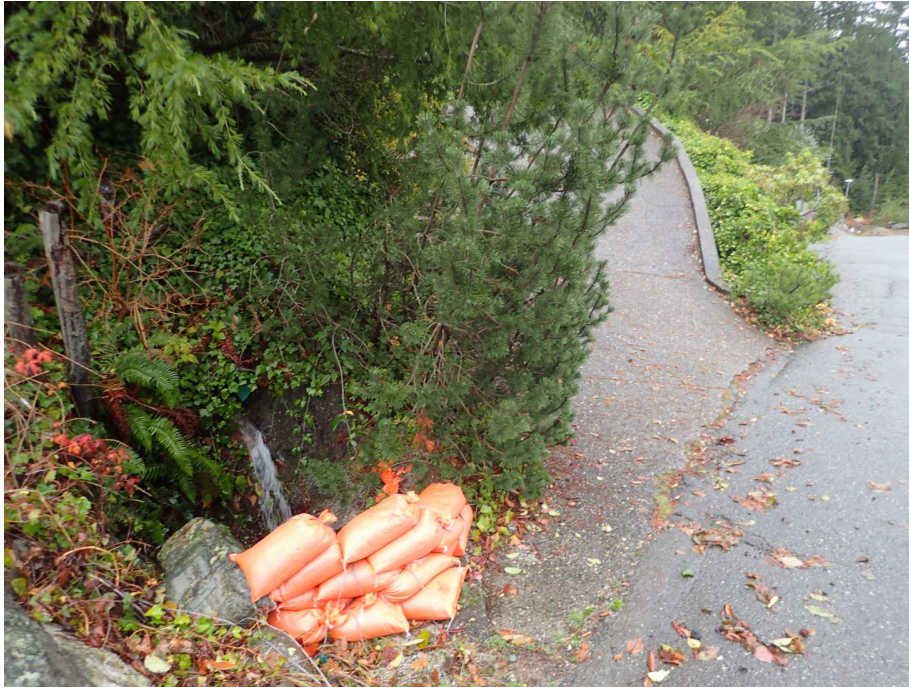
Photo 7. Lot 66 Kelvin Grove Way. Small Creek captured by drainage system undersized for full range of flows requires sand bagging to prevent overflow onto local road.

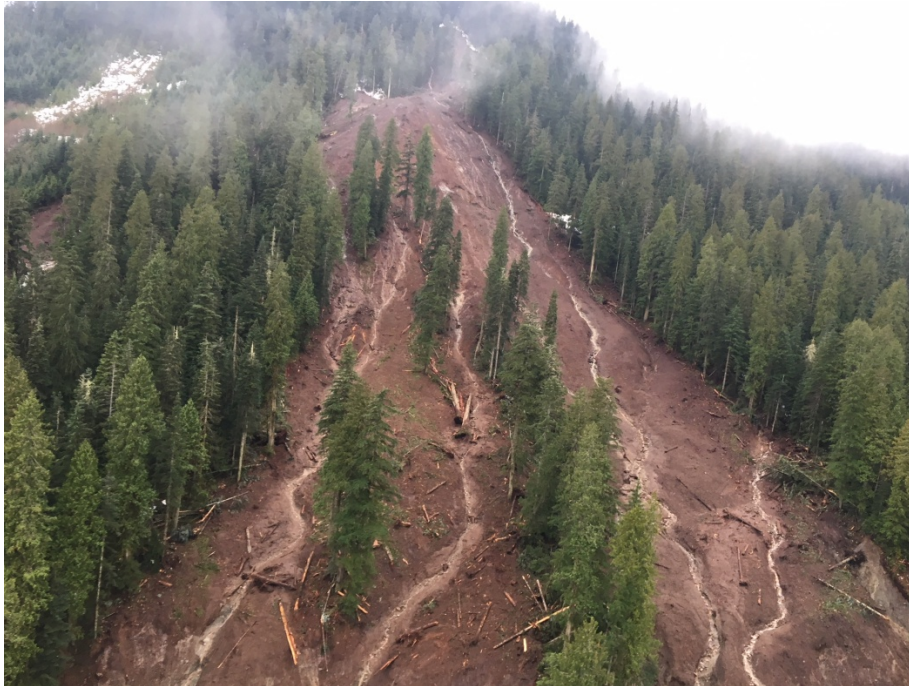
Open-slope landslides typically involve fragmented bedrock, organic debris, and mineral sediment (Photo 8). A typical slide is triggered by rockfall from a bluff, by windthrow of large trees on a steep slope, or by slab failure of a weathered soil veneer. The headscarp failure plane is typically >60%, but sometimes as low as 40%, or less.

Photo 8. Open-slope landslide, North Vancouver mountains, triggered by rain on snow, November 22, 2017.

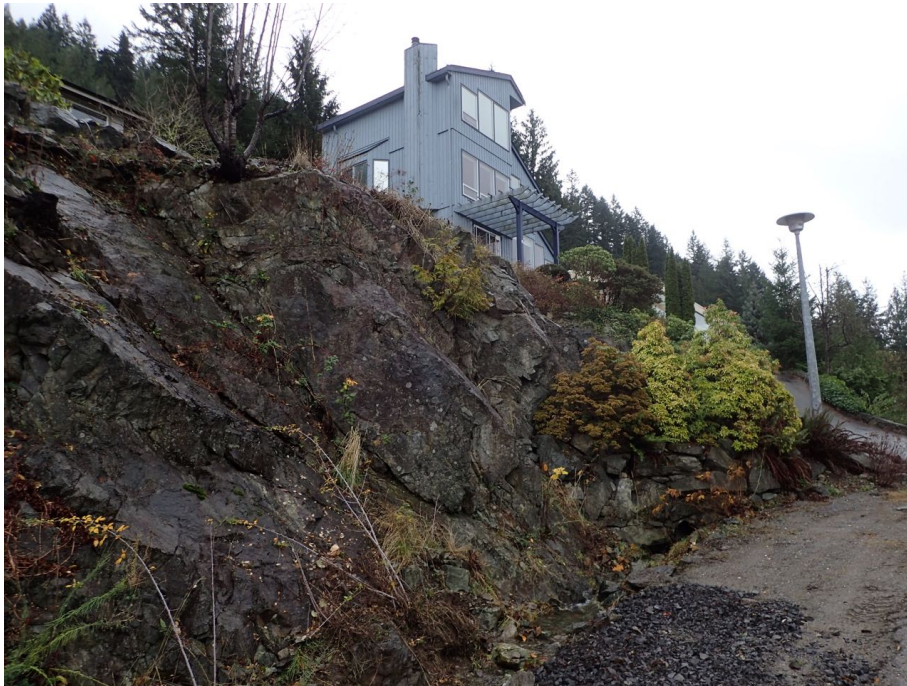
Photo 9. Unfavourable jointing in road cut, Lot 85 Kelvin Grove Way.

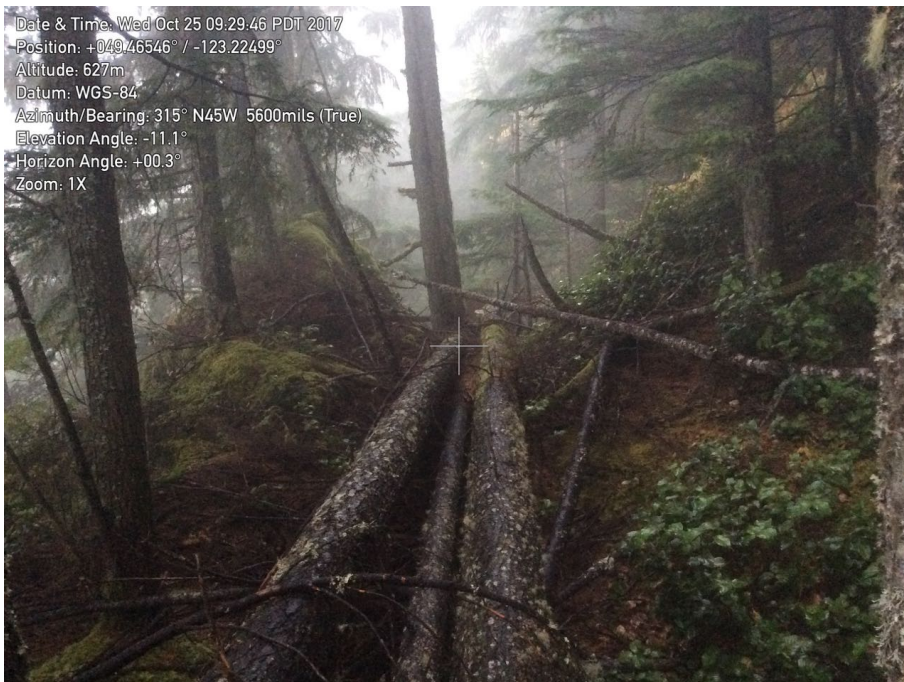
Photo 10. Waypoint 46. Antislope ridge indicating steep joint cutting crest of cliff. Several 10s m³ to 1000s m³ could be released from this site.

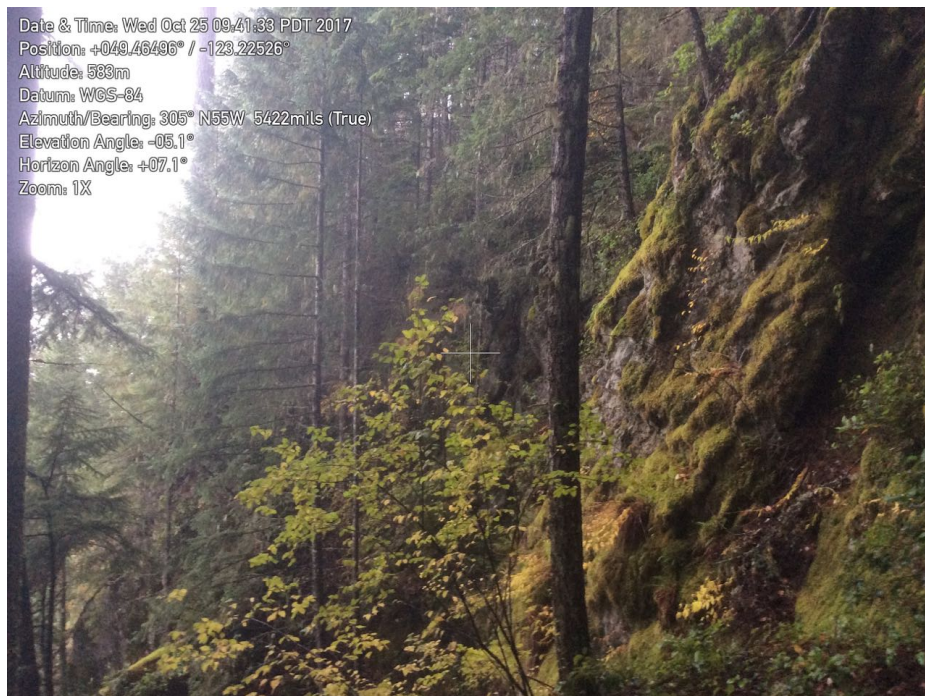
Photo 11. Bluff above Mountain Drive with unfavourable joint, parallel to steep slope.

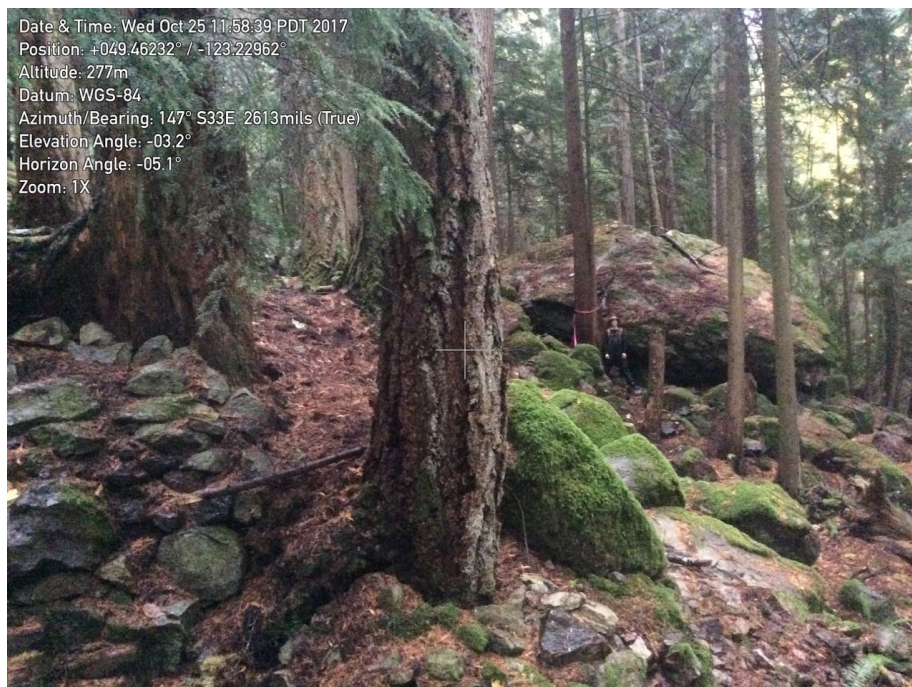
Photo 12. Rockfall debris, Lots A & B Timbertop Road. Note the person for scale.

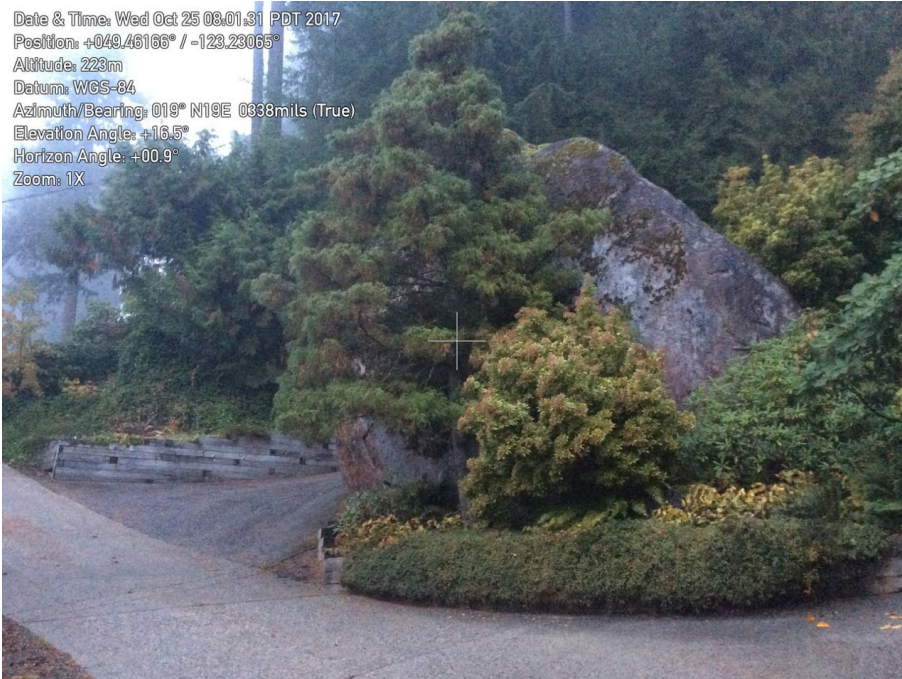
Photo 13. Rockfall block, Lot 36 Timbertop Road.

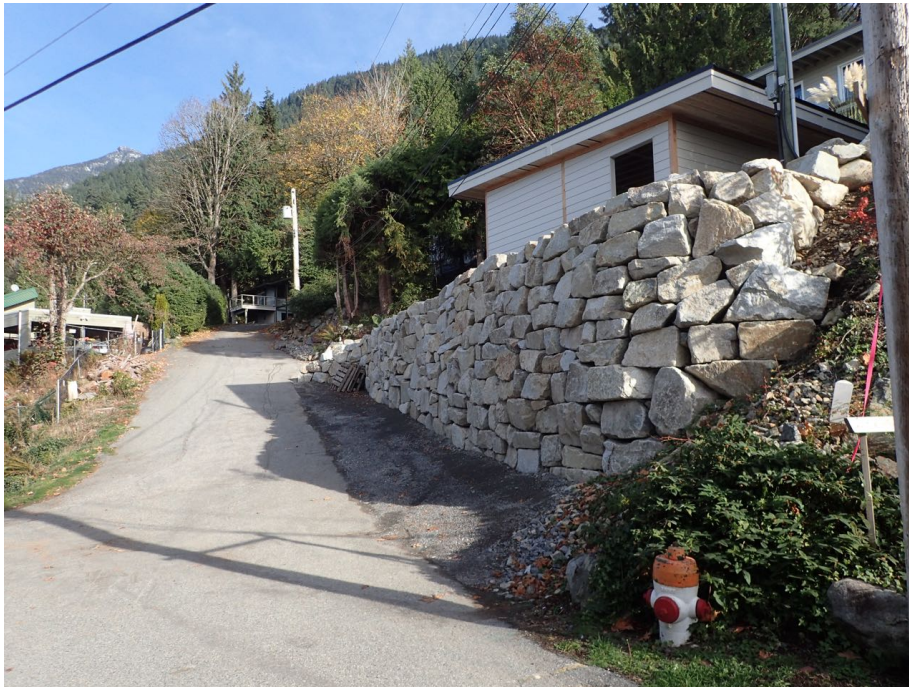
Photo 14. Lot 8 Islevue Place. Retaining walls in steep terrain require engineered design.

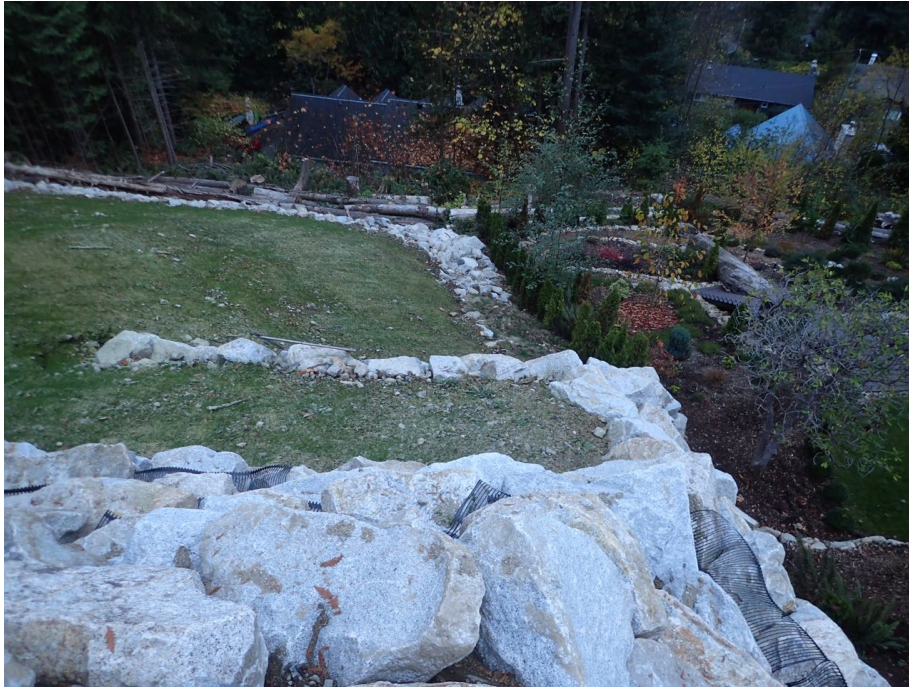
Photo 15. Stacked rock wall in steep terrain using geotextile to tie back into slope.

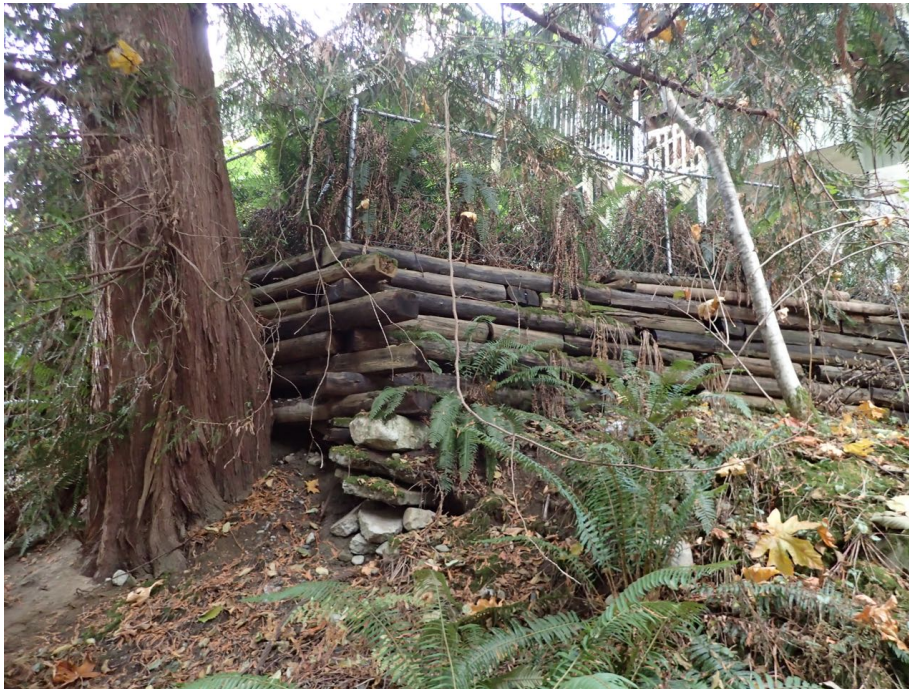
Photo 16. Substandard retaining walls represent a slope hazard.
