Village of Lions Bay

Water Storage Facilities Replacement

**Contract Documents
Issued for Tender**

**Volume 3 of 3
Appendices**

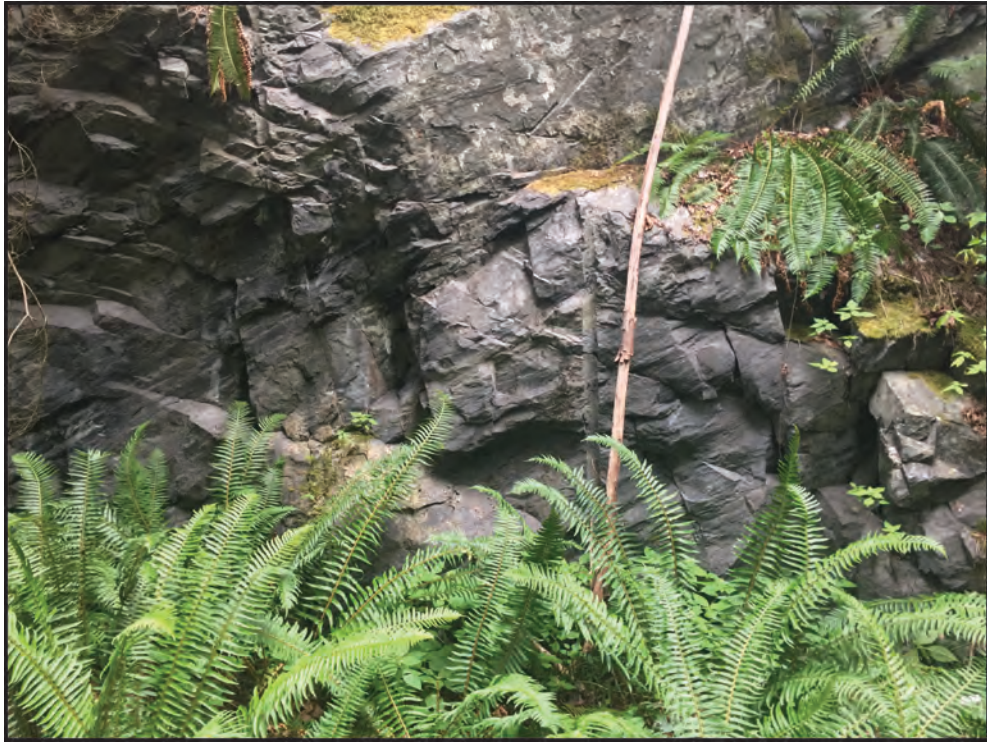
Figure 23: Basalt exposure behind Harvey Tank. Blasting tube visible in middle of photograph, facing east.

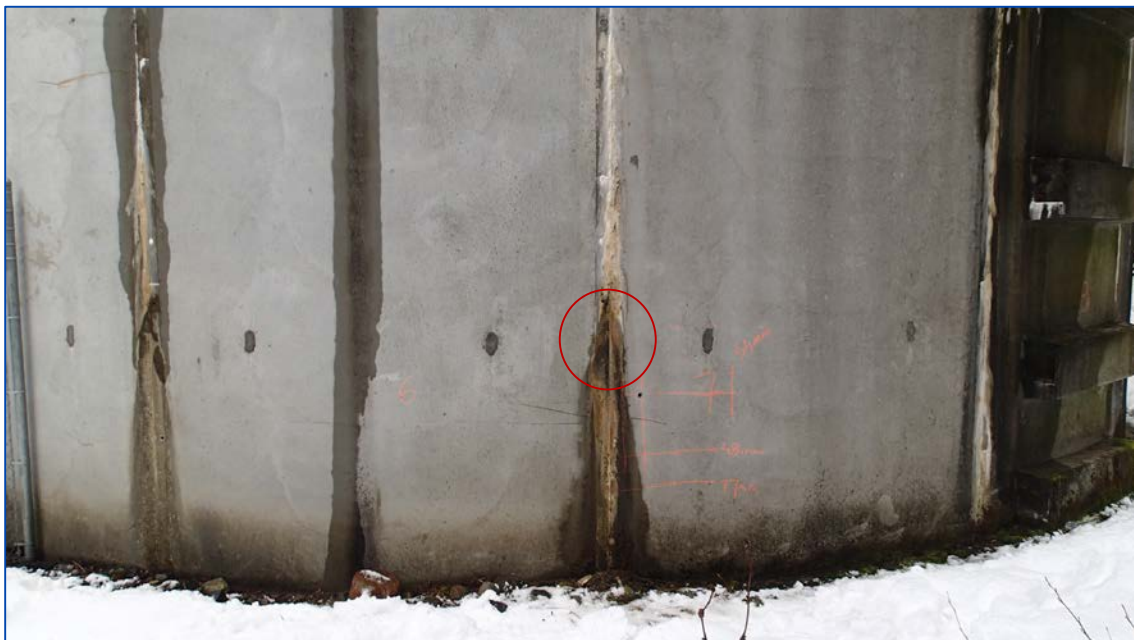
Photo 4: Leaking joints between the precast wall panels.

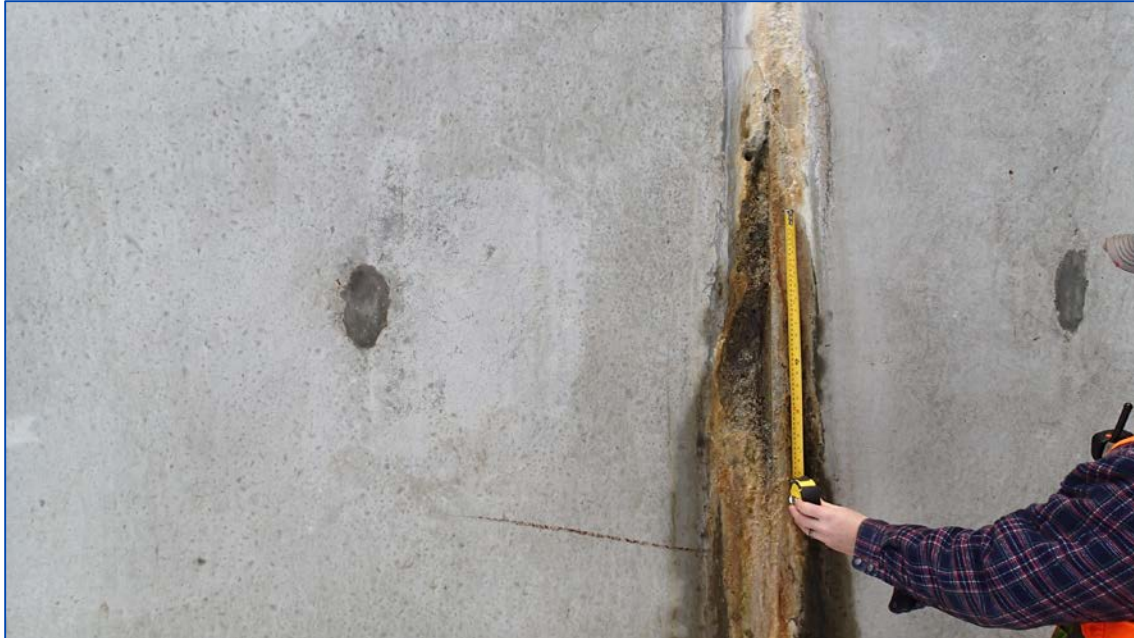
Photo 5: Close-up of Photo 4 showing deterioration of the joint.

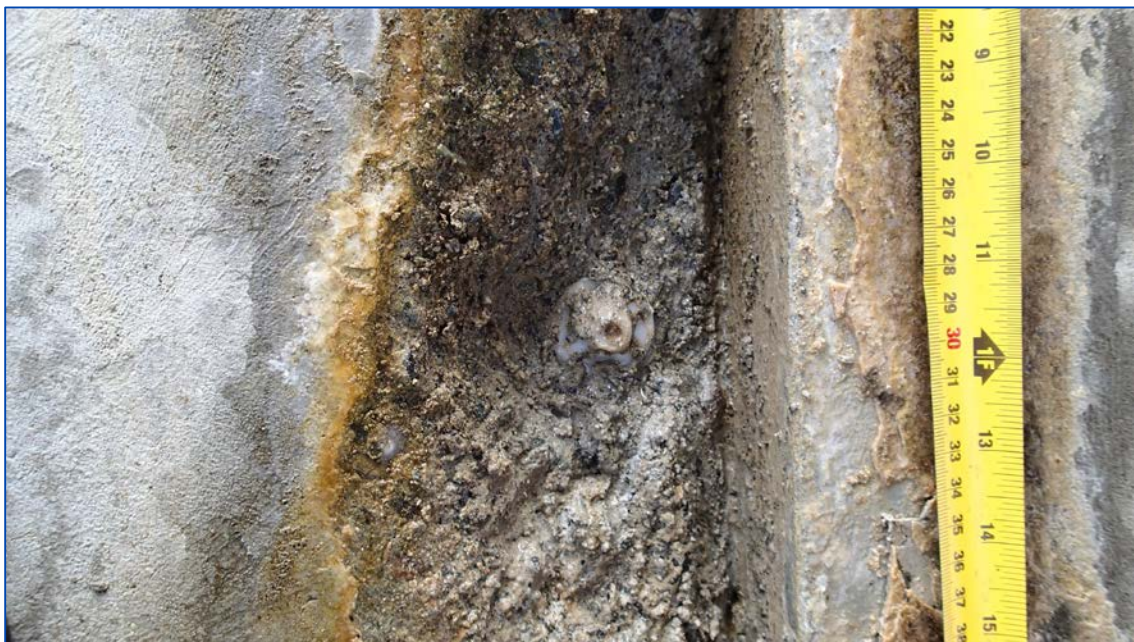
Photo 6: Close-up of Photo 5 showing deterioration of the joint.

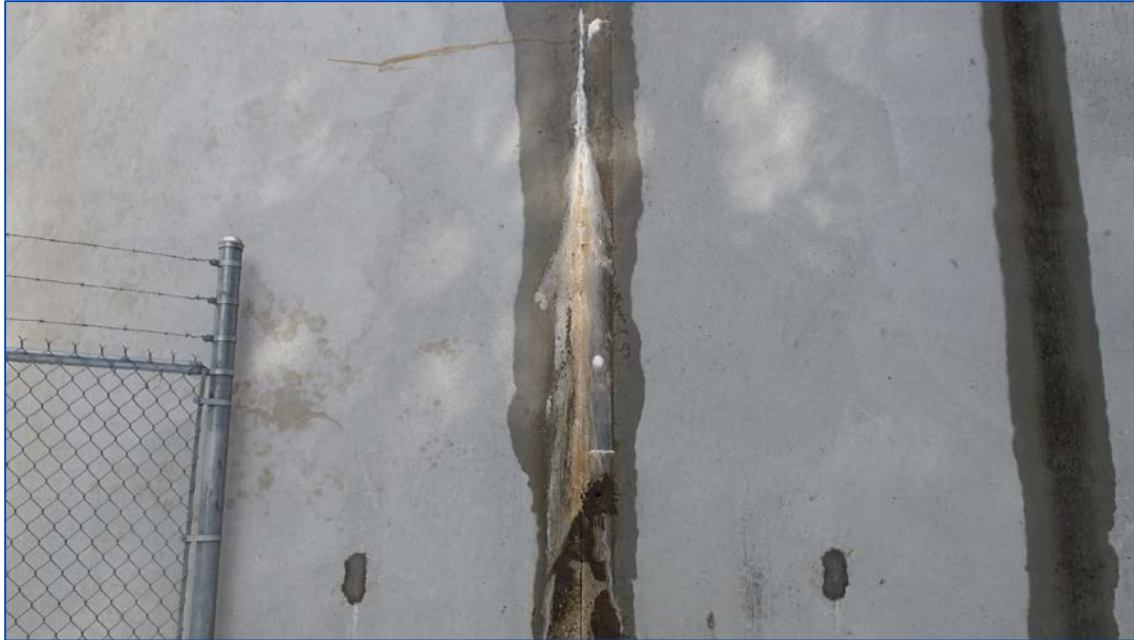
Photo 7: Presence of efflorescence at the joint between the precast wall panels.

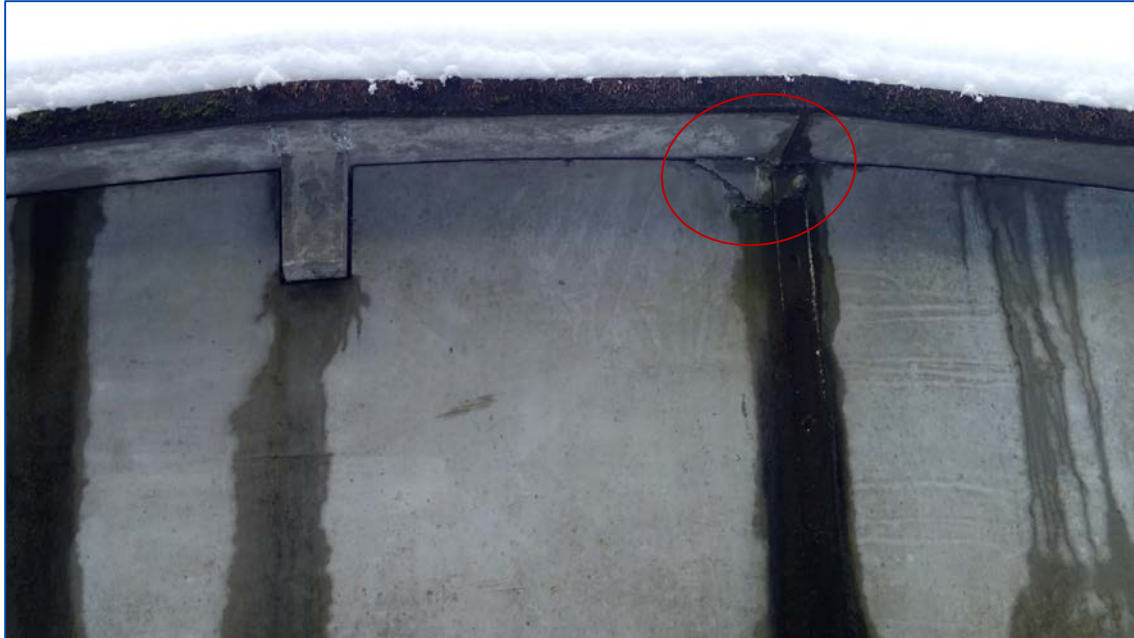
Photo 9: Close-up of Photo 8 showing a spall.

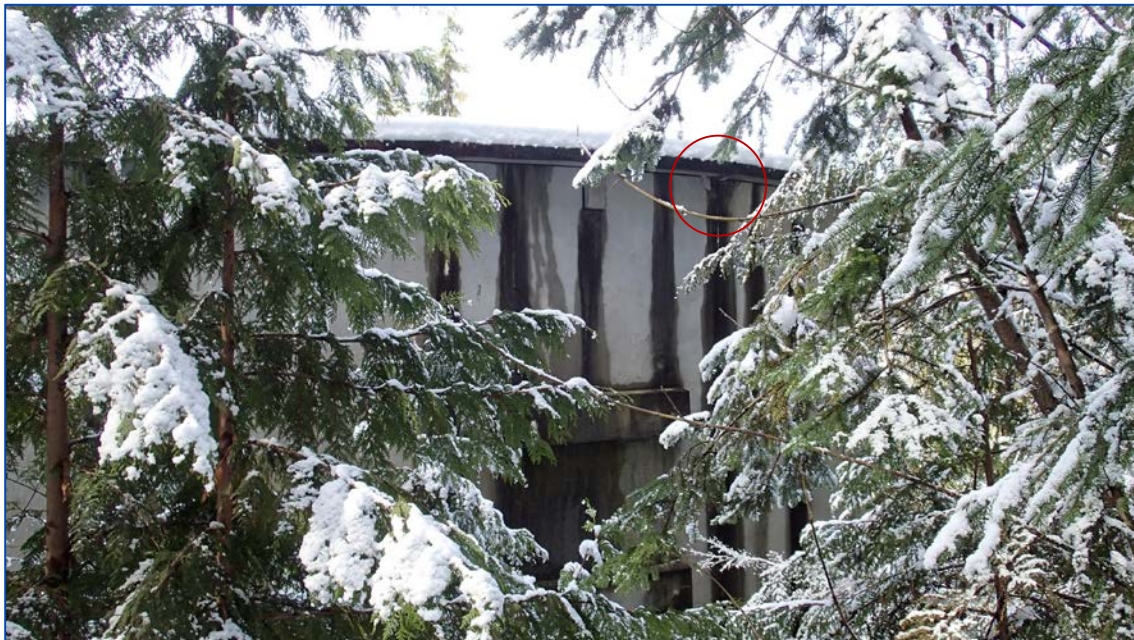
Photo 10: Presence of spall at the joint at the top of the reservoir wall.

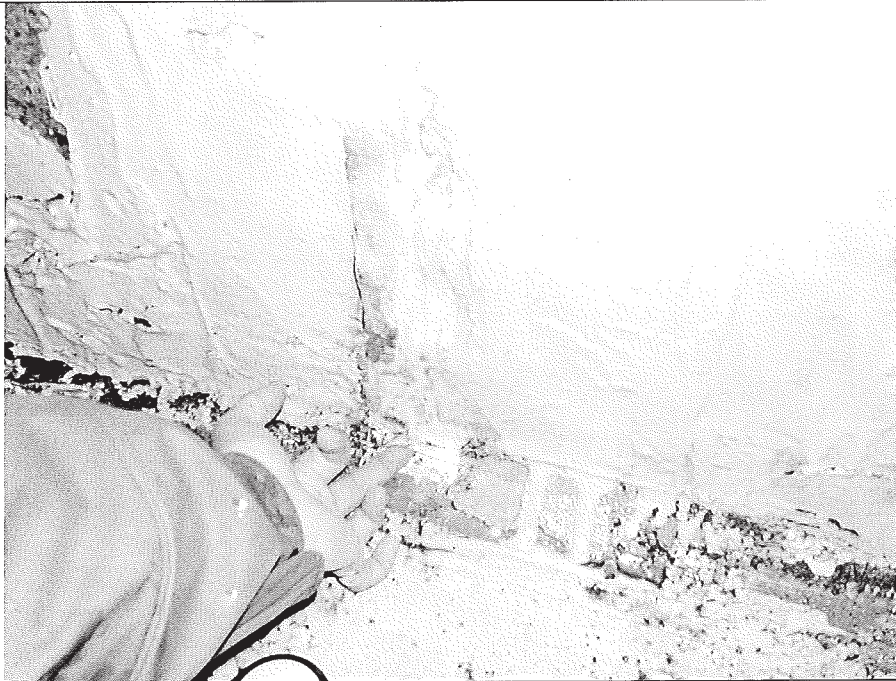
4. At this particular joint, the hypalon was stretched and ballooning out to the extent that indicated the water behind the hypalon was under pressure. This could be due to the head of water above the area of ballooning.

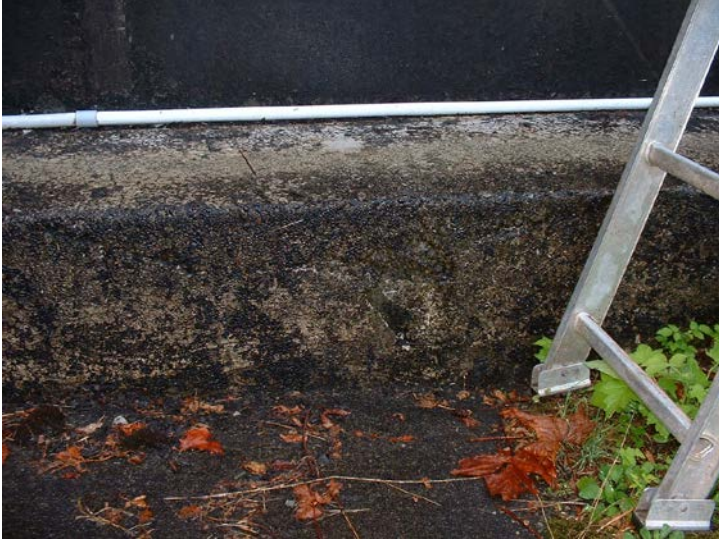
43. Honeycombing at wall foundation

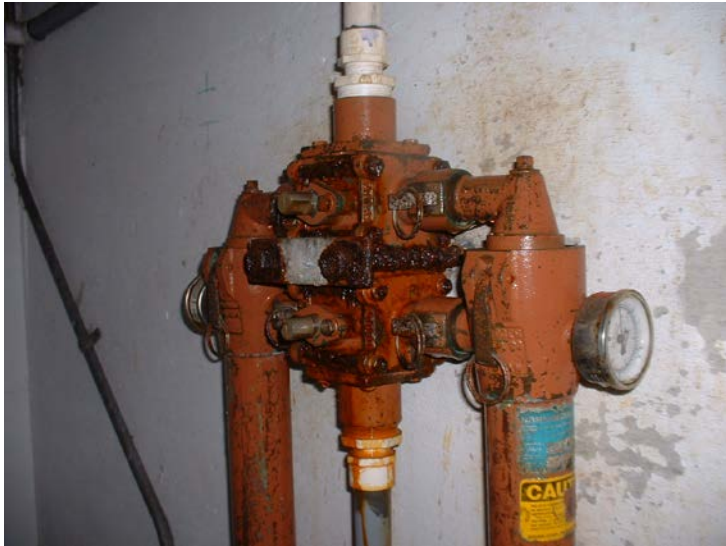
61. Mounting bolts corroded

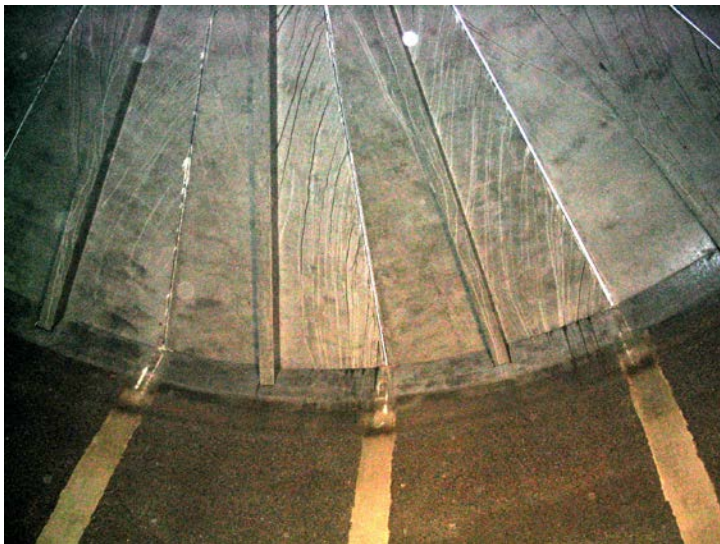
143. Note water leaking through roof panel joints

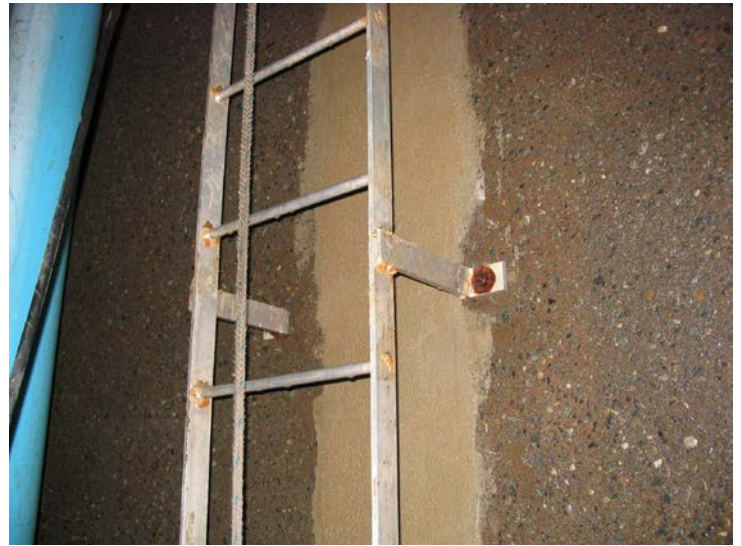
146. Corroded bolt at access ladder support inside of tank

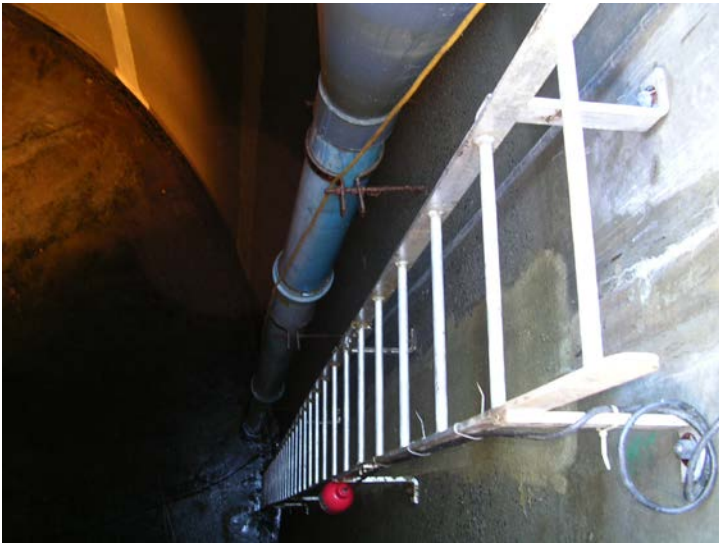
147. Access ladder and overflow pipe. Note corroded overflow pipe bracket supports

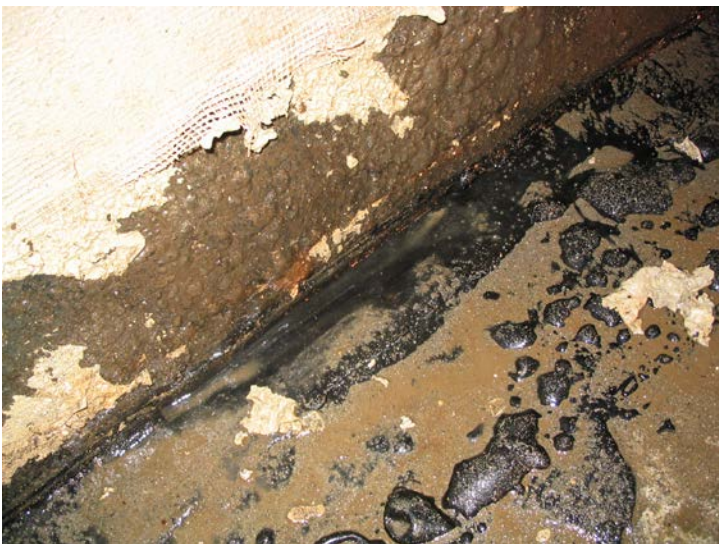
149. Evidence of failure (note air or water bubbles visible on the surface of the material) in the sealing material along joint between wall and base slab.

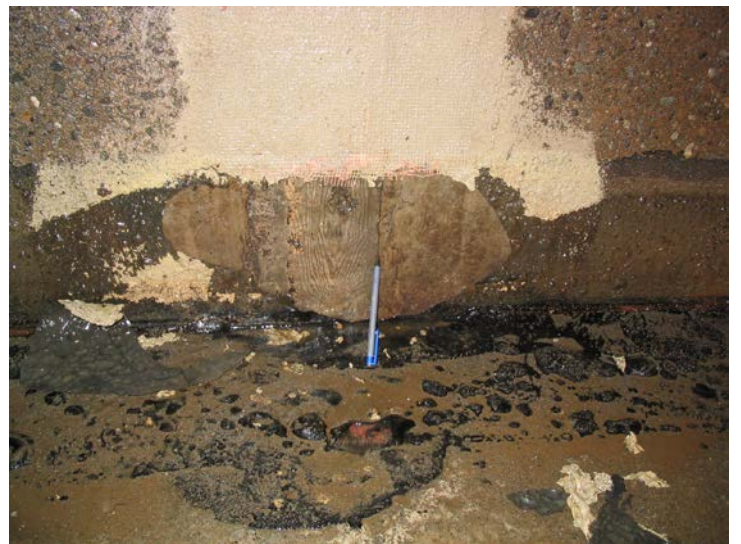
150. The rubberized material was easily pulled away from the wall and revealed vertical joints between wall panels. Water was seen to be leaking through this joint from the outside of the tank.

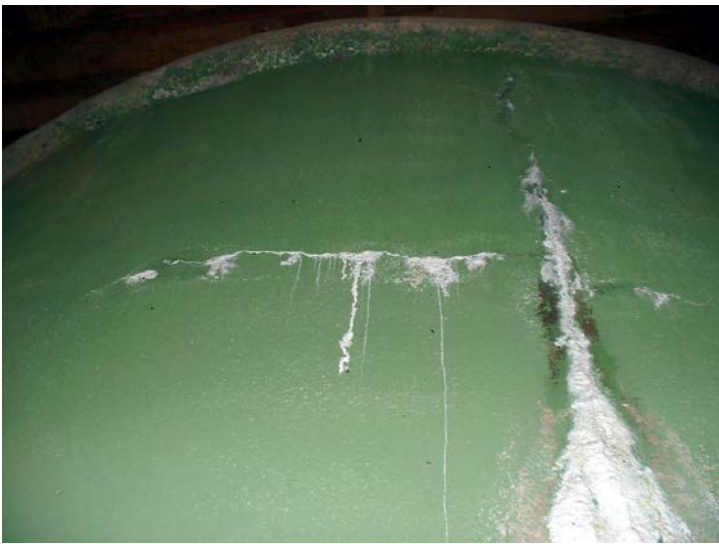
38. Horizontal and vertical cracks on tank western side

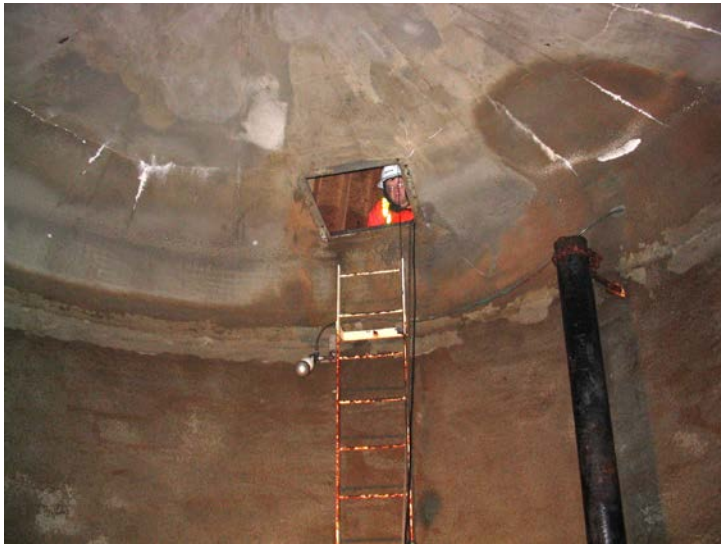
139. Underside of roof slab and interior ladder. Note cracks

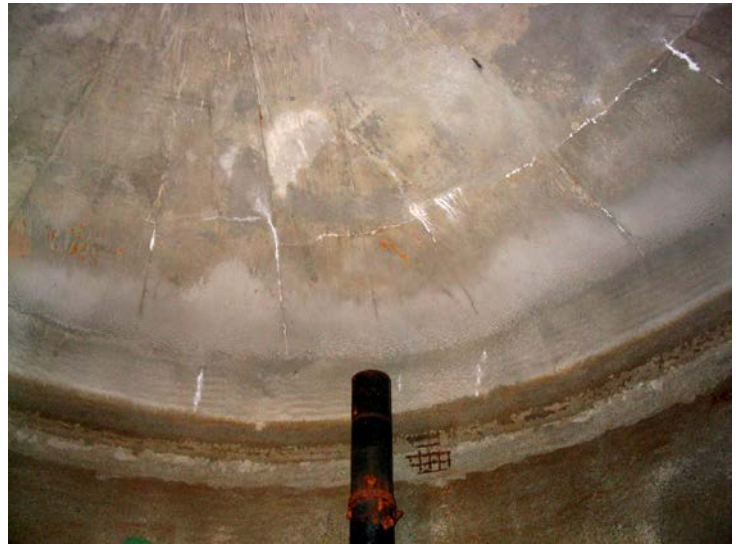
140. Underside of roof slab. Note cracks

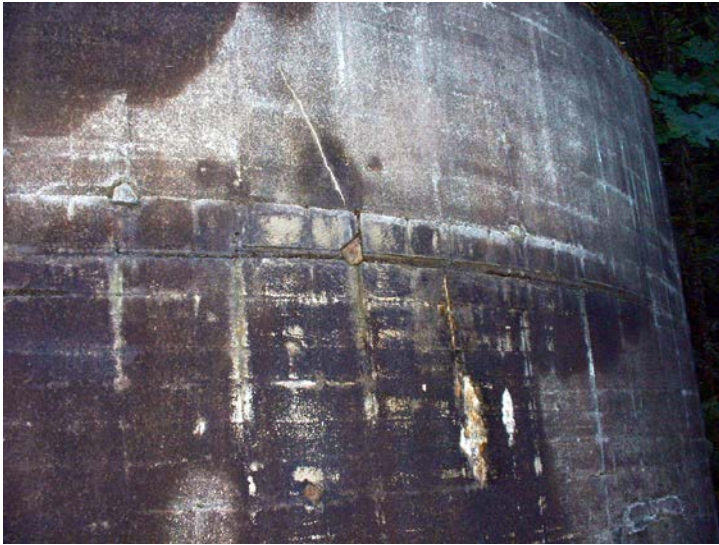
73. Evidence of honeycombed concrete at horizontal seam

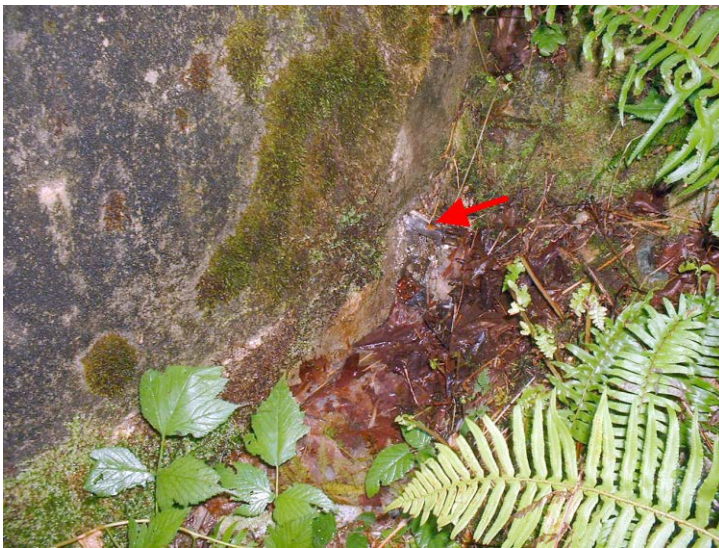
84. Hole at bottom of wall where water was observed to pouring out similar to water out of a tap

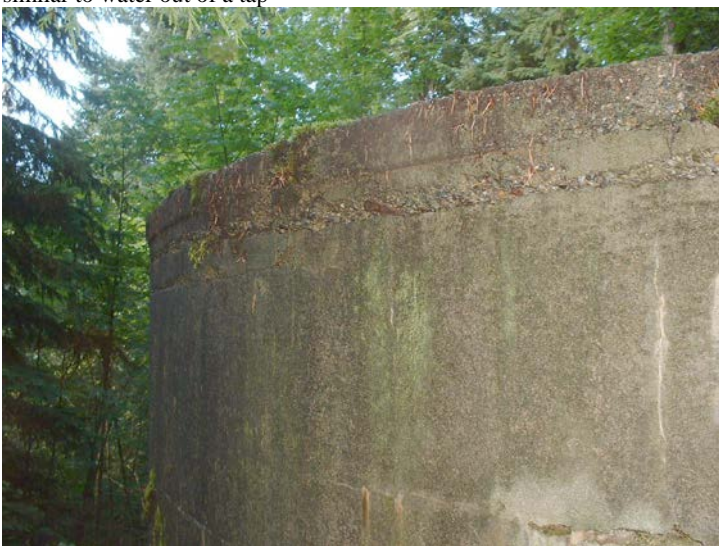
86. Horizontal crack at roof level on wall

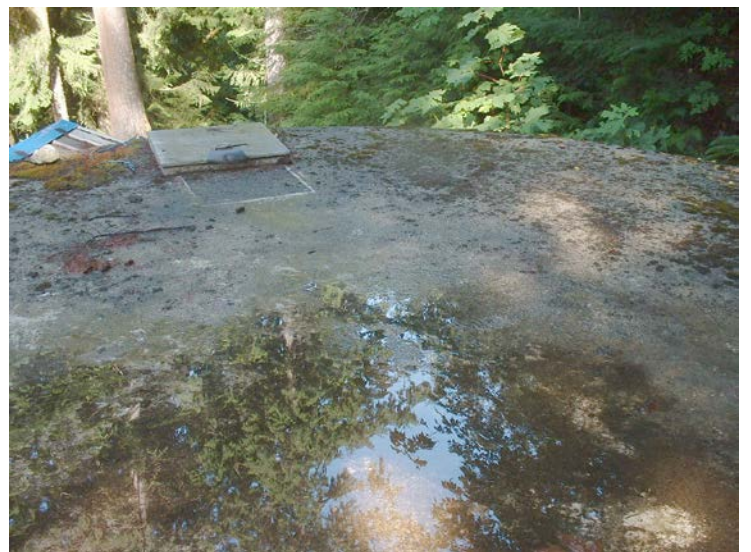
87. Water pooling on roof

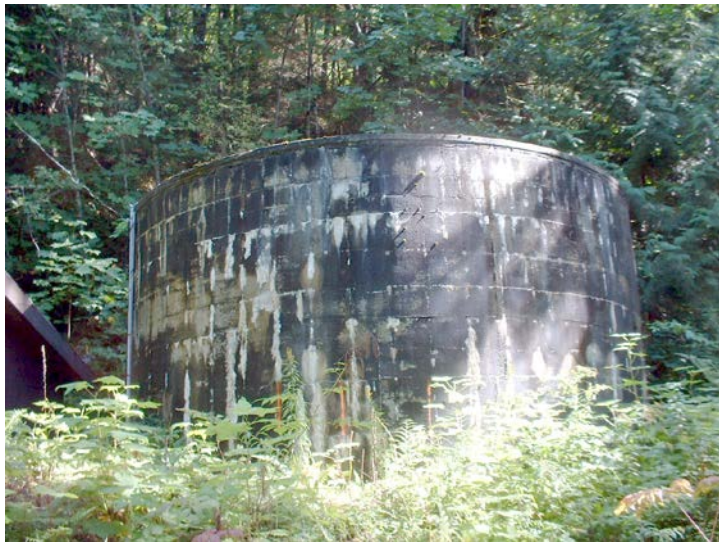
92. General view of cracking on wall

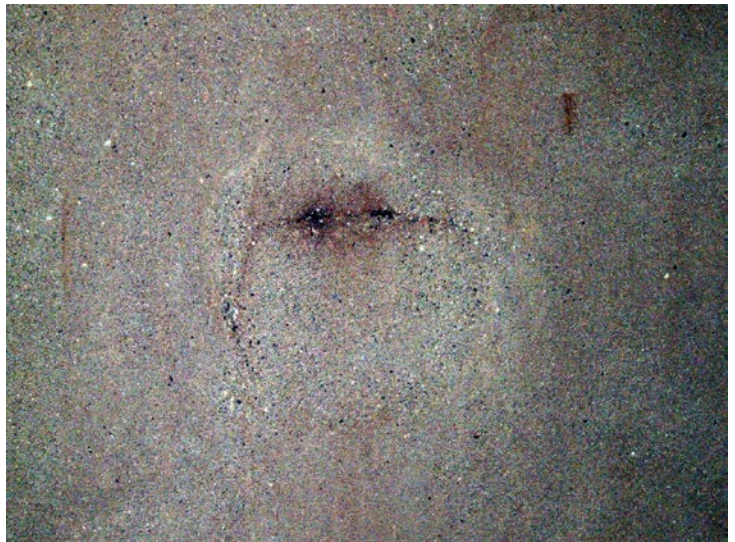
164. Cracked and delaminated concrete at east side of reservoir interior wall.

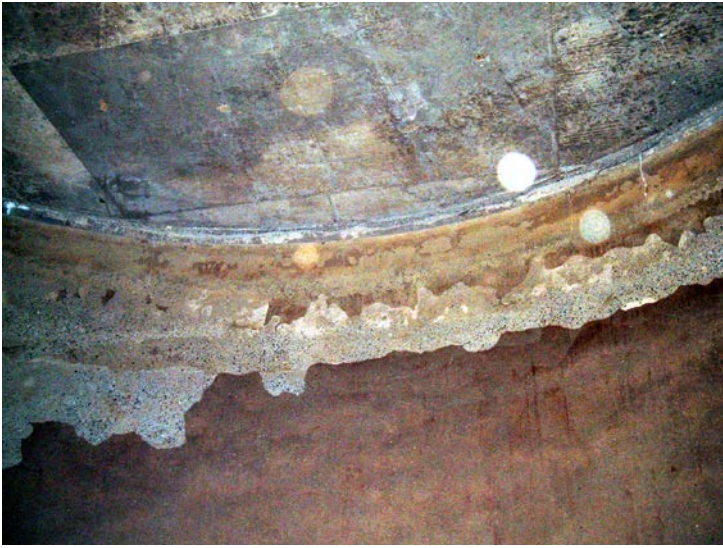
165. Cementitious coating material peeled off at top of interior wall.

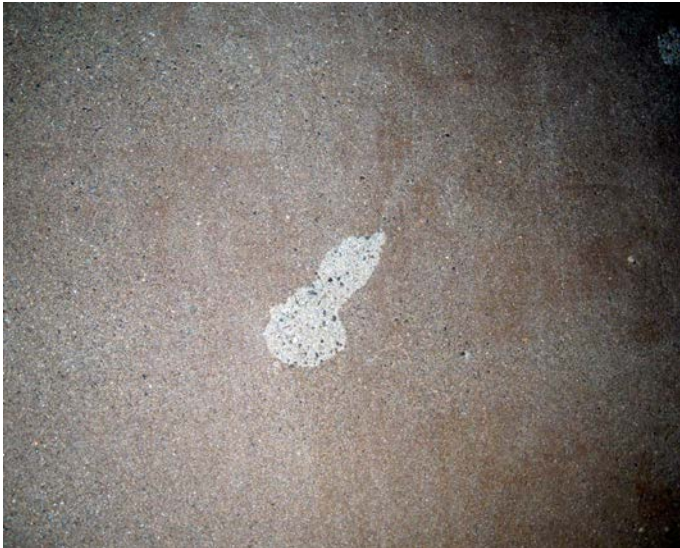
166. Spalling cementitious coating on interior wall.

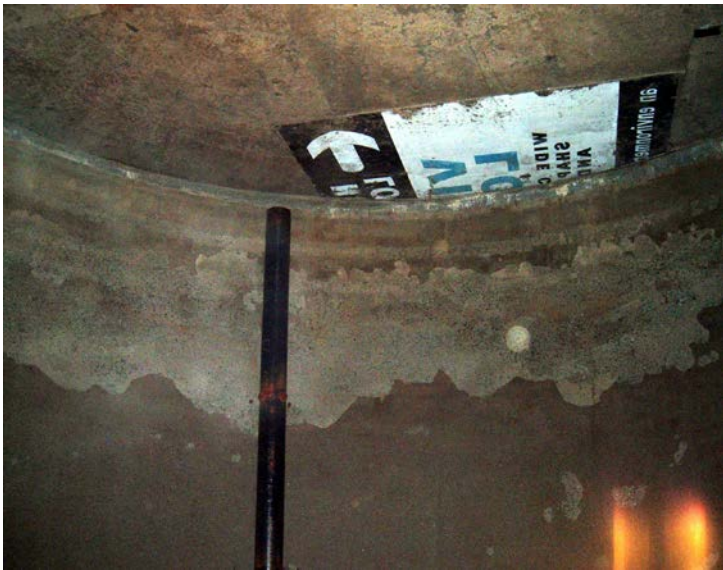
167. Missing anchorage at top of overflow pipe

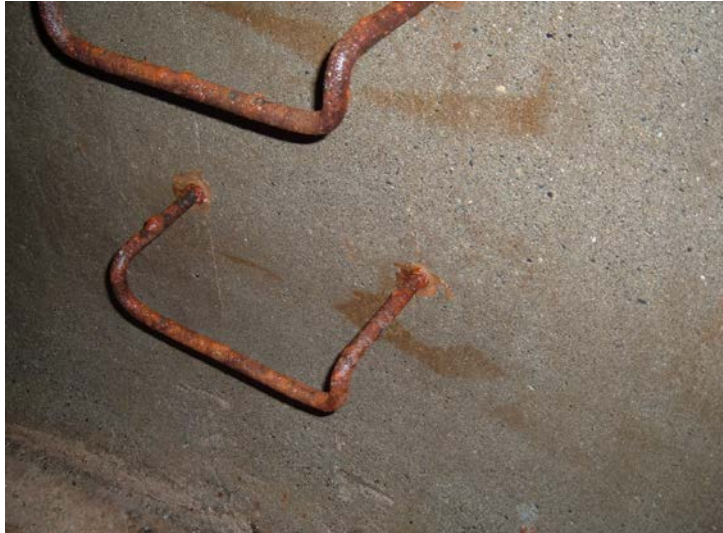
169. Corroded ladder rung

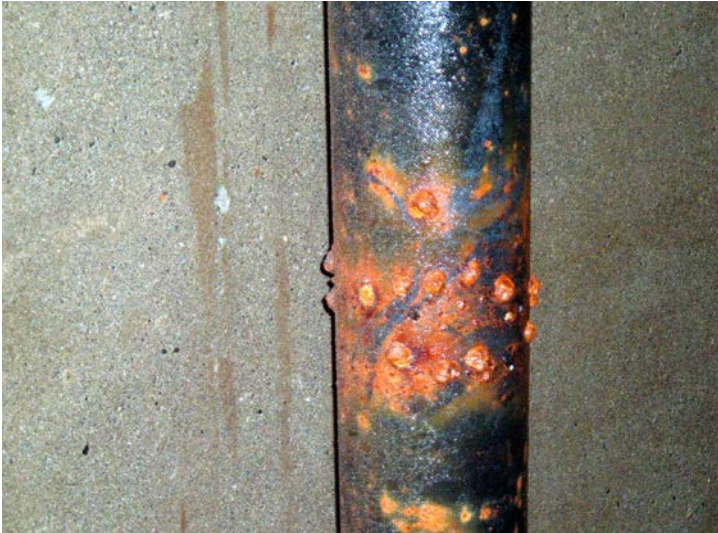
170. Corroded overflow pipe at mid height

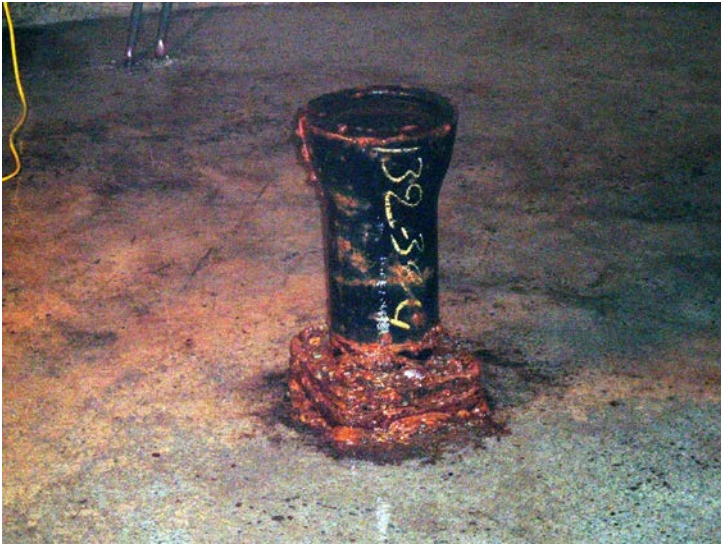
171. Corroded Outlet pipe on reservoir floor

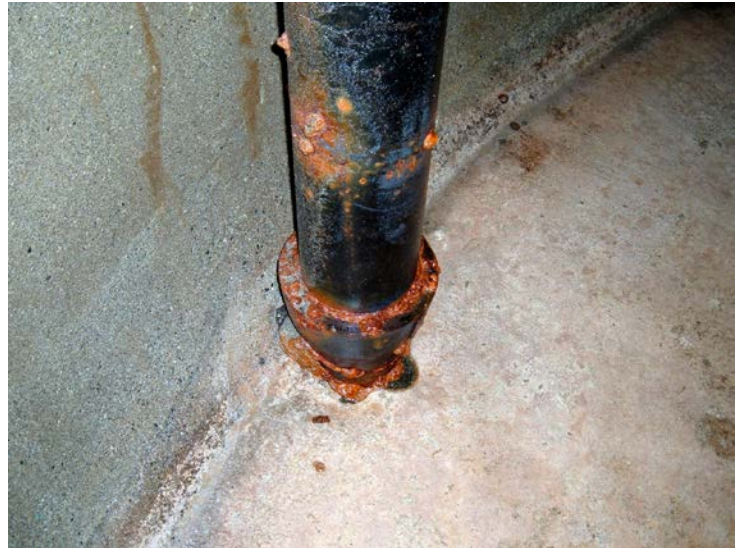
172. Corroded overflow pipe at bottom.

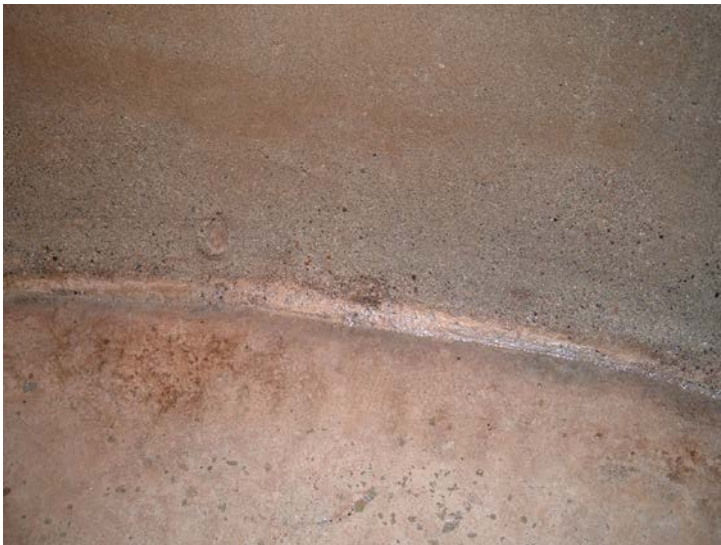
173. Joint between reservoir interior wall and floor in good condition
