Village of Lions Bay

Harvey Tank Replacement Project

Contract Documents
Issued for Tender

Volume 3 of 3
Appendices

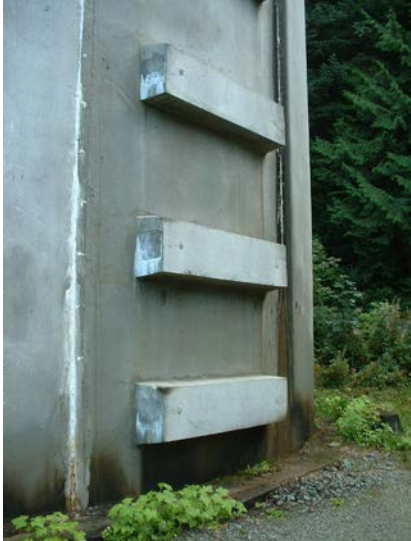
44. Anchor blocks for post-tensioned cables. South side of tank adjacent to large vertical leak (Water loss 4 liters per minute)

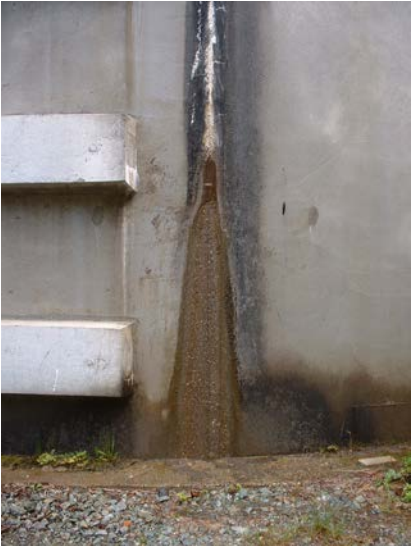
45. Large leak at wall panel junction

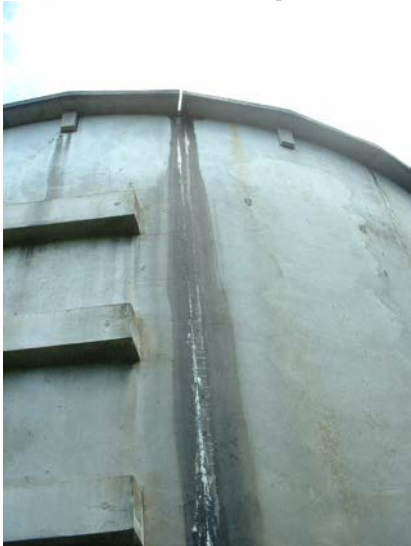
46. Upper half of tank at leak seam

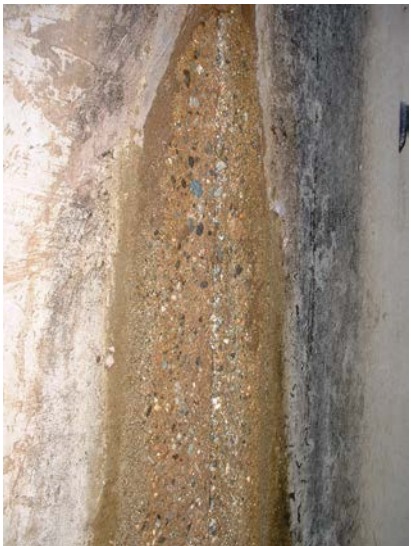
47. Close up of large leak

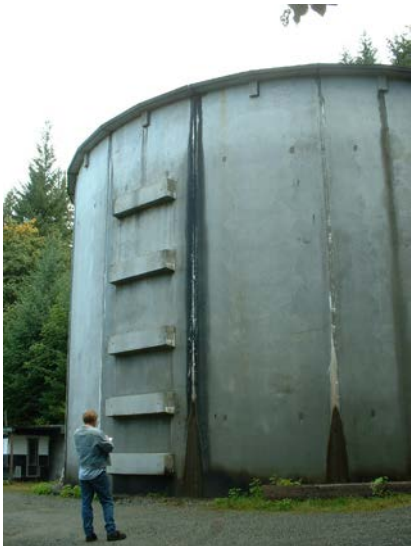
48. General view of anchor block adjacent to large leak

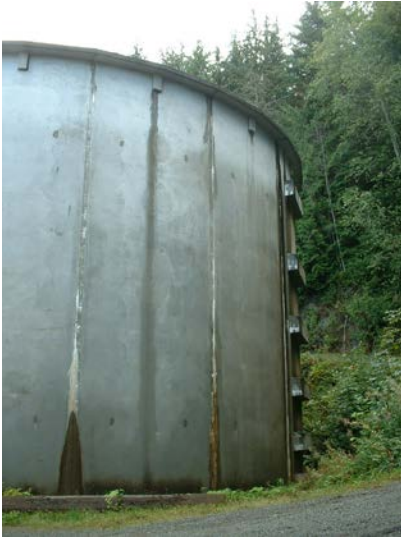
49. Eastern side of tank showing east side anchor blocks and further leaks

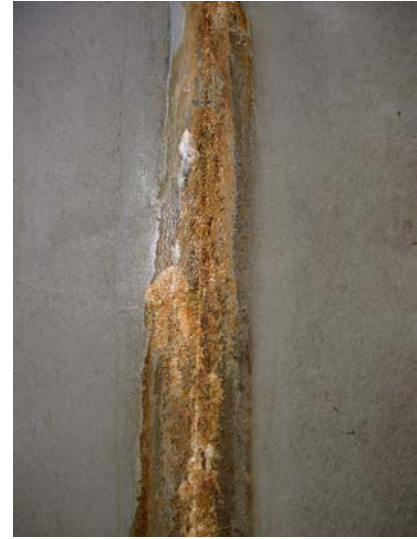
50. Leak at panel junction showing possible corrosion staining

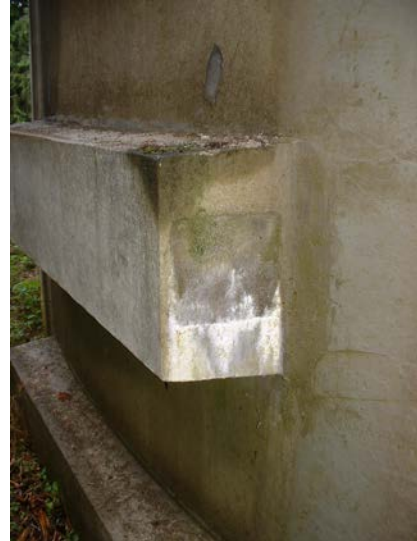
51. General view of anchor blocks. Note algae growth on chlorination building roof

52. Note efflorescence at SE anchor block

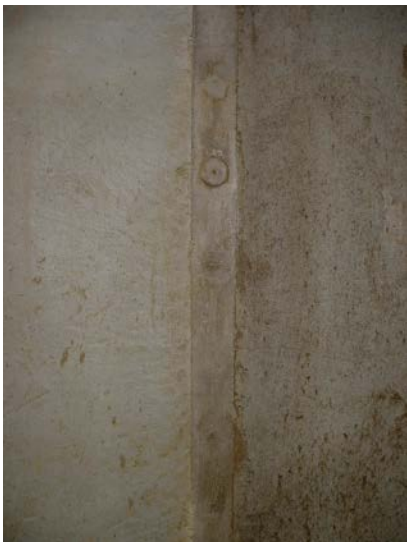
53. "Closing in" section of concrete between two wall panels at North side of tanks

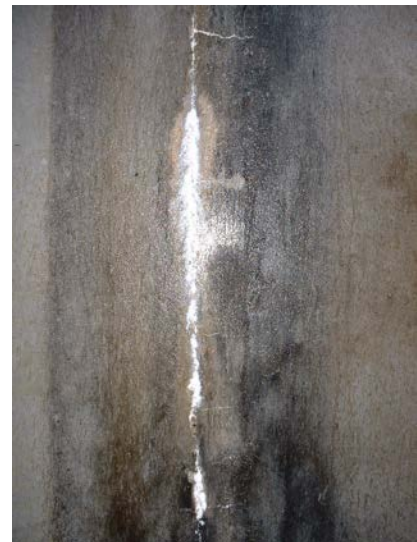
54. Horizontal and vertical cracks adjacent to north west anchor blocks

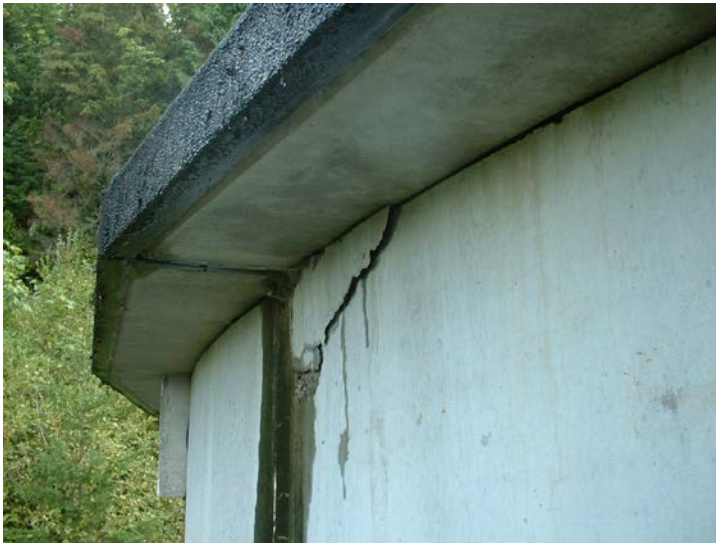
55. Spalling at top of wall – NW side

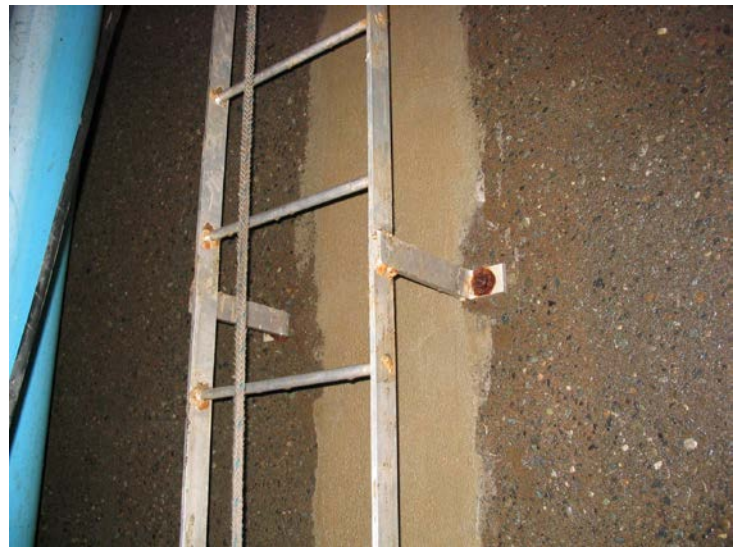
146. Corroded bolt at access ladder support inside of tank

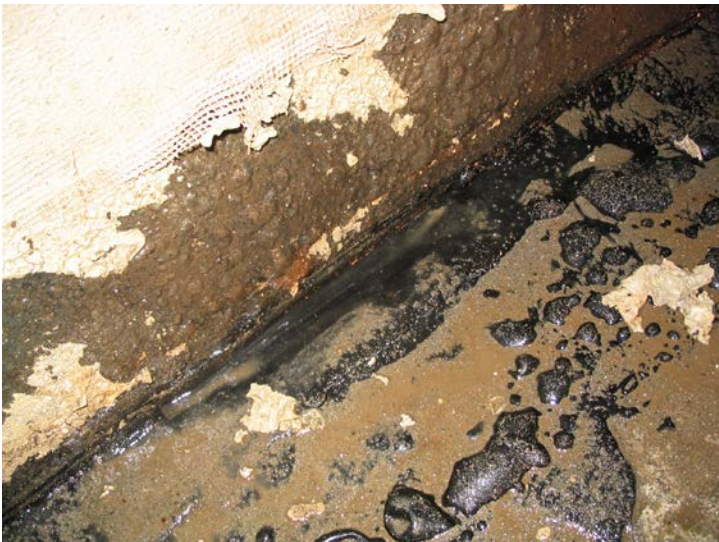
149. Evidence of failure (note air or water bubbles visible on the surface of the material) in the sealing material along joint between wall and base slab.

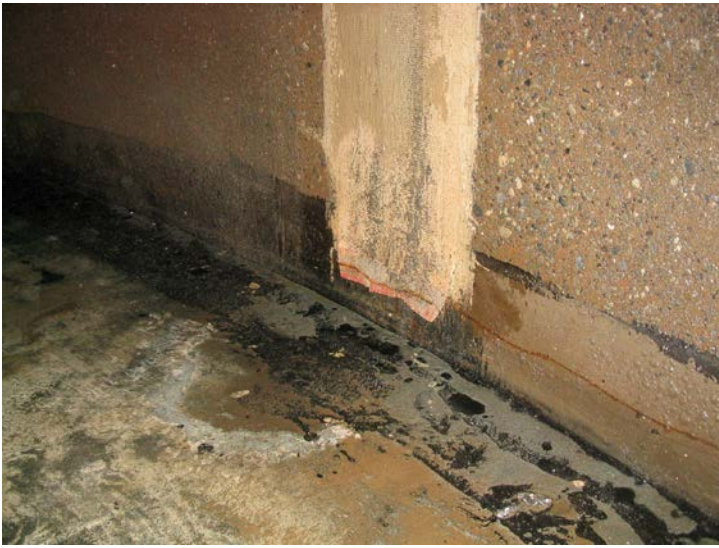
152. Evidence of general failure of sealing material along edge of wall and bottom slab and along the vertical joints in wall panels.

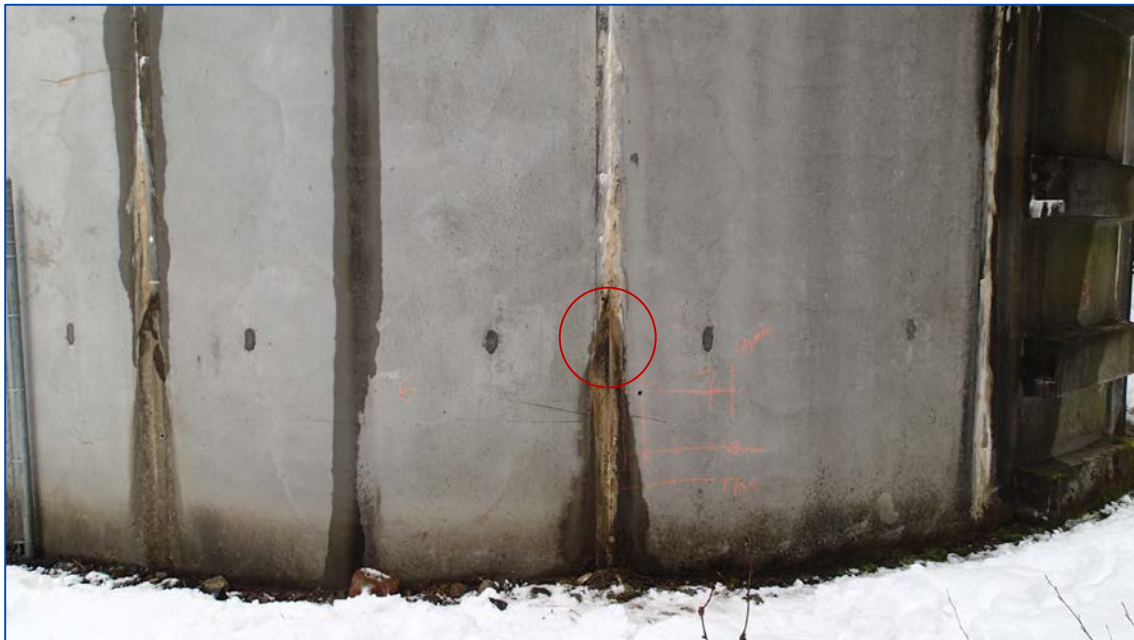
Photo 4: Leaking joints between the precast wall panels.

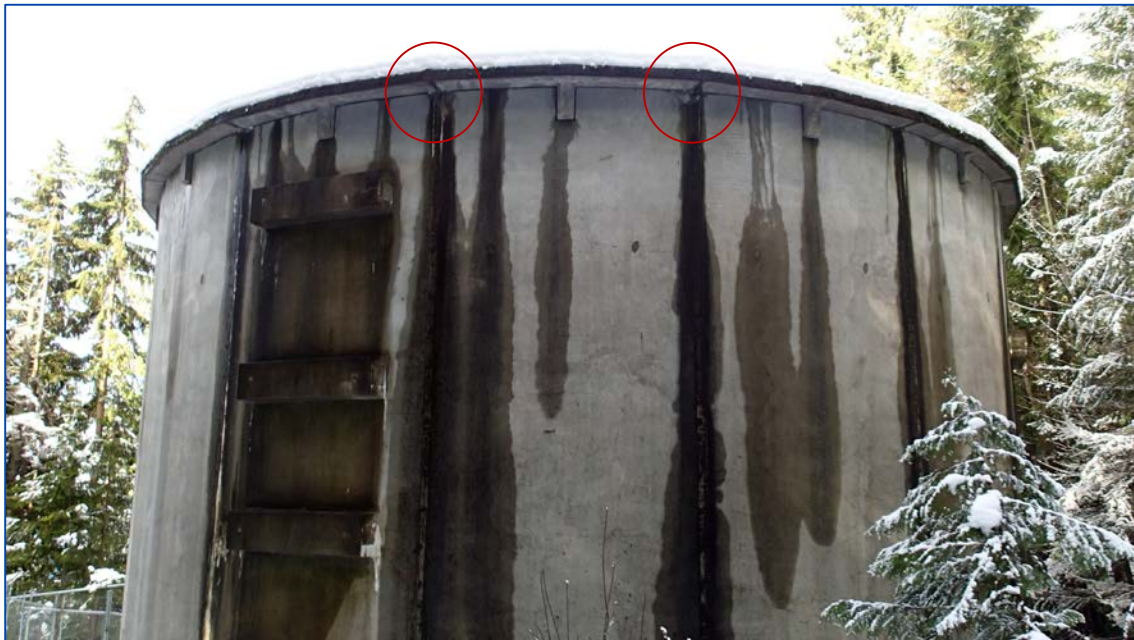
Photo 8: Spalls at the precast wall panel joints at the top of the reservoir wall.

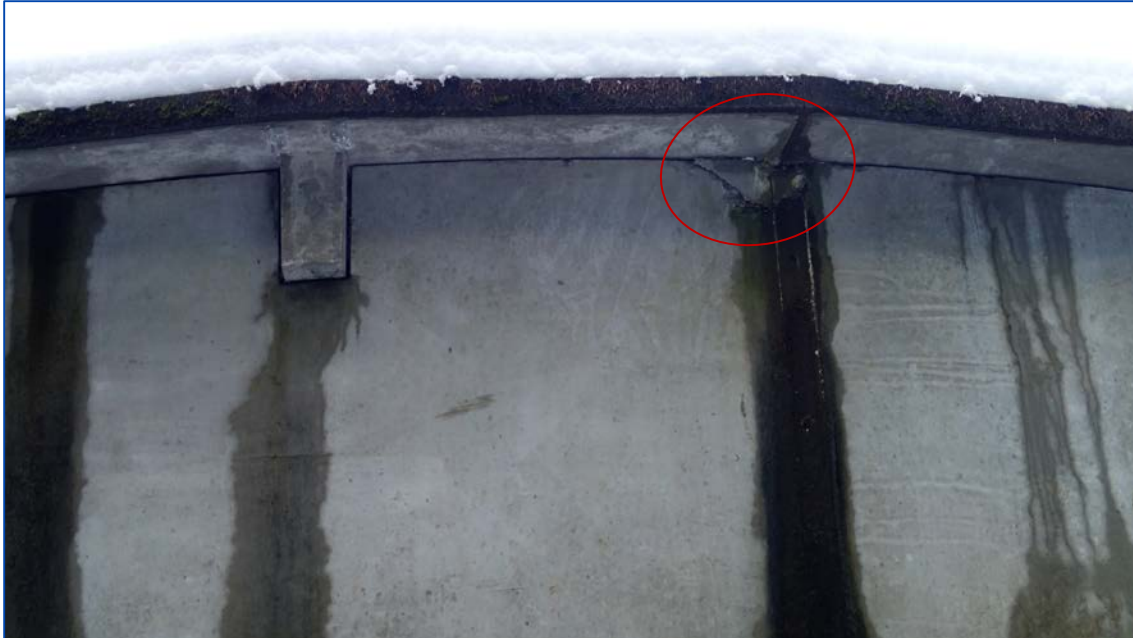
Photo 9: Close-up of Photo 8 showing a spall.

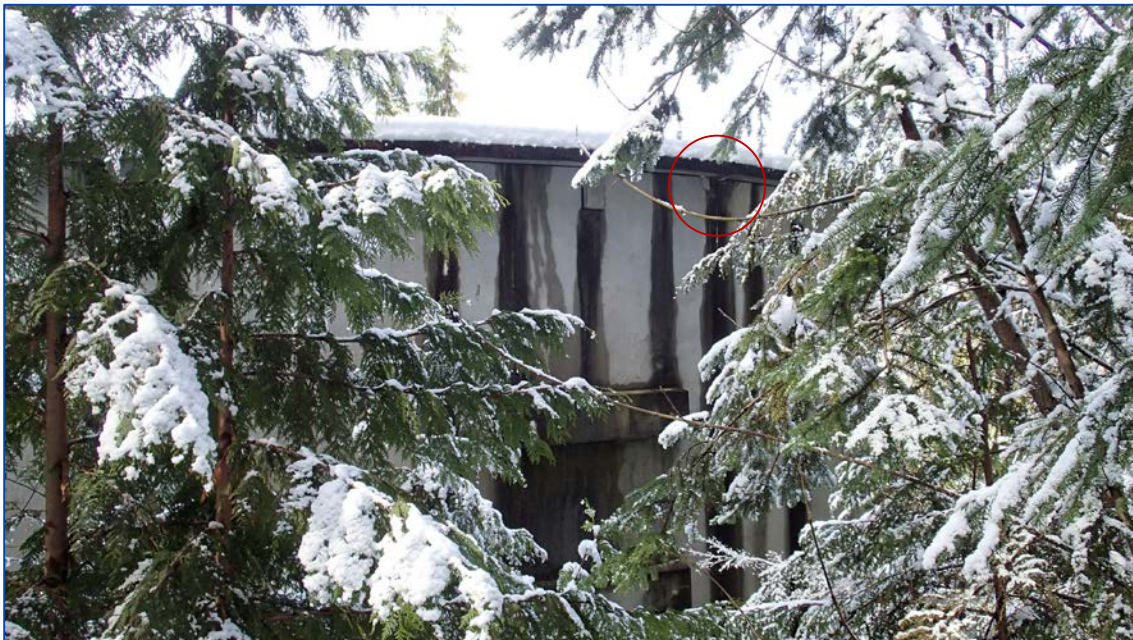
Photo 10: Presence of spall at the joint at the top of the reservoir wall.

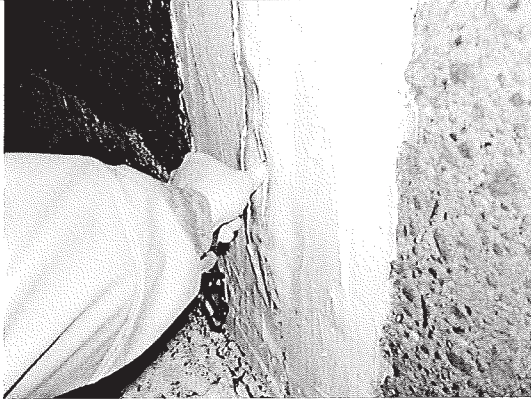
3. Water was found to be located behind the hypalon in many areas. When pressing onto the hypalon one could hear the water squishing behind the repair material

4. At this particular joint, the hypalon was stretched and ballooning out to the extent that indicated the water behind the hypalon was under pressure. This could be due to the head of water above the area of ballooning.
