March 31, 2022

**RE:** Arborist Report #1 for tree at corner of Bayview Rd & Stewart Rd, Lions Bay

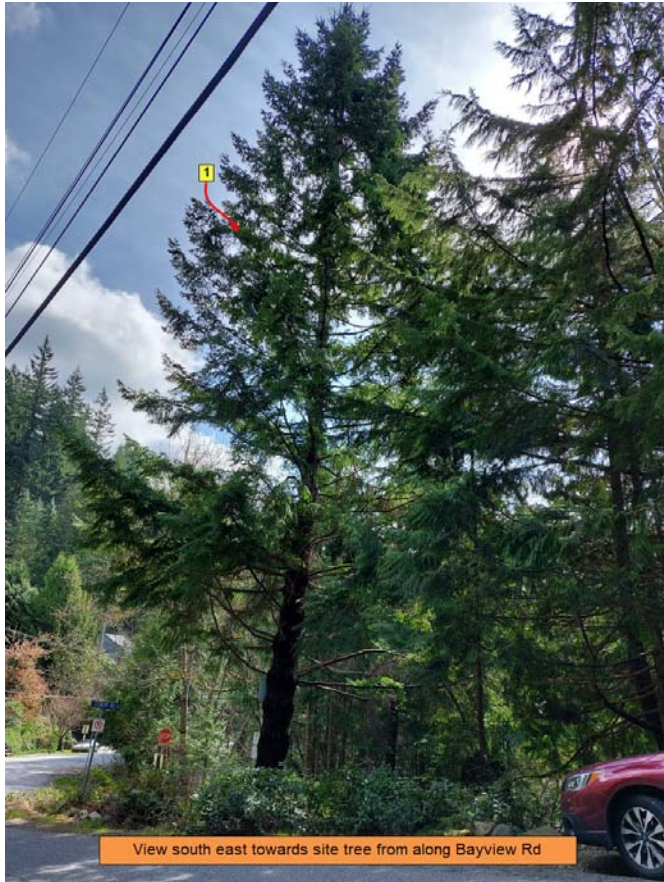
Picture 3. Tree #1 – view SE from Bayview Rd

View south east towards site tree from along Bayview Rd

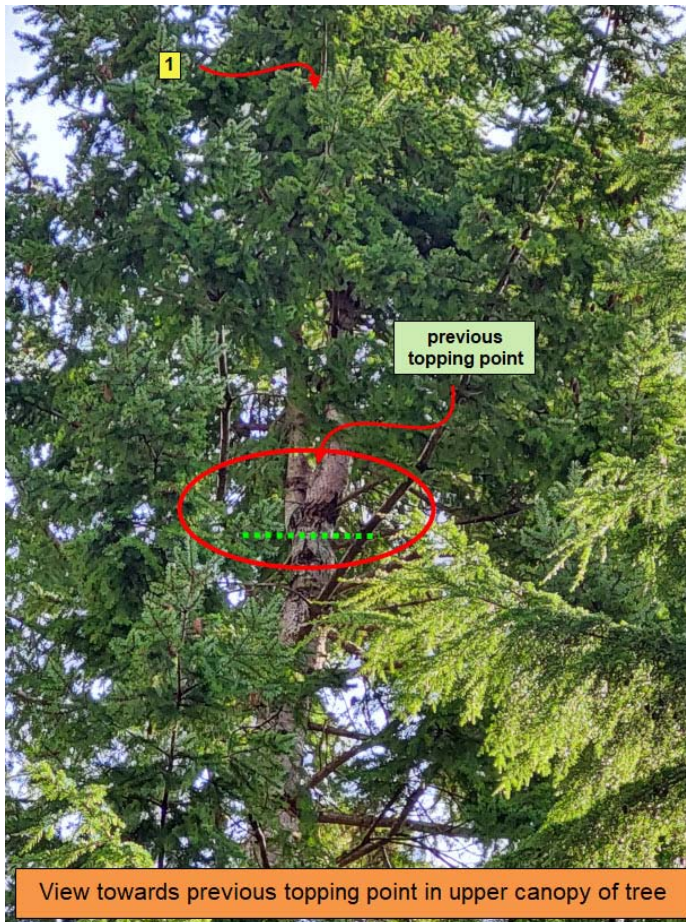
Picture 5. Tree #1 – previous topping pt

As mentioned tree #1 does appear to have a co-dominant or split top. This appears to have occurred naturally likely through breakage by wind, snow load or even a bird perching on its top. As a result co-dominant stems have grown.

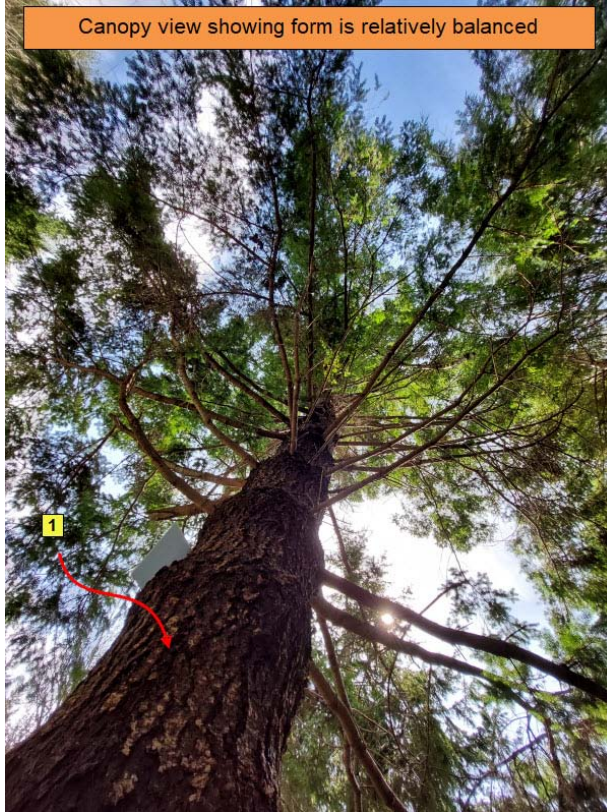
Picture 6. Tree #1 – canopy view

Canopy view showing form is relatively balanced

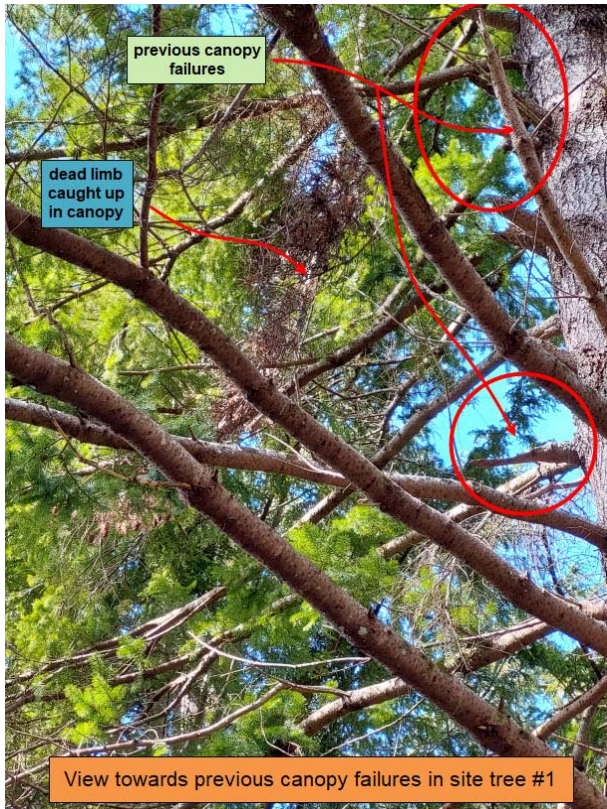
Tree #1 is considered to have a fairly healthy and balanced canopy with an overall nice form. There is evidence of previous canopy failures that have occurred in this tree. There are a number of stubs from broken branches as well as a number of dead or broken & hanging branches within the canopy.

View towards previous canopy failures in site tree #1

Picture 7. Tree #1 – canopy failures

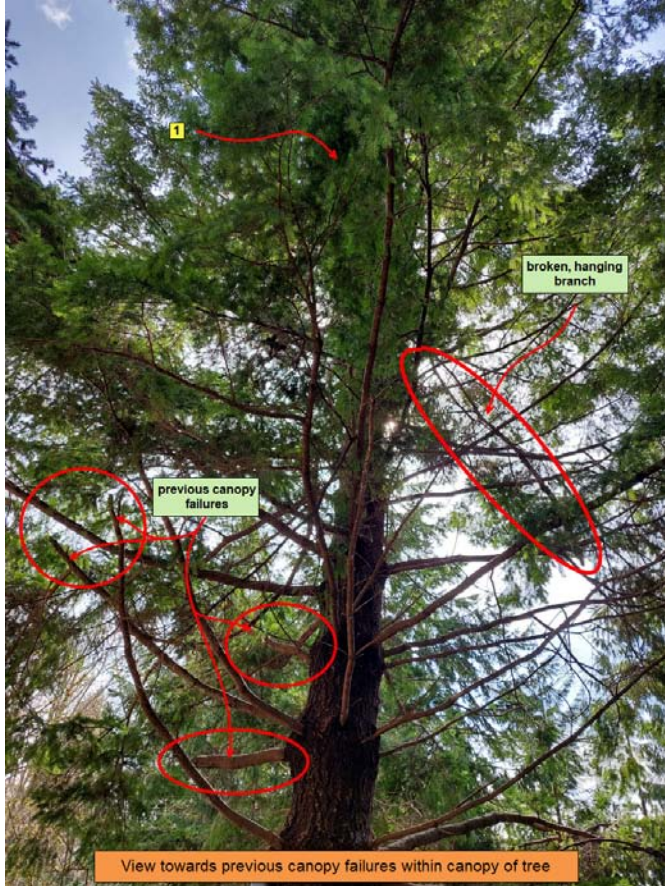
Picture 8. Tree #1 – previous canopy failures

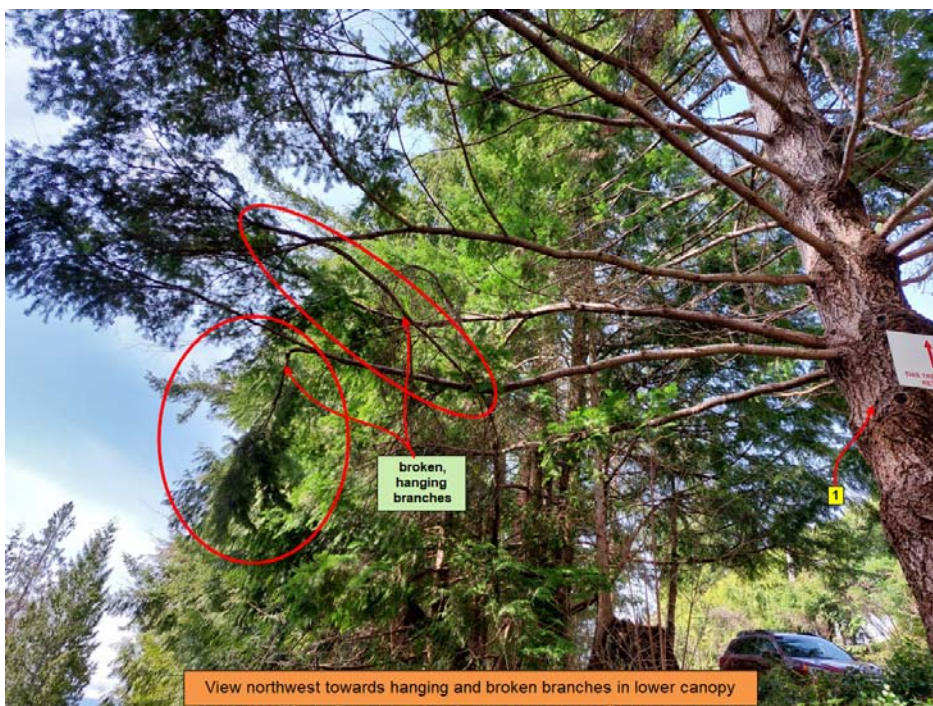
Picture 9. Tree #1 – broken, hanging branches

- This pruning is to be thoughtful and intentional to mitigate the likelihood or reduce the risk of dead, broken or hanging branches from failing. **\*\*Do not mutilate this tree** by over pruning.

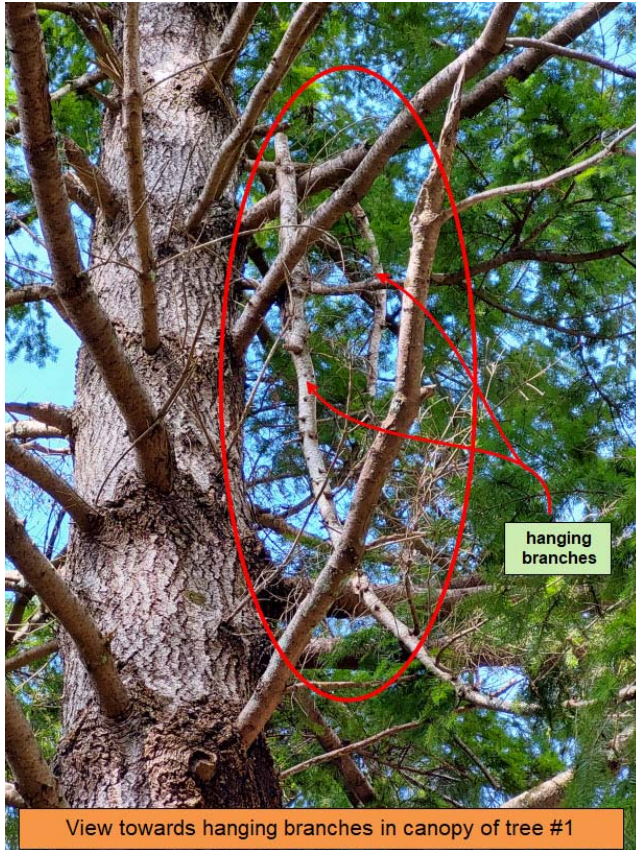
Picture 10. Tree #1 – hanging branches

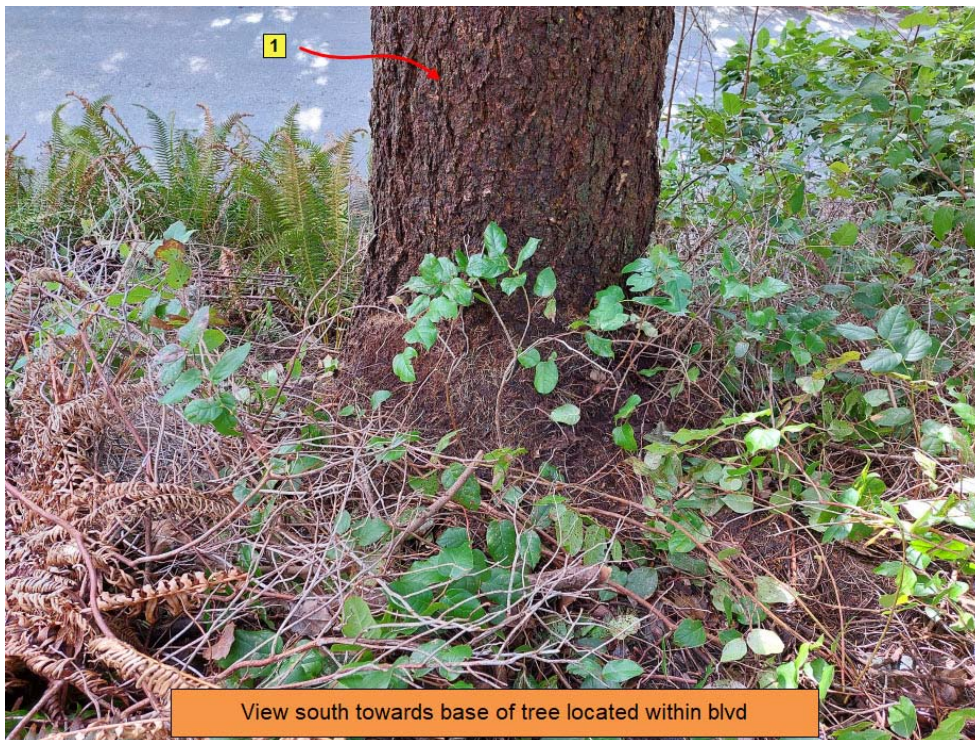
Picture 11.  
Tree #1 –  
base of tree

The subject tree is in fairly good condition overall. There are no visible fungal conks or outward signs of root decay. There are no obvious or outward indications of cholrosis and or excessive cone production within the canopy. There was no apparent indication of shifting or heaving in the root plate at the time site visit was conducted.

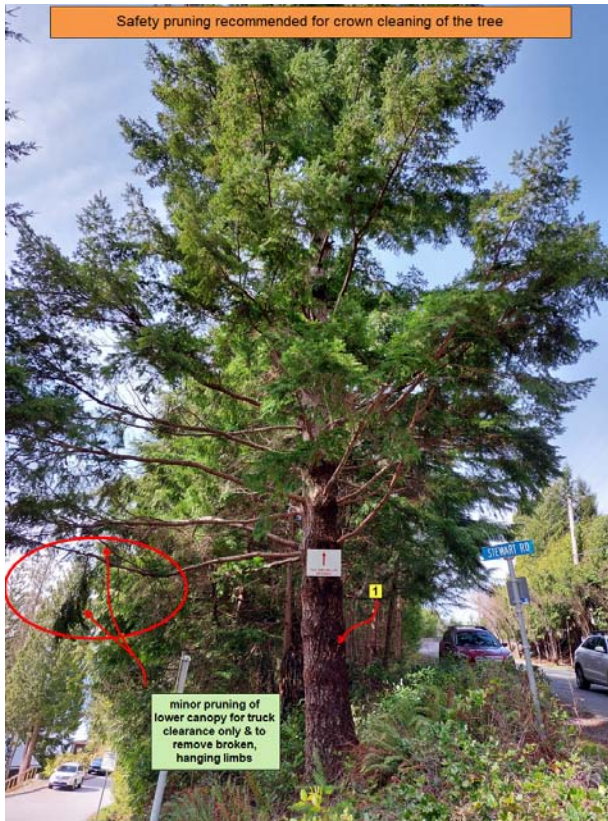
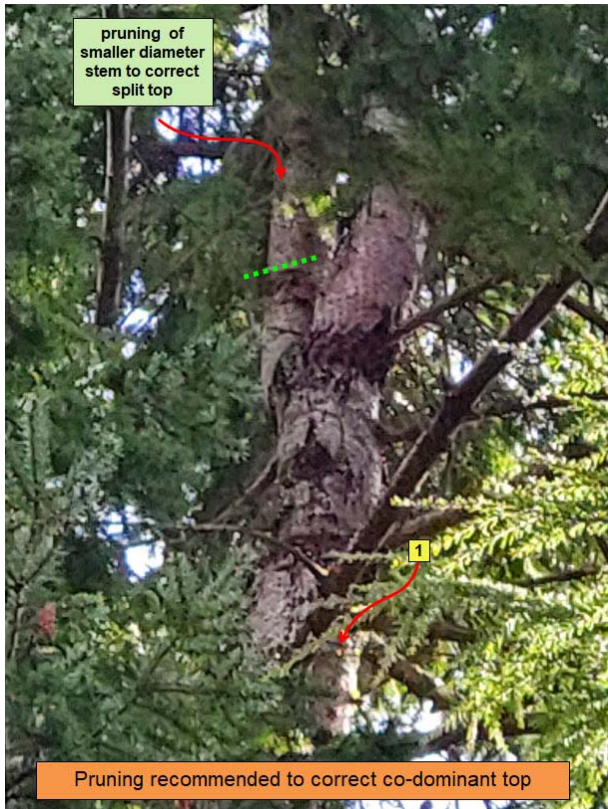
Picture 13. Tree #1 – pruning recommended

Picture 14. Tree #1 – pruning recommended

1. Retention & monitoring of the assessed tree is recommended as it provides great value to the site & the ecology within the area. It is not considered in imminent danger of failing at the time the inspection was completed based on the findings of the Level 2 assessment completed on the tree.
2. Safety pruning is recommended and is deemed reasonable. The pruning includes but is not limited to the removal of any dead, diseased or damaged branches (safety pruning or crown cleaning). That is to say focus should be anything that could get knocked out in a wind event. Minor clearance pruning can be completed on the lowest branches at the south side to establish truck clearance along Stewart Rd.

Tree #	Species	DBH (cm)	Observations
1	Douglas fir – <i>Pseudotsuga menziesii</i>	70	<b>Retain &amp; monitor</b> – safety prune to remove dead, diseased or damaged branches (crown clean); prune to establish truck clearance along Stewart Rd (this is selective and not intended to “canopy raise”); prune to correct split top to encourage tree to re-establish a terminal leader. This includes the removal of the smaller diameter or east stem to encourage self-correction
