THE MUNICIPALITY OF THE VILLAGE OF LIONS BAY

**INFRASTRUCTURE COMMITTEE MEETING
OF THE VILLAGE OF LIONS BAY
HELD ON THURSDAY, SEPTEMBER 16, 2019 at 7:00 PM
COUNCIL CHAMBERS, 400 CENTRE ROAD, LIONS BAY**

To: **Village of Lions Bay** Date: **September 6, 2019**
Attention: **Nai Jaffer, Public Works Manager** Project No.: **32282**
Cc:
Reference: **Oceanview Road Open Channel Hydraulic Assessment - Draft**
From: **Ghazal Shirazian, E.I.T., Project Engineer**
Andrew Baird, P.Eng., Senior Project Engineer

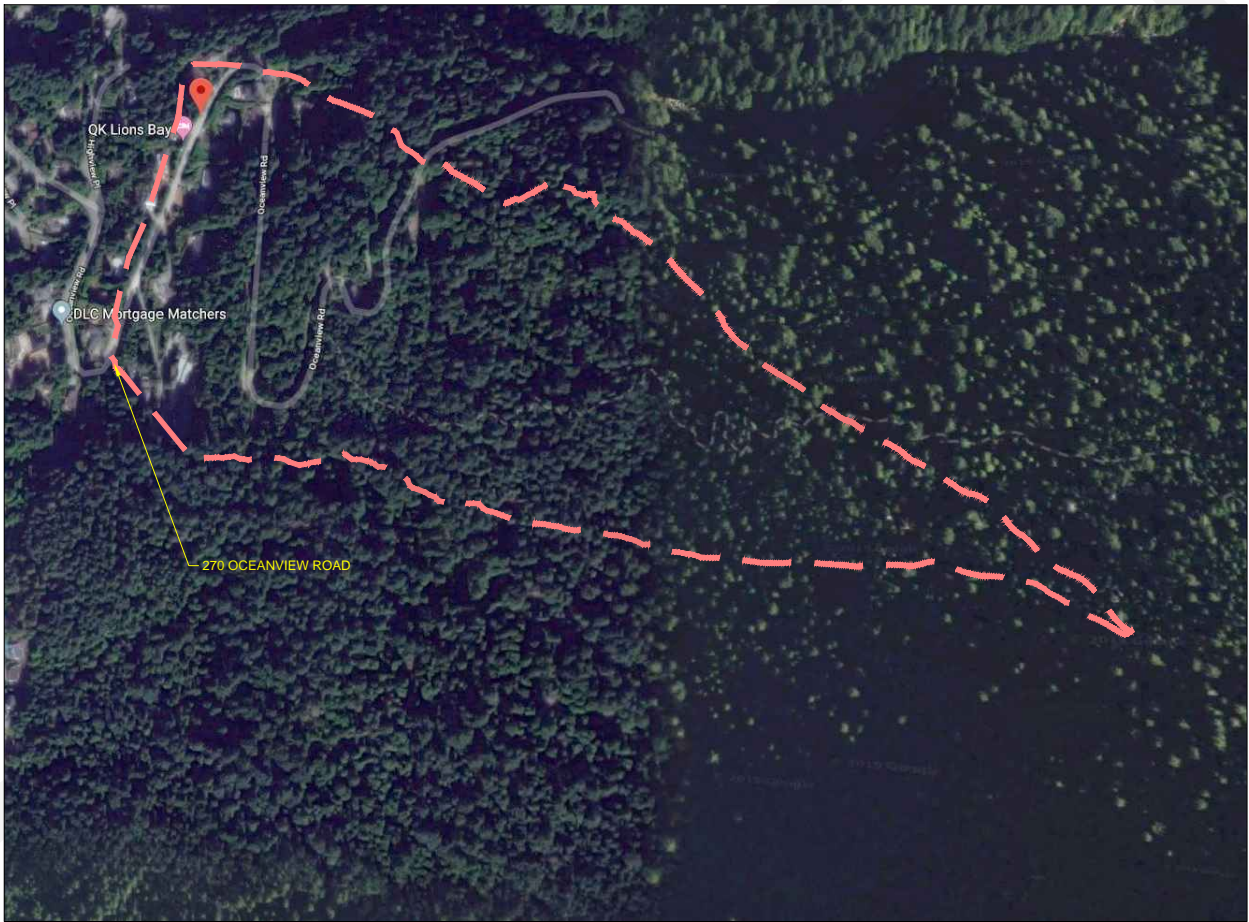
SCALE	NTS	DATE	19-09-04	DWG. NO.
DRAWN BY	EJS	DESIGN BY	GSH	1 OF 1
CHECKED	ATB	APPROVED BY	ATB	
PROJECT NUMBER	32282	DRAWING NUMBER	FIGURE A	REV.

The catchment area for the channel in this study area is approximately 30ha consisting of 1.6ha of paved roadway and 28.4ha of natural forested area with an average gradient of 56%. The extent of the catchment area is shown in Figure A (attached). The Village of Lions Bay Infrastructure Master Plan Report done by AECOM, dated July 28, 2016 (IMP), suggested to use the higher value for a specific storm event between Squamish IDF Curve and West Vancouver Municipal Hall IDF Curve. A synthetic hyetograph was developed using the highest numbers obtained from the IDF Curves mentioned above and an SCS Type IA rainfall distribution was used in this analysis. The peak flows for 10-year, 25-year, and 100-year for the duration of 1hr, 2hr, 6hr, 12hr, and 24hr calculated using XPSWMM are shown in Table 2.1.

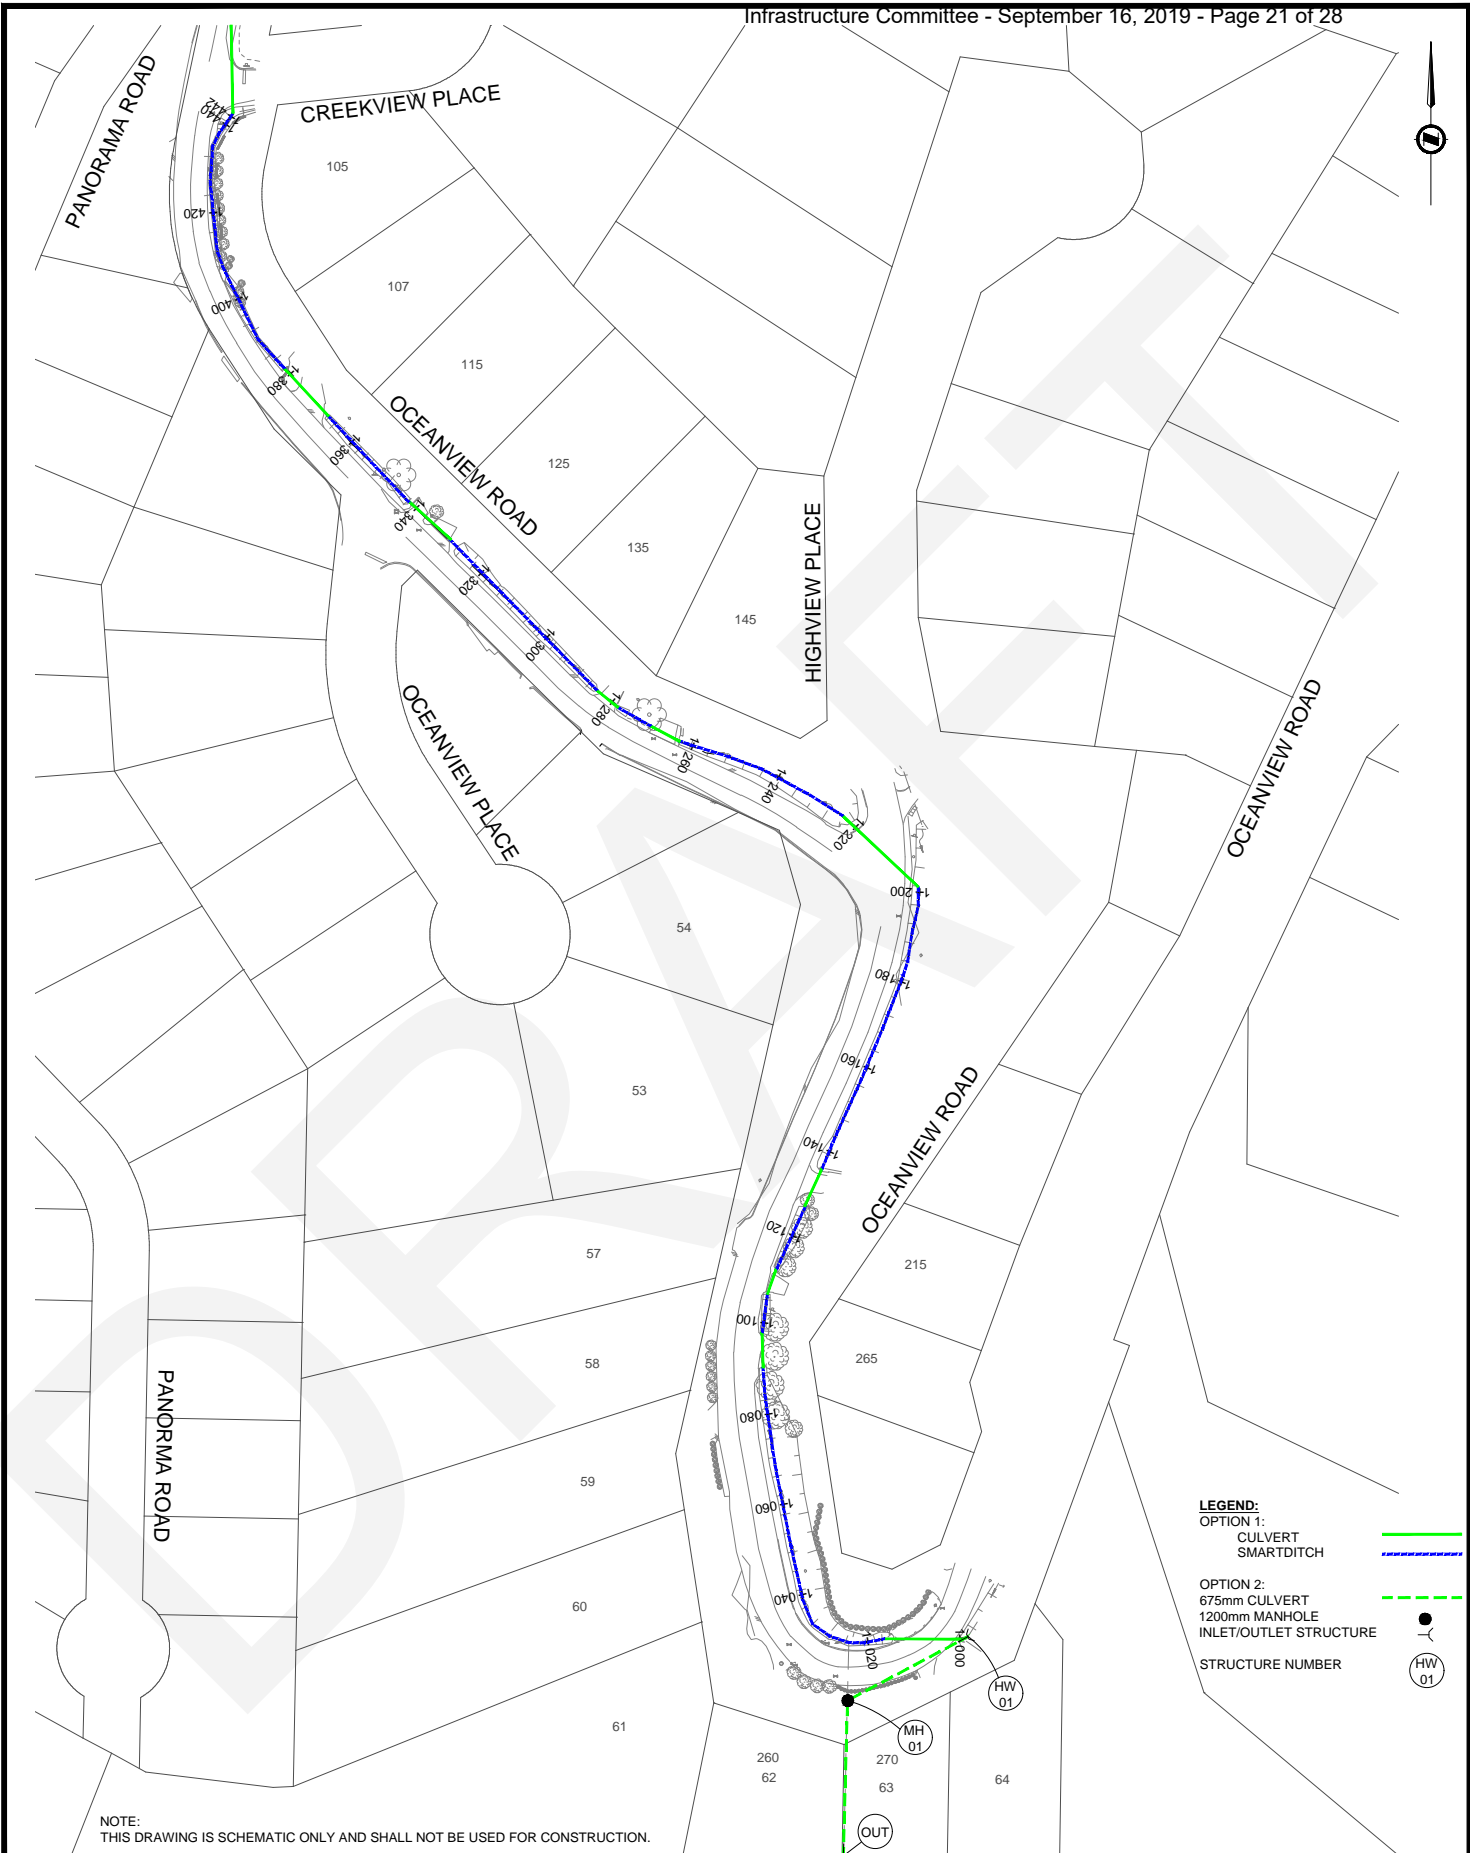
SCALE	NTS	DATE	19-08-22	DWG. NO.
DRAWN BY	GSH	DESIGN BY	GSH	1 OF 1
CHECKED	ATB	APPROVED BY	ATB	
PROJECT NUMBER	32282	DRAWING NUMBER	FIGURE B	REV.

Some sections of the open channel and all the culverts were found to be under capacity based on the 10-year design event. In addition, the culverts are in poor condition and should to be replaced. The following two options were evaluated to increase the capacity of channel and culverts. Figure B attached shows the two options.

- Option 1 - Modify the channel cross section and upsize the culverts
- Option 2 – Divert the flow through a new culvert between Lot 260 and Lot 270

In this option, the 10-year peak flow would be re-routed to Rundle Creek through a proposed 675mm concrete pipe located between Lot 260 and Lot 270 as it is shown in Figure B (attached). The existing 450mm culvert crossing Oceanview Drive would be removed and the open channel system would remain in place to facilitate the road drainage. Table 3.5 shows the proposed pipes parameters and capacities.

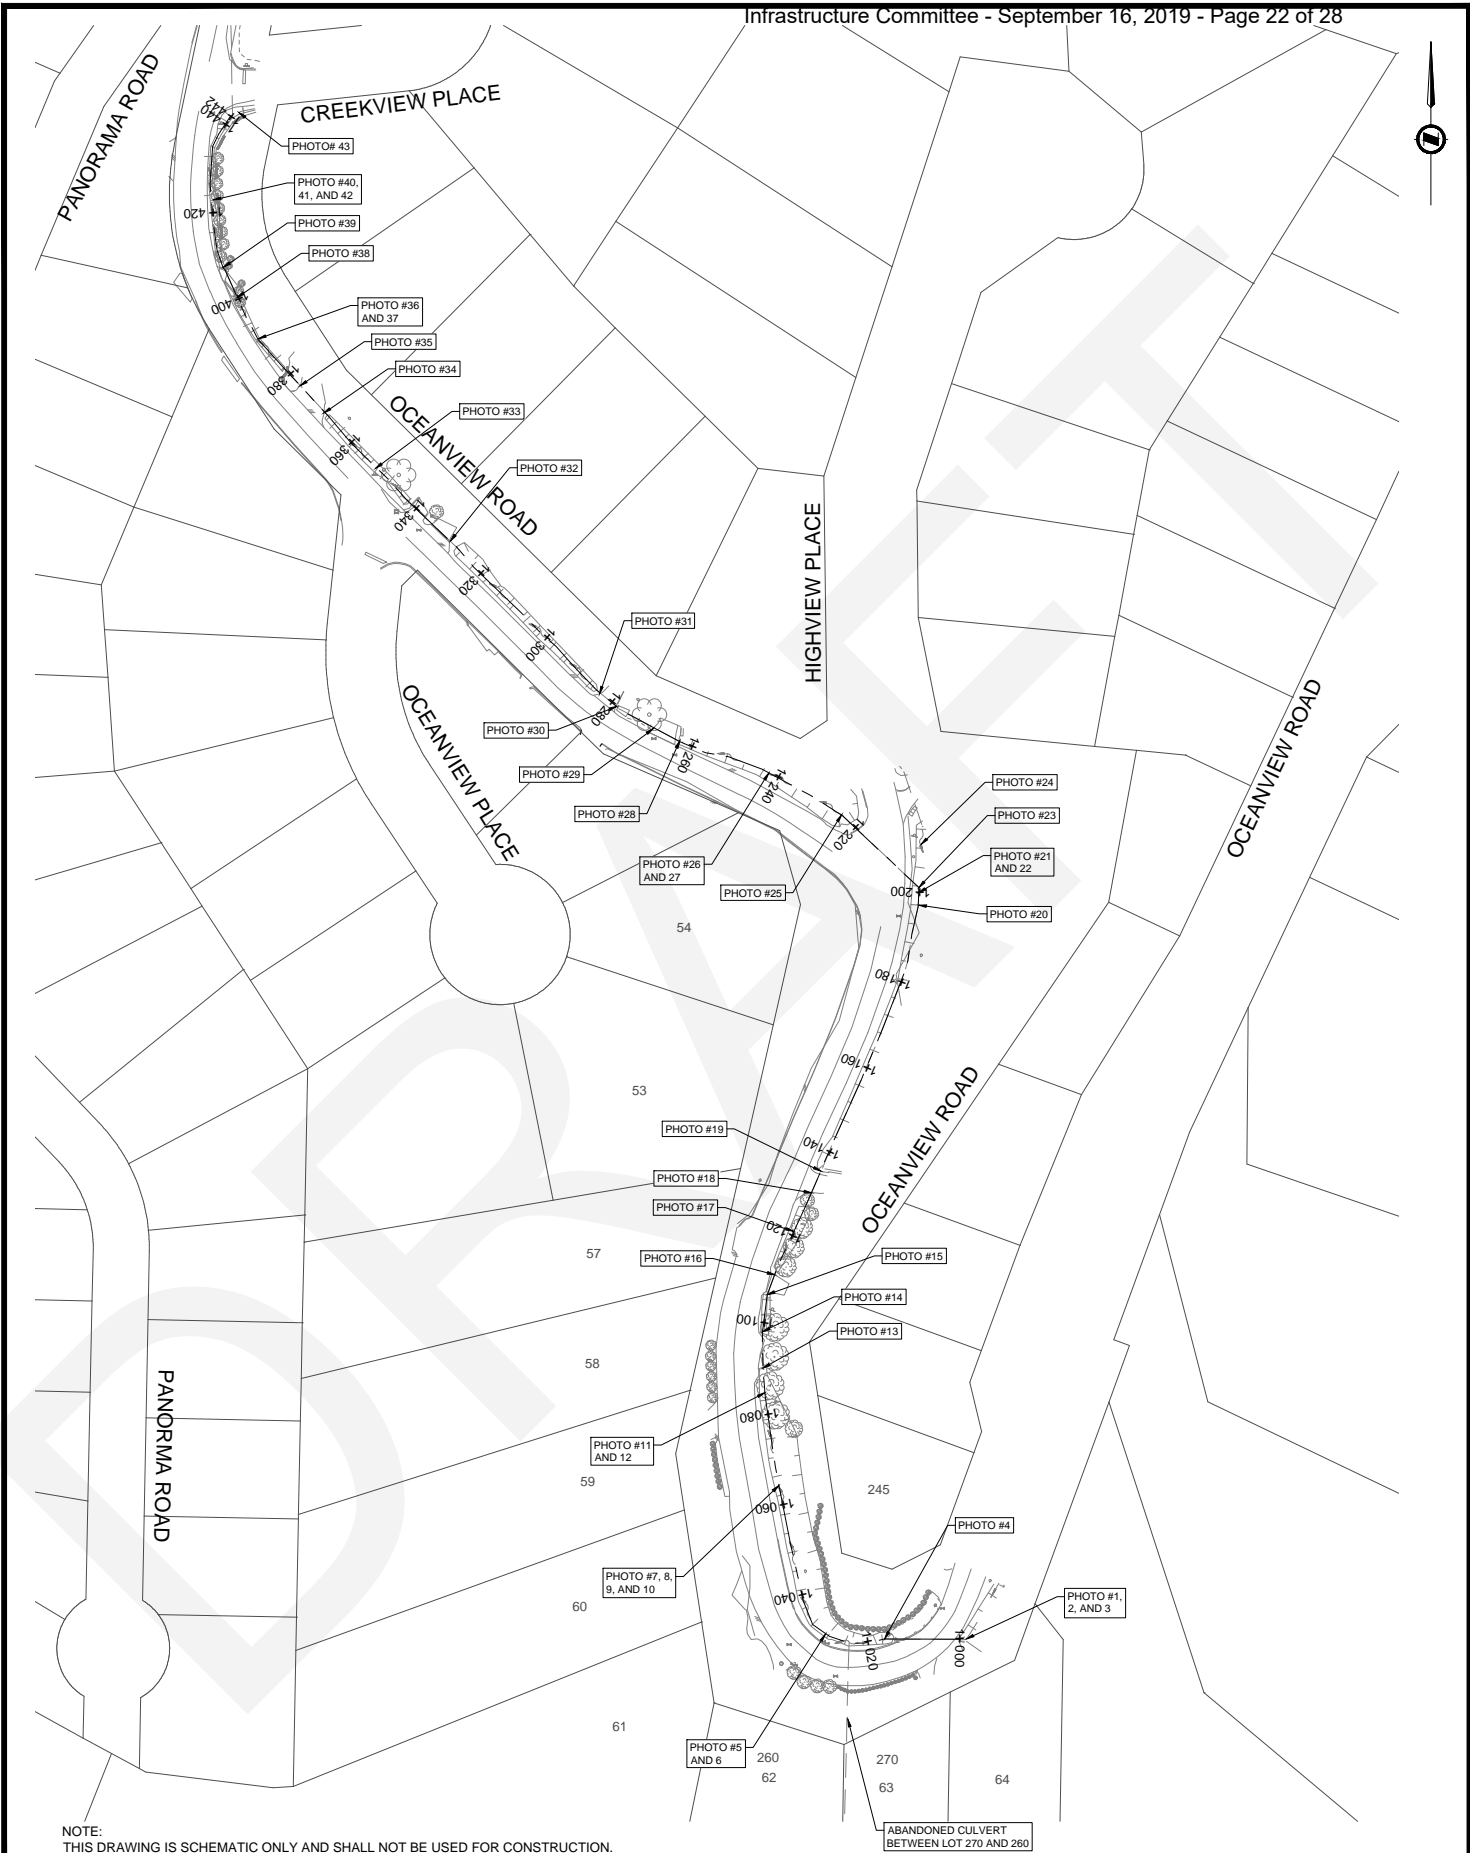
SCALE	NTS	DATE	19-08-22	DWG. NO.
DRAWN BY	GSH	DESIGN BY	GSH	1 OF 1
CHECKED	ATB	APPROVED BY	ATB	
PROJECT NUMBER	32282	DRAWING NUMBER	FIGURE C	REV.

Sta.	Culvert				Channel Cross section					Comments
	Dia. (mm)	Material	L (m)	S (%)	D (m)	W (m)	Side Slope (H:V)	S (%)	n	
1+000	450	Concrete	15.0	10.1	-	-	-	-	-	Good condition, concrete headwall inlet
1+015	-	-	-	-	0.45	0.9	1:0.8	21.5	0.05	Boulders observed in channel for approx. the first 5m, cobbles and gravel banks including some vegetation thereafter
1+037	-	-	-	-	0.7	0.3	1:0.5	9.8	0.04	Channel consisted of cobbles and gravel banks including some vegetation and trees
1+082	-	-	-	-	0.7	0.4	1:0.8	7.5	0.035	Channel consisted of cobbles and gravel banks including some vegetation and trees
1+090	450	Corrugated Steel	8.0	8.75	-	-	-	-	-	Poor condition, corroded bottom and deformed, debris covered inlet, and outlet not visible due to vegetation cover
1+098	-	-	-	-	0.55	0.5	Rect.	6.3	0.04	Channel consisted of large cobbles and vegetation, banks contained large rocks in some sections and overgrown vegetation causing flow restriction

Sta.	Culvert				Channel Cross section					Comments
	Dia. (mm)	Material	L (m)	S (%)	D (m)	W (m)	Side Slope (H:V)	S (%)	n	
1+106	450	Corrugated Steel	6.0	5.0	-	-	-	-	-	Poor Condition, corroded bottom, inlet was obstructed by large rocks and vegetation, and outlet not visible due to vegetation cover
1+112	-	-	-	-	0.45	0.4	1:0.5	7.4	0.035	Channel consisted of cobbles and overgrown vegetation, over hanging branches observed obstructing the channel
1+127	525	Corrugated HPDE	69.0	5.1	-	-	-	-	-	Inlet not visible due to overhanging branches, installed in 2011 to mitigate infiltration issues
1+196	-	-	-	-	0.9	0.3	1:0.25	11.5	0.05	Channel consisted of cobbles and gravel banks including vegetation growth
1+200	450	Corrugated Steel	23.0	10.9	-	-	-	-	-	Poor Condition, corroded bottom, three vertical grates at the inlet with trapped leaves and sticks, outlet not visible due to vegetation cover
1+223	-	-	-	-	0.3	0.4	Rect.	9.2	0.035	Channel consisted of cobbles, gravel and thick vegetation in some areas, banks contained vegetation, wet

Sta.	Culvert				Channel Cross section					Comments
	Dia. (mm)	Material	L (m)	S (%)	D (m)	W (m)	Side Slope (H:V)	S (%)	n	
										channel, but no presence of flowing water
1+262	450	Corrugated Steel	12.0	11.8	-	-	-	-	-	Poor Condition, corroded bottom, obstructed inlet with small rocks, leaves, and sticks, outlet not visible due to vegetation cover, no presence of water
1+274	-	-	-	-	0.5	0.4	1:0.5	20.5	0.05	Channel consisted of cobbles and vegetation
1+276	450	Corrugated Steel	6.0	13.7	-	-	-	-	-	Poor Condition, corroded bottom, inlet and outlet not visible due to vegetation cover
1+282	-	-	-	-	0.6	0.4	1:0.5	16.9	0.05	Channel consisted of cobbles and gravel, banks including vegetation.
1+324	525	Corrugated Steel	14.0	13.3	-	-	-	-	-	Poor Condition, corroded bottom, misplaced four vertical grates, outlet not visible due to vegetation cover, no presence of water
1+337	-	-	-	-	0.5	0.4	1:0.5	14.8	0.05	Channel consisted of cobbles and vegetation, no presence of water

1+362	525	Corrugated Steel	13.0	13.3	-	-	-	-	-	Poor Condition, corroded bottom, imbedded in the ground at outlet, small rocks, leaves, and sticks at the outlet, no presence of water

Sta.	Culvert				Channel Cross section					Comments
	Dia. (mm)	Material	L (m)	S (%)	D (m)	W (m)	Side Slope (H:V)	S (%)	n	
1+375	-	-	-	-	0.3	0.4	1:0.8	15.3	0.05	Channel consisted of cobbles and vegetation, no presence of water
1+394	450	Corrugated Steel	5.0	13.2	-	-	-	-	-	Poor Condition, corroded bottom, outlet not visible due to vegetation cover, no presence of water
1+429	-	-	-	-	0.5	0.5	1:0.8	15.4	0.05	Channel consisted of cobbles and vegetation, no presence of water
1+465	525	Corrugated Steel	150	10.7						Inlet in poor Condition, corroded bottom, no presence of water
1+615	Outlet to Harvey Creek

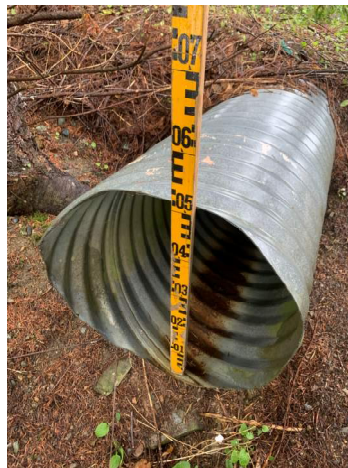
Outlet to Harvey Creek

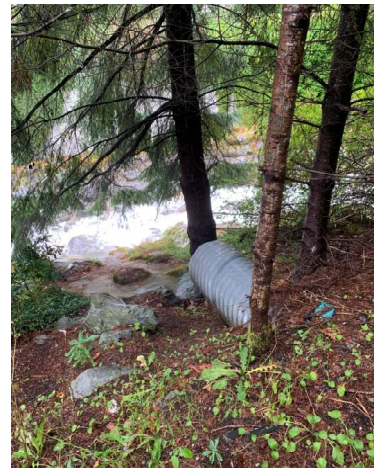
Outlet to Harvey Creek
