THE MUNICIPALITY OF THE VILLAGE OF LIONS BAY

**INFRASTRUCTURE COMMITTEE MEETING  
OF THE VILLAGE OF LIONS BAY  
HELD ON MONDAY, MARCH 26, 2018 at 7:00 PM  
COUNCIL CHAMBERS, 400 CENTRE ROAD, LIONS BAY**

**GEOTECHNICAL REVIEW OF ACCESS ROADS  
HARVEY AND MAGNESIA CREEK INTAKES  
LIONS BAY, BC**

Mag intake flushing March 16, 2018

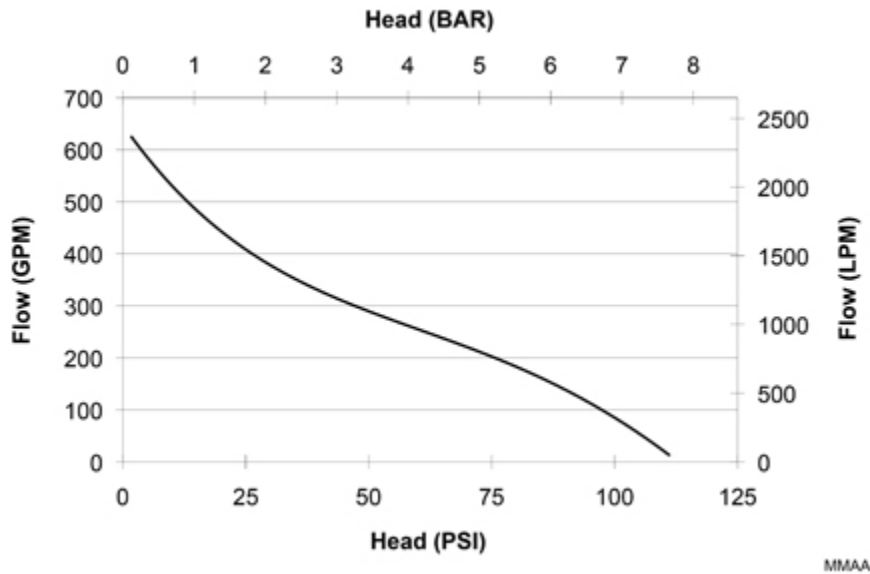
Honda gx630/ CET water pump - PFP-20HPHND-2D

We used the fire departments CET brand water pump. Specs shown below:

POWER : 15.5KW

MAX FLOW : 630 GPM

MAX PRESSURE : 105 PSI

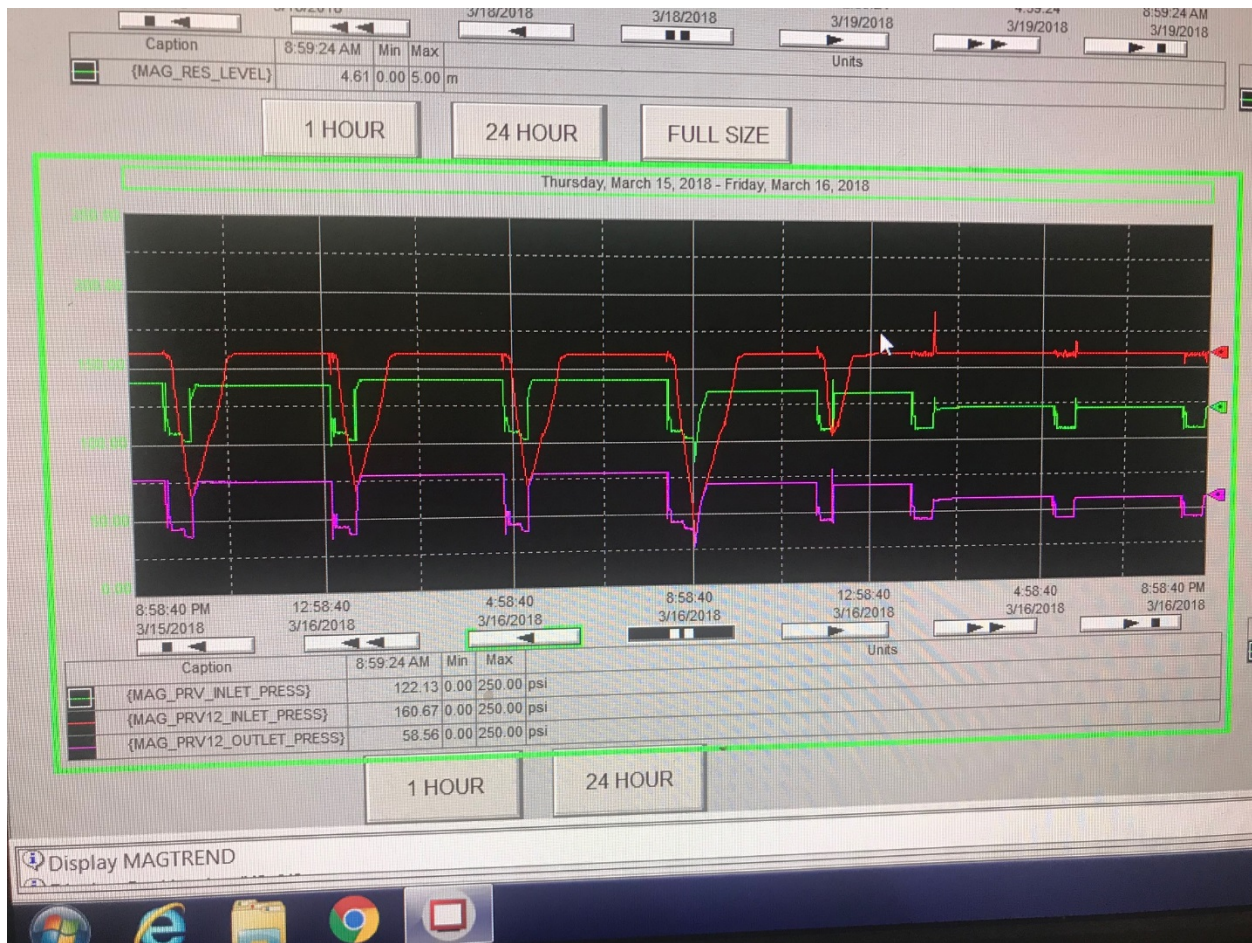
Red line below indicates upstream water pressure, showing inability to supply sufficient water as the tank fills at 210gpm on the 2" cla-valve , (plugged intake) then after the mouse cursor, showing ability to supply >210gpm while filling at 210gpm.(cleaned intake) Uncertain if it would be able to supply sufficient water when mag was filling on the 6" cla-valve, but certainly still operating well below its designed capacity: to be able to supply "twice the volume of what the pipe can carry" (creus)

We then tried a make shift nozzle from pipe thread nipples. Using a 1 1/2" nozzle we blasted the top of the grate. Large amounts of sand, mud, organics and sticks were washed away from the grate with this method. We alternated washing with the fire hose and draining the weir with the sluice gate to achieve an "as good as it gets" cleaned infiltration gallery
