Village of Lions Bay

Infrastructure Master Plan

60437708

July 28, 2016

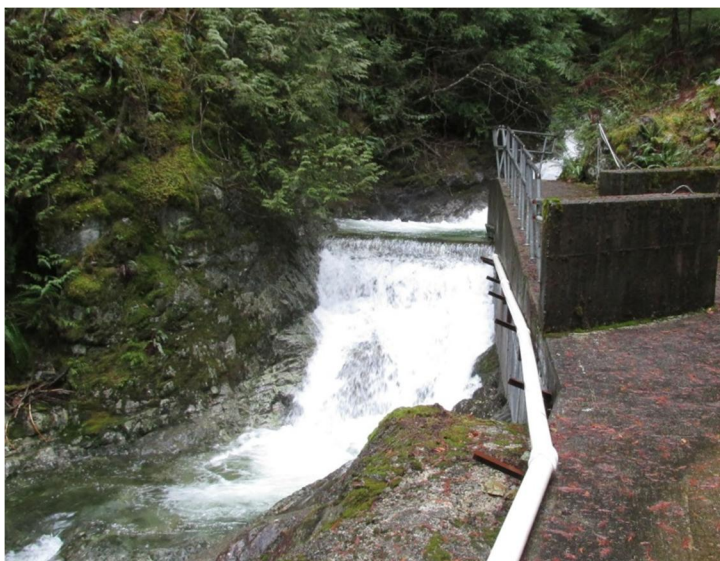
Figure 2-3: Photo of the Harvey Intake

- The Harvey Creek intake and many of the reservoirs are nearing the end of their service lives and will need replacement in the near future.

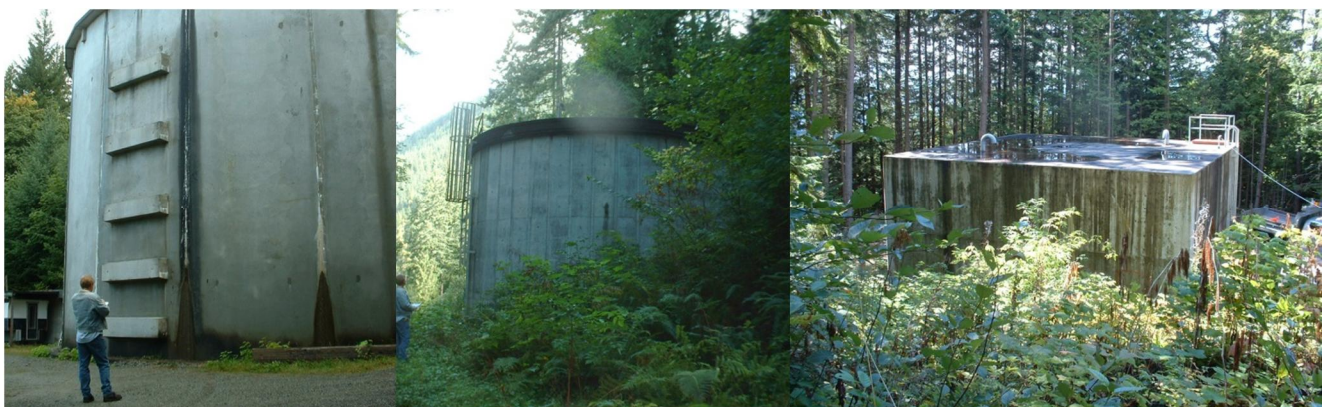
Figure 2-4: Photos of Harvey 400, Harvey, and Magnesia Tanks (left to right)

The average expected service life of a reservoir is approximately 50 years. As some of the reservoirs were constructed in the 1960's (Highway, Phase 4, 5, and 6 tanks), they are likely approaching the end of their service lives. The Village should conduct regular inspections of these tanks and conduct recommended rehabilitation work in a timely manner. This will help prevent unexpected failures, extend the service lives of the tanks, reduce their overall life cycle costs and help predict future capital expenditures.

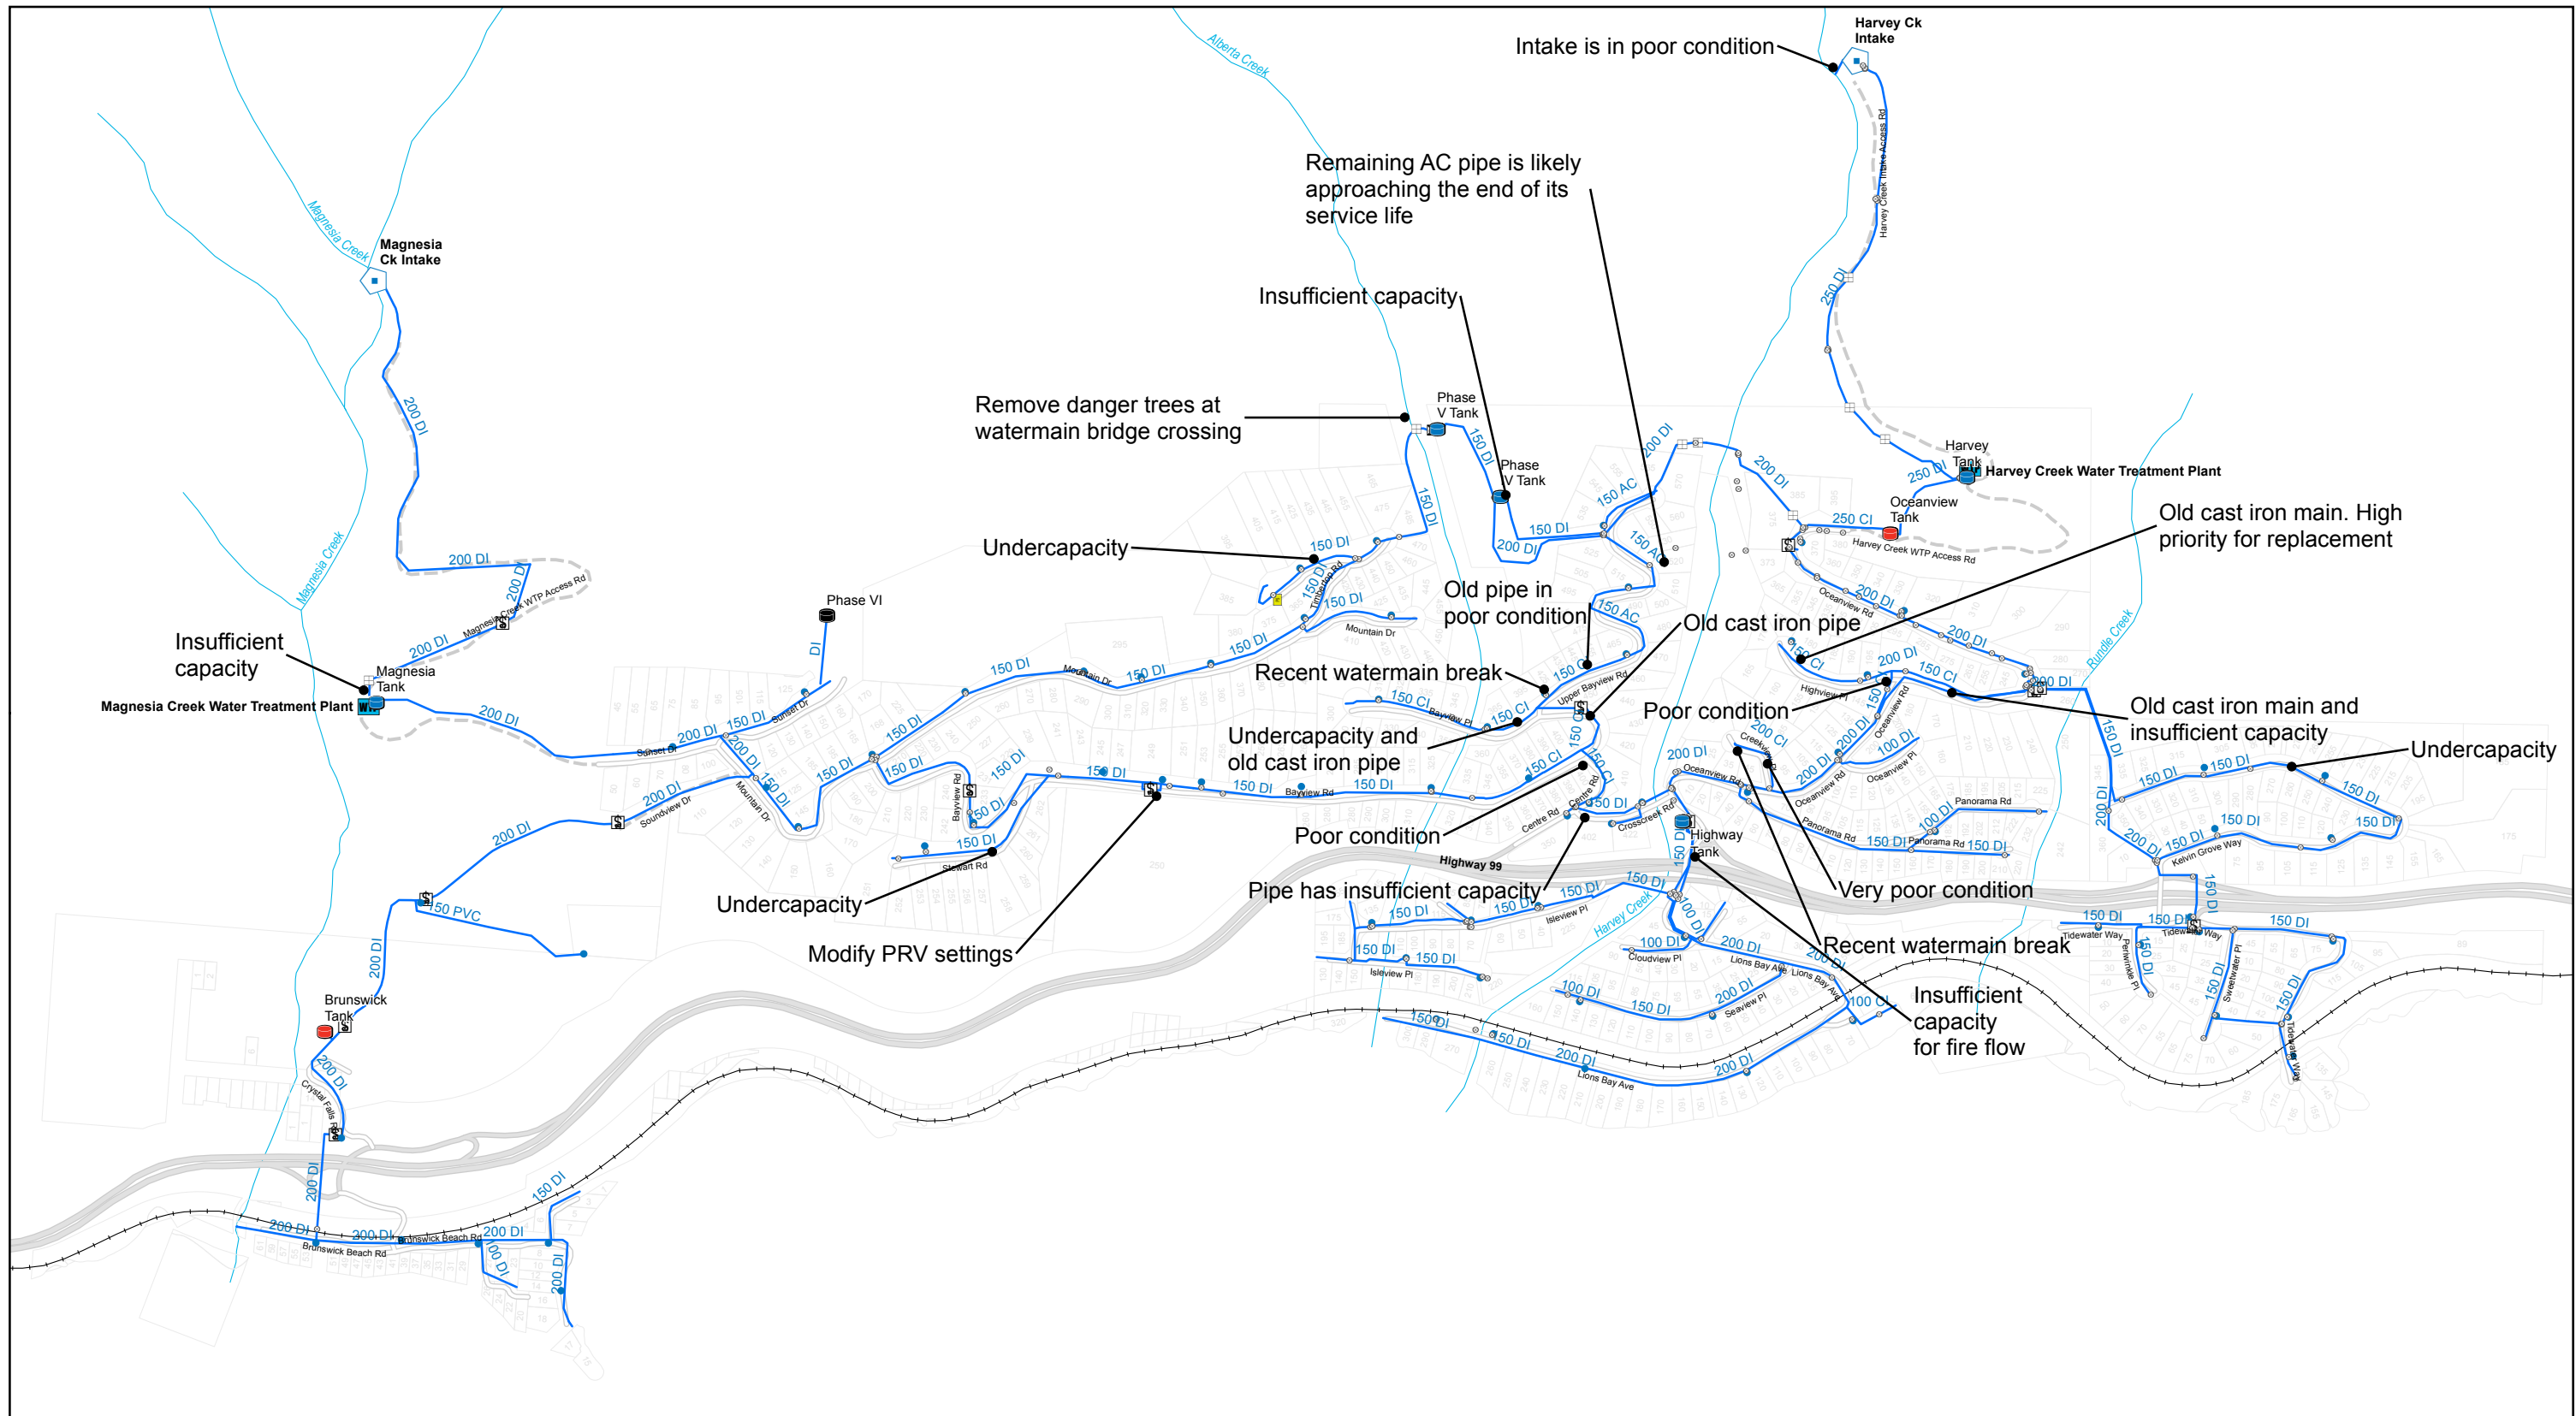
VILLAGE OF LIONS BAY
Infrastructure Master Plan
 Figure 2-5 Water System Issues

Review of each PRV station will be required to determine how compliance with WorkSafe BC standards can be met. Through correspondence with Village staff it was estimated that six of the PRV stations will require full replacement while the remaining six stations will require upgrades to replace ageing components such as strainers and valves, and for SCADA improvements to increase system automation while also collecting system performance data. Lastly, many of the existing PRV chambers have drainage issues which should be addressed to increase the lifespan of the PRV components and resolved prior to installation of SCADA equipment.

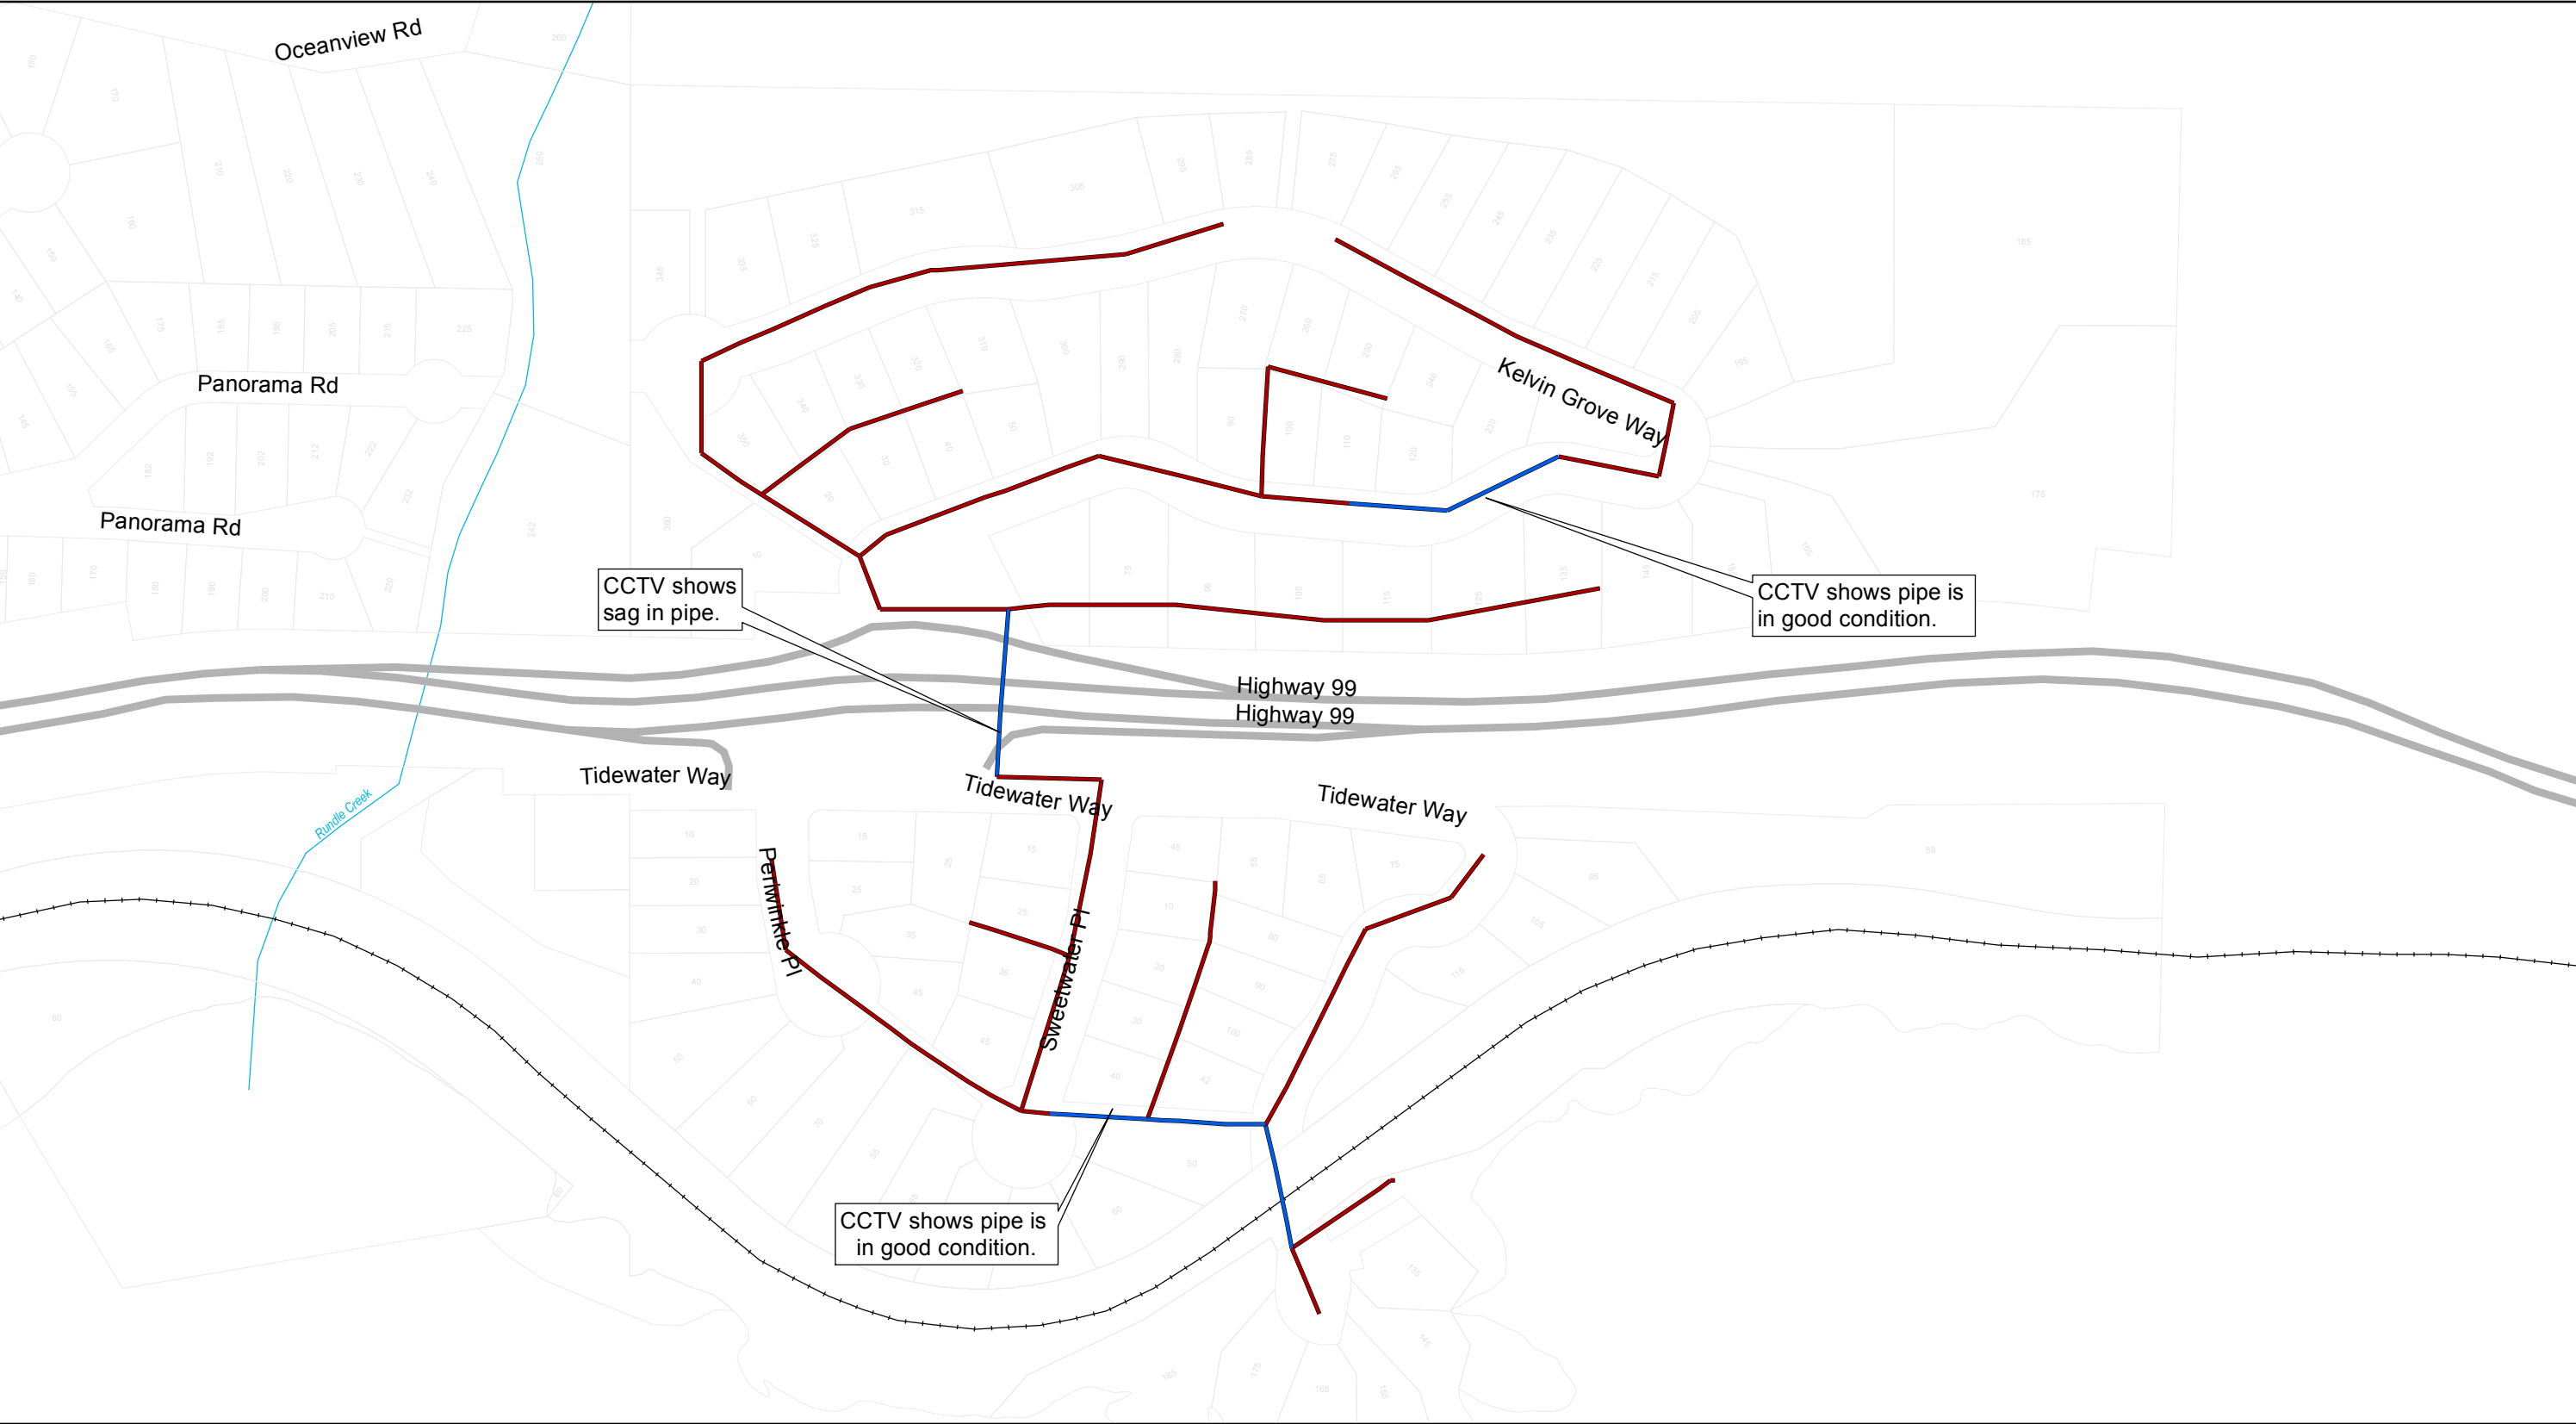
VILLAGE OF LIONS BAY
Infrastructure Master Plan
Figure 3-2 Sanitary Sewers Inspected by CCTV

We conducted CCTV inspection of six sections of sanitary sewer; including: the portions of the system that runs under the highway and the railway tracks. Based on the CCTV inspections the pipe appears to be in good condition. Figure 3-2 shows the sections of sanitary sewer that were inspected and any found defects. The only found defect was a sag in the sewer under the Sea to Sky Highway, which should be monitored during subsequent CCTV inspections. The Village should inspect its entire sanitary sewer network at least every 20 years. That way they can monitor the condition of its sanitary network and be progressive in its renewal as the system begins to age and deteriorate.

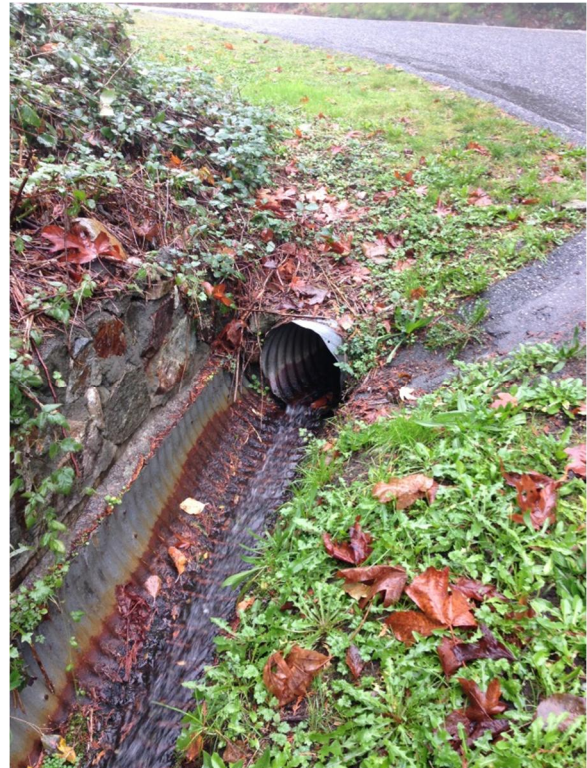
Figure 4-2: Photo of Corrugated Steel Pipe Culverts

- In November / December 2015, there were several significant rainfall events in the Village. During one of these events, water was witnessed flowing out of the surface of the asphalt road as a result of a blocked culvert under the surface. This was likely causing significant damage to the roadway and evidence of this was visible on the surface.

Many of the problems highlighted above involve corrugated steel pipes. Corrugated steel pipes are relatively inexpensive and easier to install in comparison to concrete pipes. However, their shorter lifespan can lead to a higher overall life cycle cost. For this reason many municipalities such as the City of Surrey prohibit the installation of corrugated steel pipes.

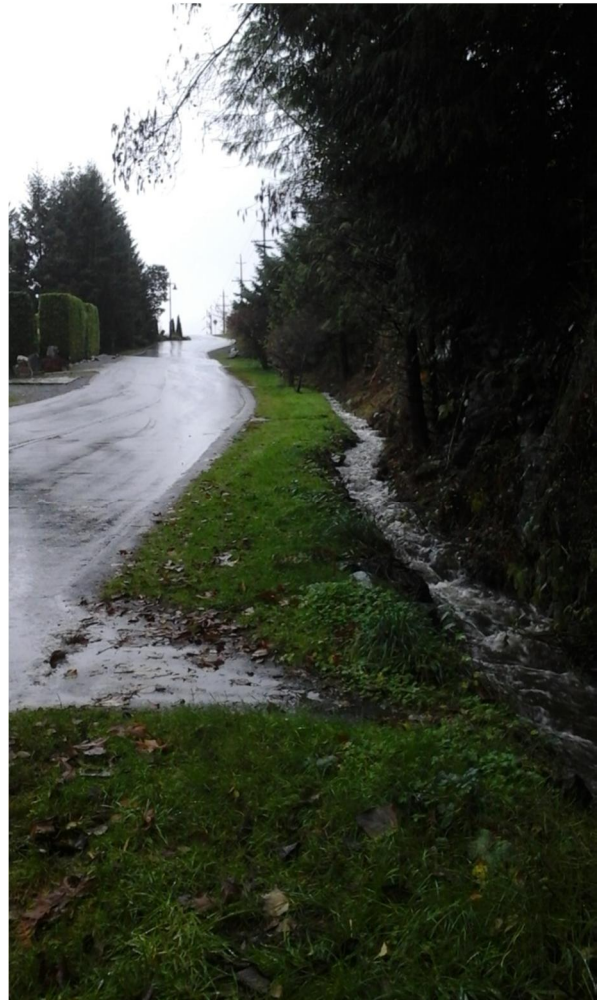
Figure 4-4: Photos of Roadway Ditch

- All sections of roadways should be served with some form of drainage (ditches, catch basins, culverts etc.) to avoid high volumes of sheet flow that can damage roadways or risk flooding private properties. Roadways such as Bayview Place, Panorama Road, Lions Bay Avenue, Isleview Place, Cloudview Place, Oceanview Place and the south end of Oceanview Road are not currently serviced sufficiently with drainage infrastructure.
- Several culverts were found to be clogged with gravel, which limits the available capacity. The Village should have a preventative maintenance program which includes regular inspection and cleaning of culverts.
- Several sections of ditches within the road right-of-way have been encroached upon and are infilled.
