## THE MUNICIPALITY OF THE VILLAGE OF LIONS BAY

**COMMITTEE OF THE WHOLE MEETING  
OF THE VILLAGE OF LIONS BAY  
HELD ON THURSDAY, APRIL 7, 2022 at 7:00 PM  
COUNCIL CHAMBERS, 400 CENTRE ROAD, LIONS BAY  
AND VIA ZOOM VIDEO CONFERENCE**

<b>Type</b>	<b>Information Report</b>		
<b>Title</b>	<b>Village of Lions Bay OCP Amendment – Development Permit Areas</b>		
<b>Author</b>	<b>Steven Olmstead, Planning Consultant</b>	<b>Reviewed By:</b>	<b>Peter DeJong, CAO</b>
<b>Date</b>	<b>January 4, 2018</b>	<b>Version</b>	<b>1</b>
<b>Issued for</b>	<b>January 9, 2018</b>

## **The Village of Lions Bay: A Natural Hazards Assessment Area Strategy for Coastal, Creek and Hillslope Hazards.**

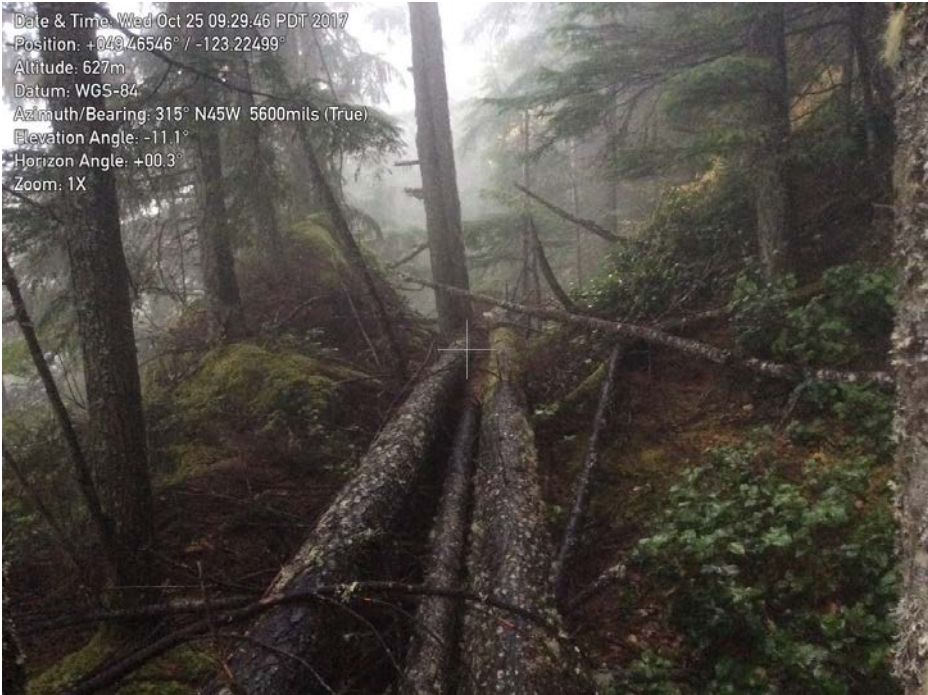
Cliff crest

Gaping tension crack

Uphill facing scarp

Large fragments

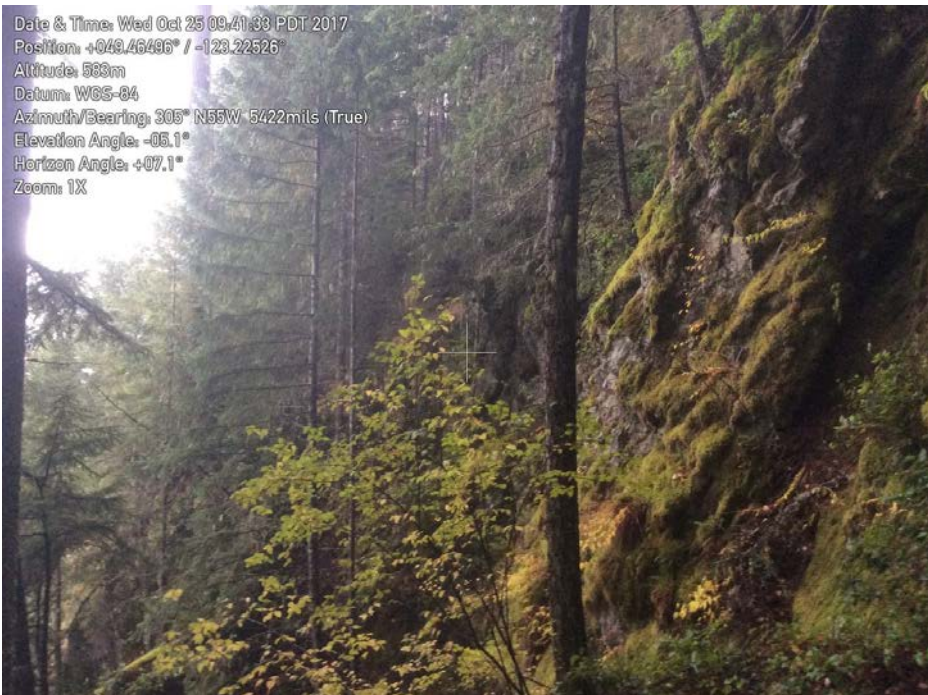
Unfavourable joints

Steep, slope parallel

Talus

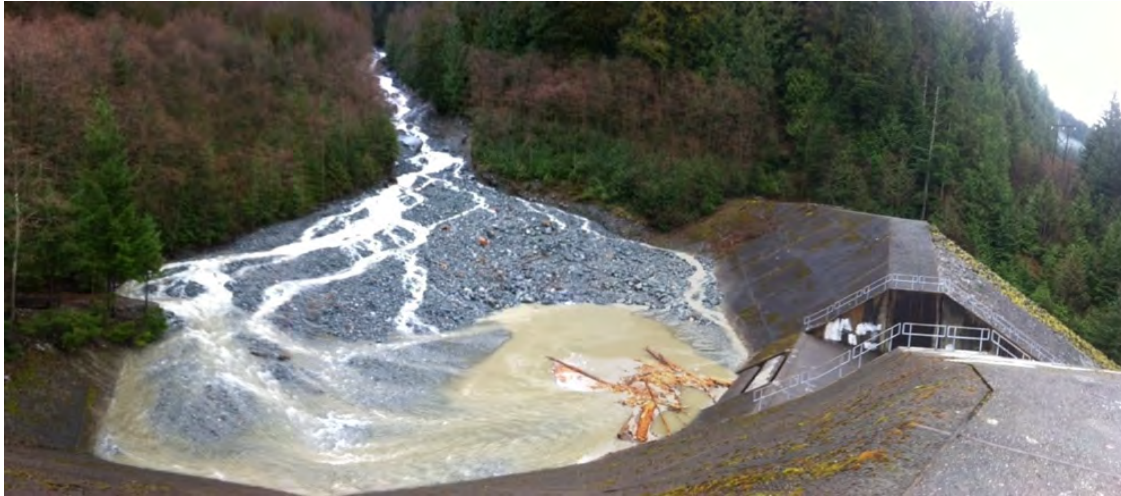
**Figure 3.** Charles Creek retention structure with debris flow infill. Downloaded from internet (<https://www.flickr.com/photos/tranbc/8510095573>).

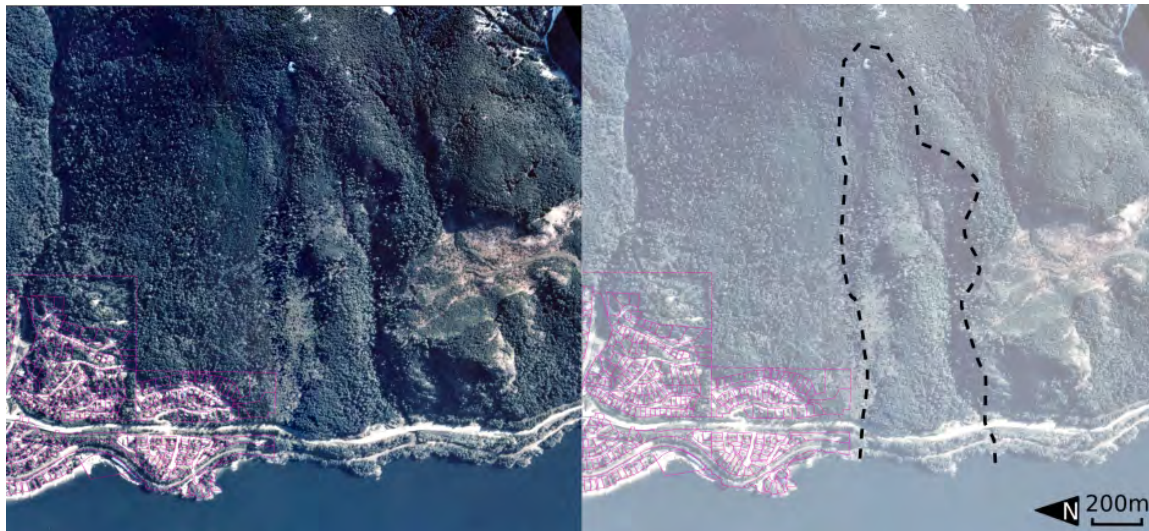
Just 100 m south of the Village of Lions Bay, the whole slope from sea level to 1100 m elevation shows signs of weakness. The area is sided by two linear depressions defining an area about 500 m width and delimited by a horseshoe-shaped headscarp at the top and by a convex toe at sea level (Figure 5). The convex toe dictates the highway path. The stability of this feature is unknown. This area is outside the LIDAR coverage but it has been recognized and mapped on the historic orthophotos. In personal communication, this area was previously identified to Cordilleran Geoscience by Karen Savage, P.Eng., of Horizon Engineering. Even if this feature might not directly affect Village of Lions Bay, it affects the highway and may pose significant hazard to the access to the Village of Lions Bay.

**Figure 5.** Potential sacking slope identified just south of Village of Lions Bay.

These examples of potential deep-seated instability require characterisation and assessment by a qualified geological engineer.

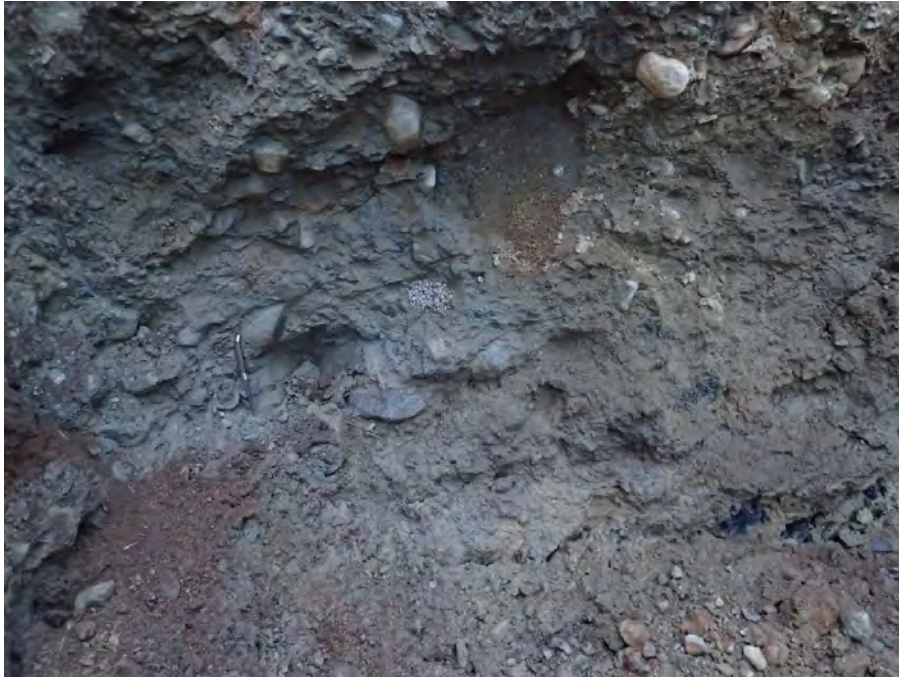
**Photo 1.** Till in house excavation, Lot 60 Oceanview Road.

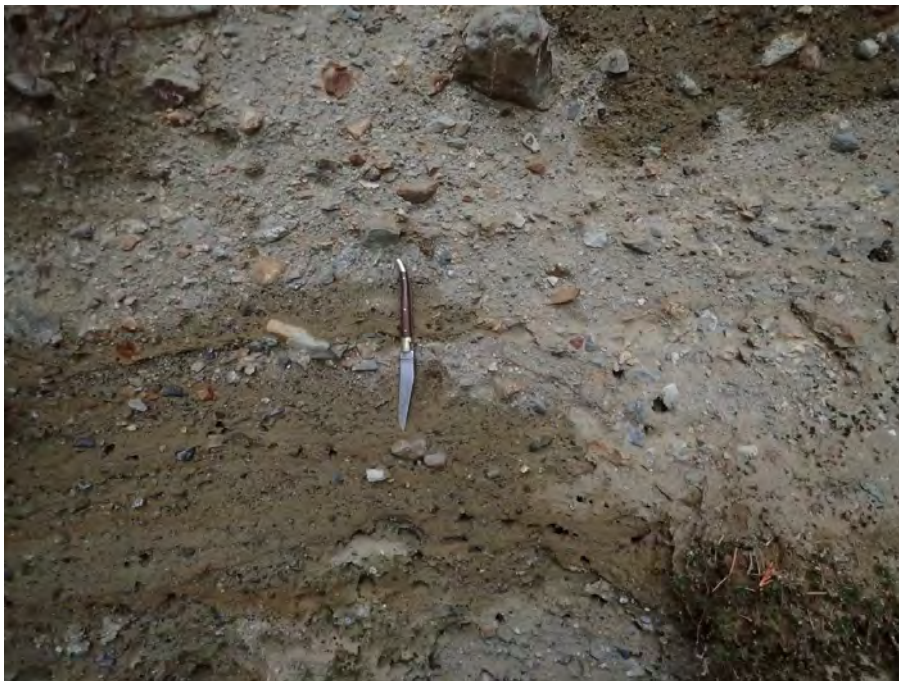
**Photo 2.** Glaciofluvial fan-delta sediments, 160 m elevation, Lot 22 Highview Place.

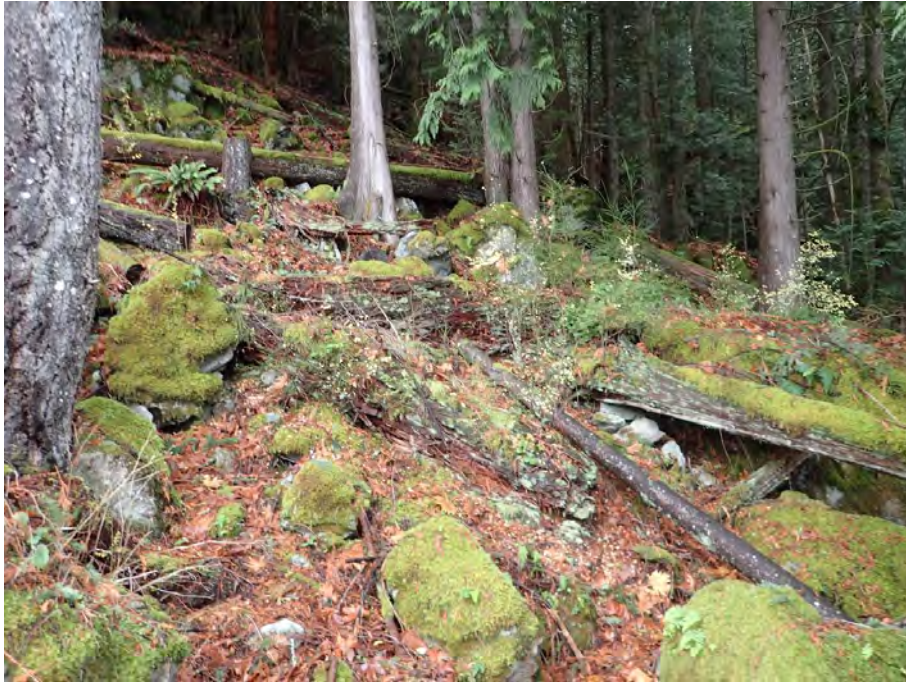
**Photo 3.** Blocky talus slope on Lots 60-61, Kelvin Grove Way.

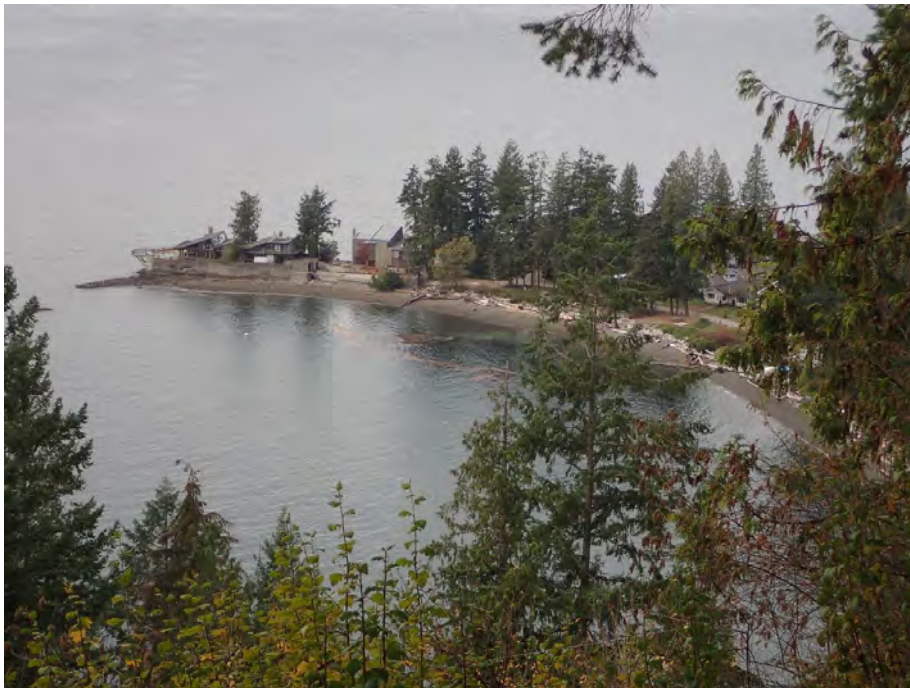
**Photo 4.** View of the tombolo spit, Brunswick Beach. Low lying land is subject to flooding and erosion given sea level rise.

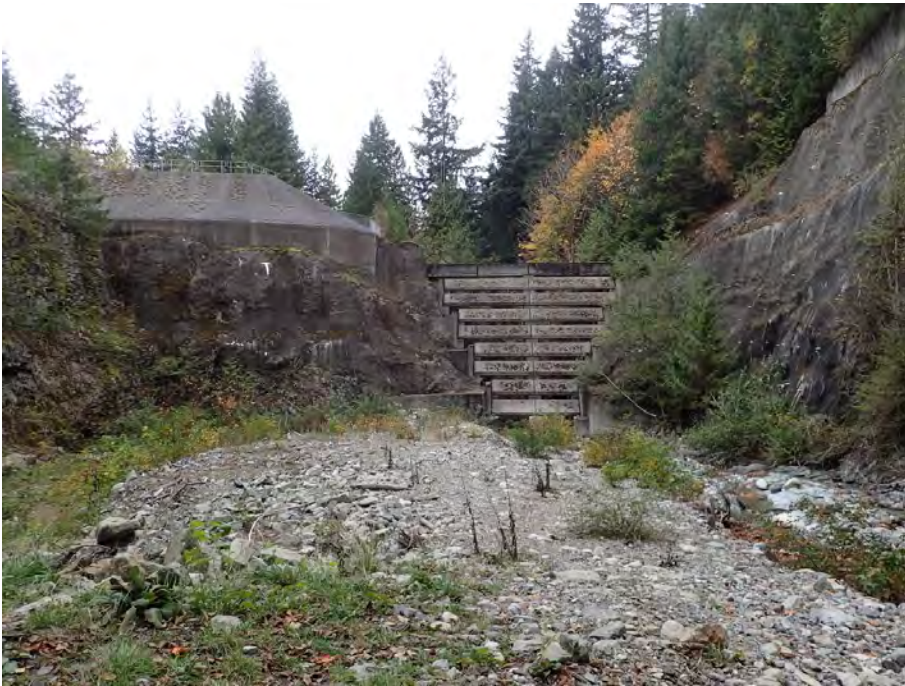
**Photo 5.** Magnesia Creek catch basin.

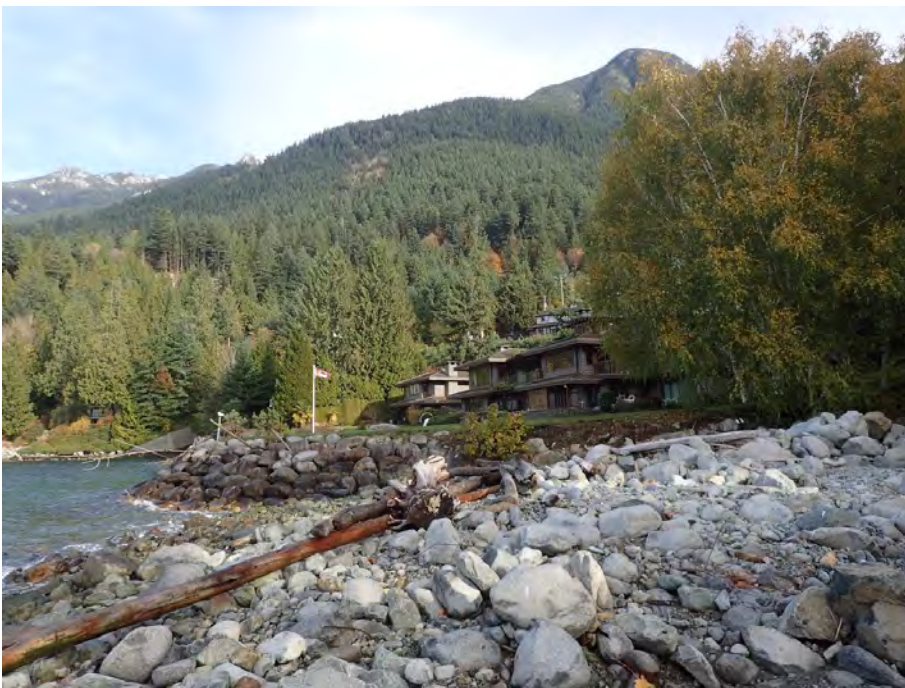
**Photo 6.** Lots 21 & A Lions Bay Avenue have natural banks not significantly raised above Harvey Creek, and could be vulnerable to flood hazard.

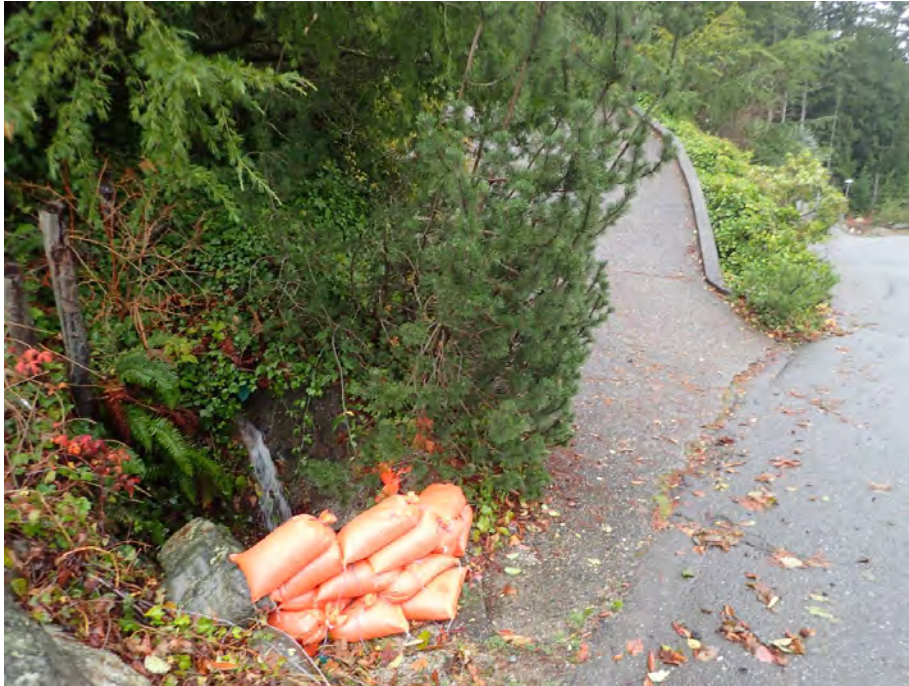
**Photo 7.** Lot 66 Kelvin Grove Way. Small Creek captured by drainage system undersized for full range of flows requires sand bagging to prevent overflow onto local road.

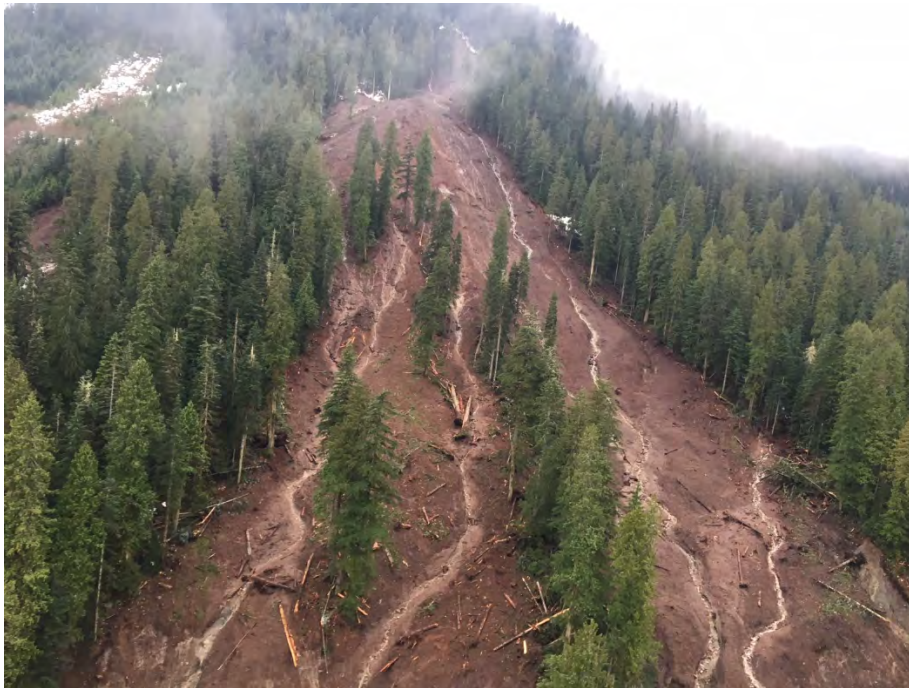
**Photo 8.** Open-slope landslide, North Vancouver mountains, triggered by rain on snow, November 22, 2017.

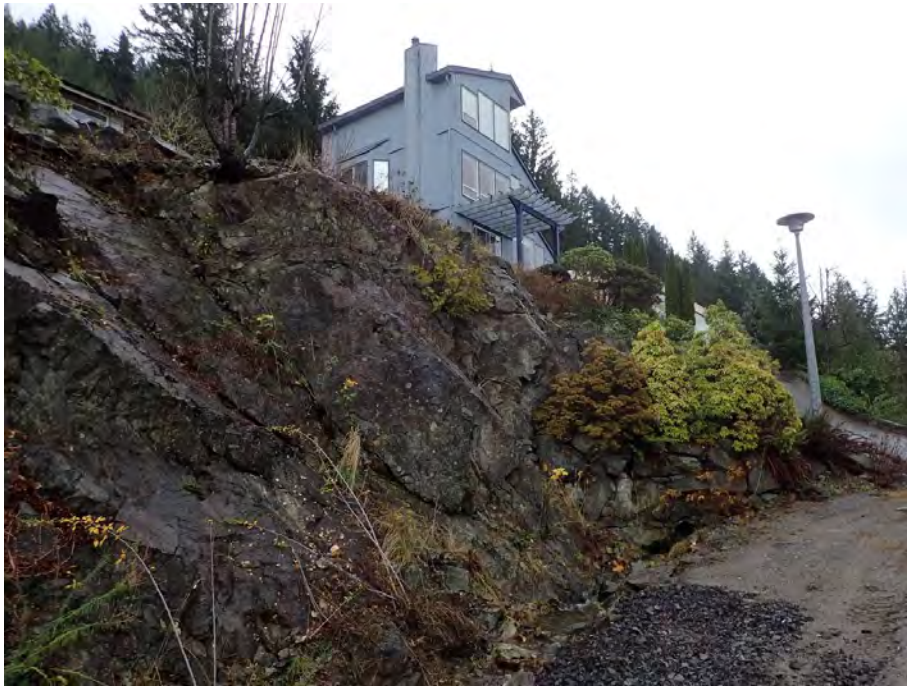
**Photo 9.** Unfavourable jointing in road cut, Lot 85 Kelvin Grove Way.

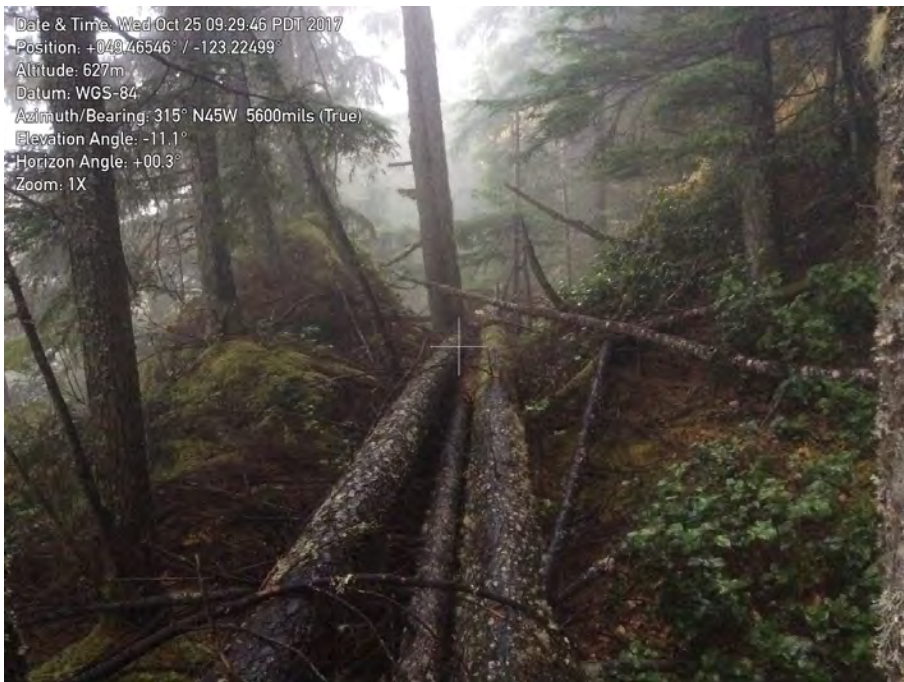
**Photo 10.** Waypoint 46. Antislope ridge indicating steep joint cutting crest of cliff. Several 10s m<sup>3</sup> to 1000s m<sup>3</sup> could be released from this site.

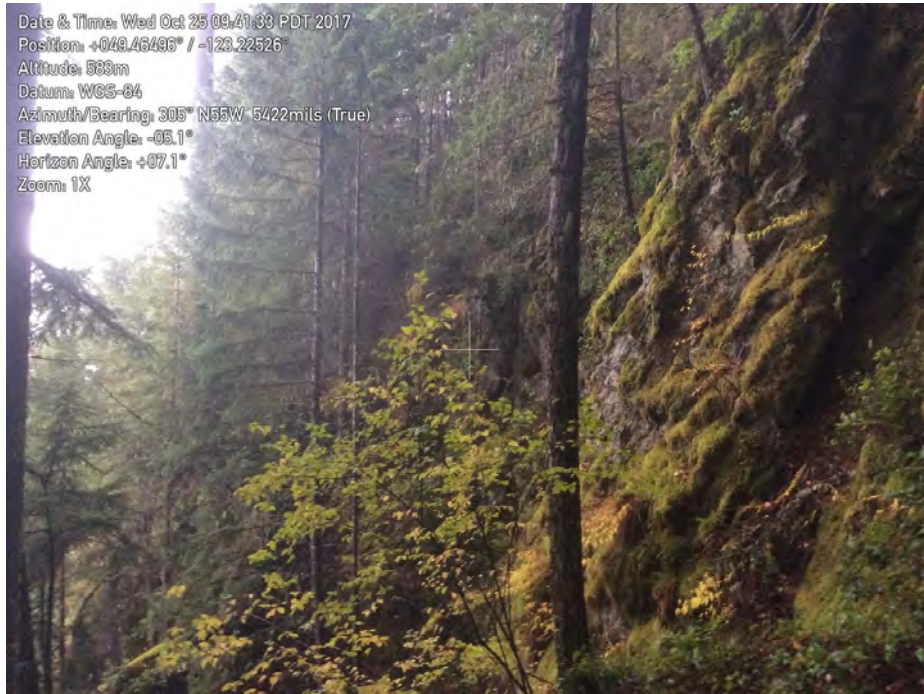
**Photo 11.** Bluff above Mountain Drive with unfavourable joint, parallel to steep slope.

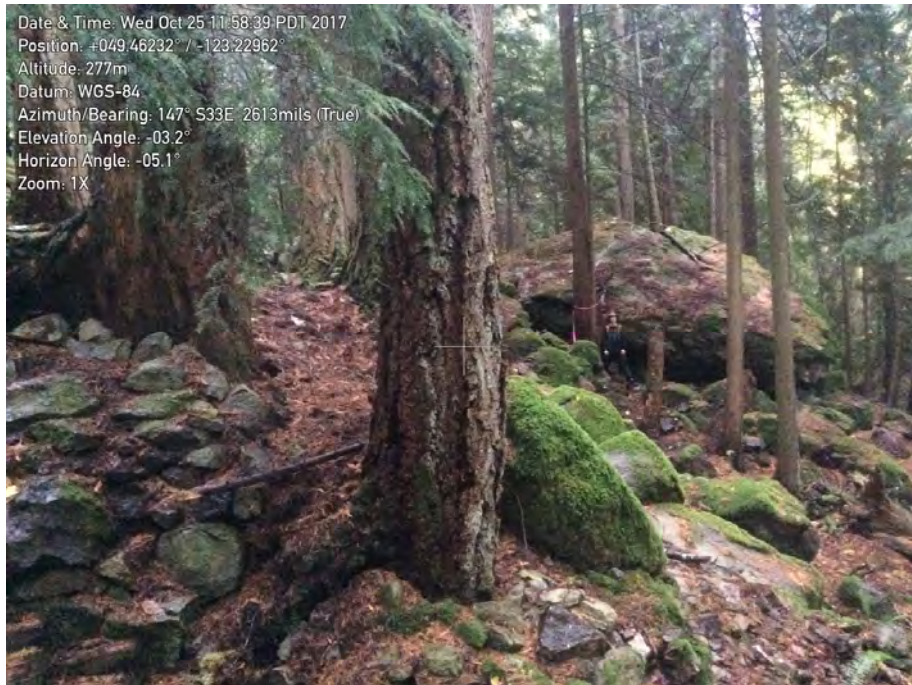
**Photo 12.** Rockfall debris, Lots A & B Timbertop Road. Note the person for scale.

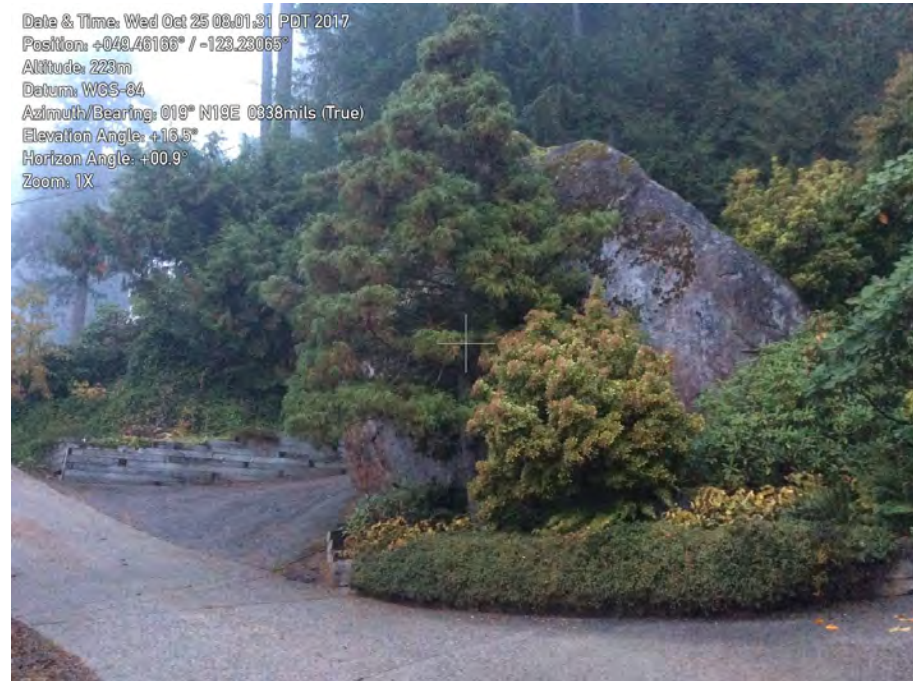
**Photo 13.** Rockfall block, Lot 36 Timbertop Road.

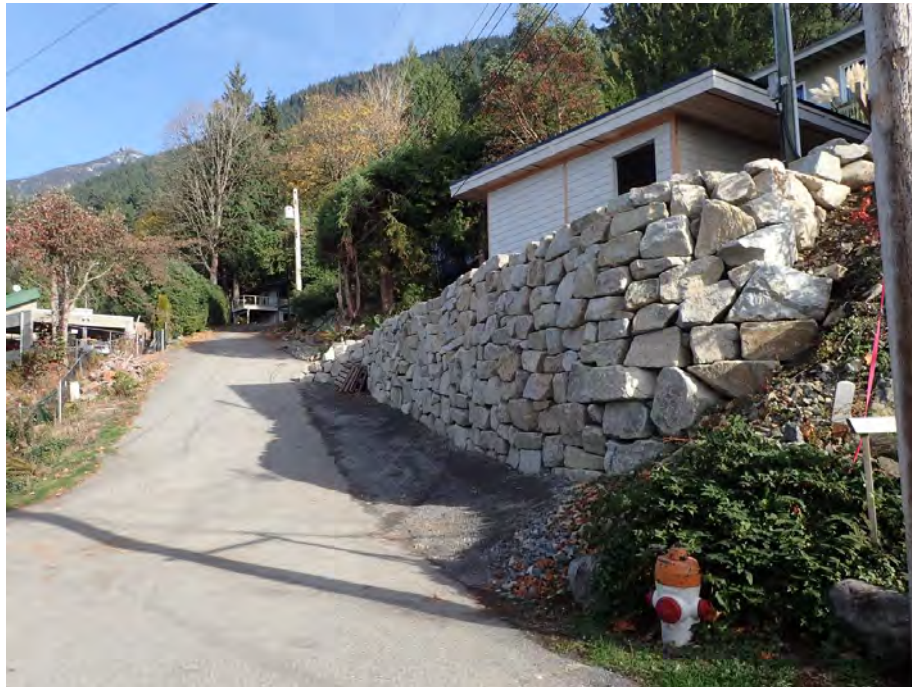
**Photo 14.** Lot 8 Islevue Place. Retaining walls in steep terrain require engineered design.

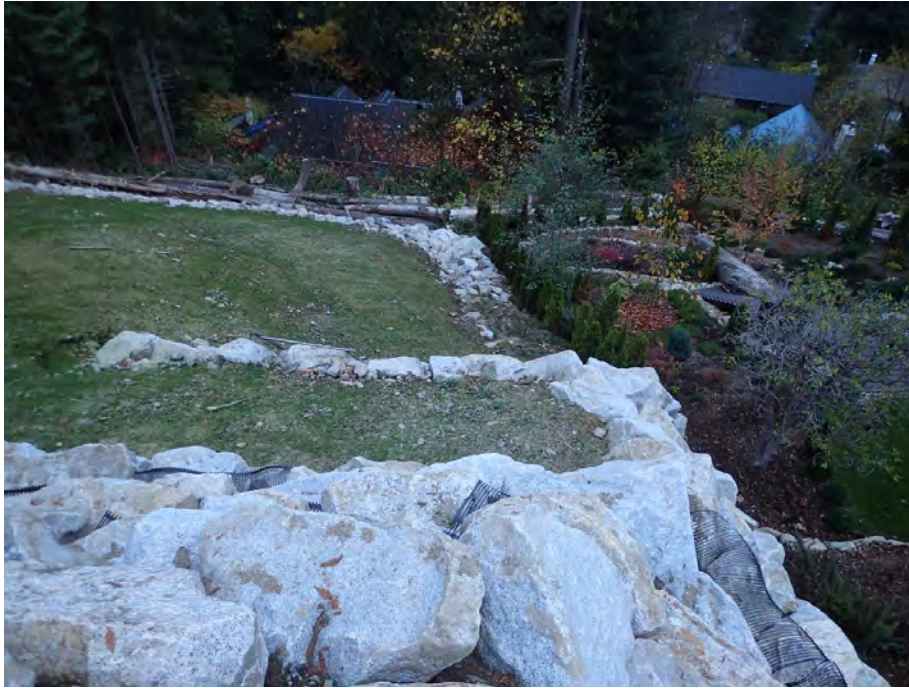
**Photo 15.** Stacked rock wall in steep terrain using geotextile to tie back into slope.

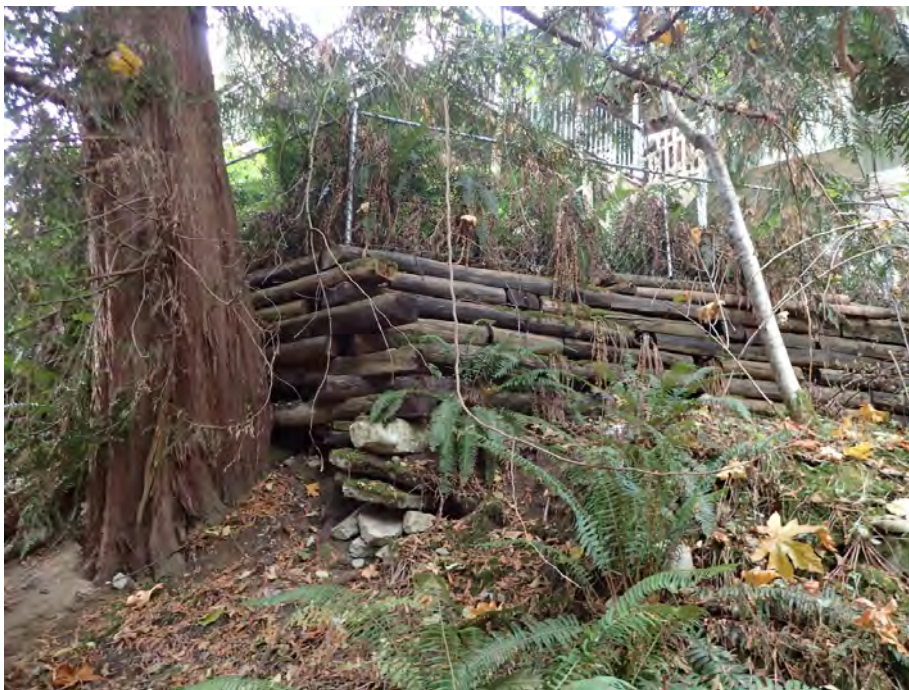
**Photo 16.** Substandard retaining walls represent a slope hazard.
