Village of Lions Bay

Water Storage Facilities Replacement

Contract Documents
Issued for Tender

Volume 3 of 3
Appendices

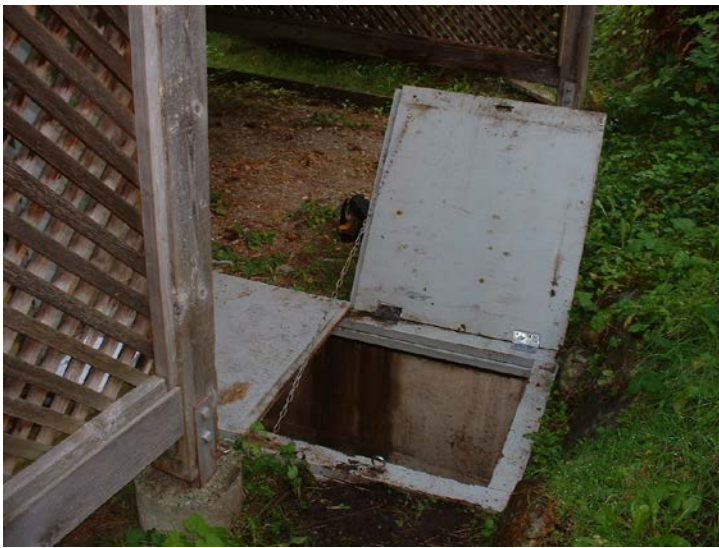
33. Open latch at valve chamber

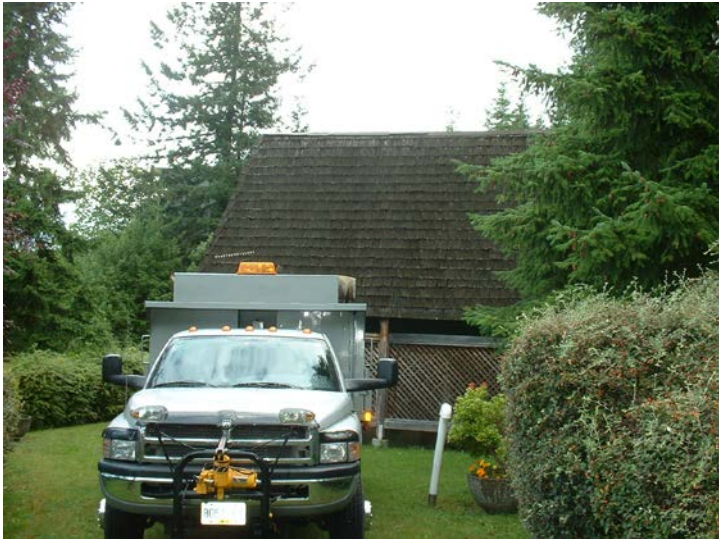
35. General view of roof structure

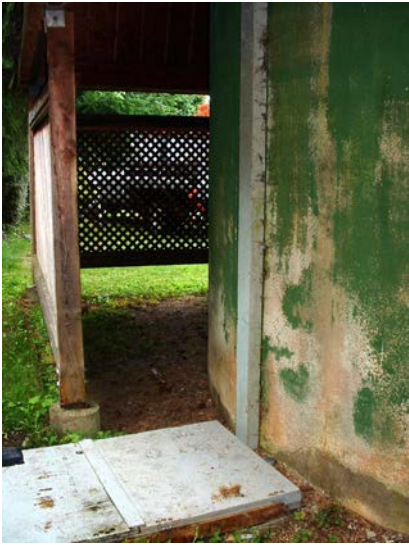
40. Fill station sensing line

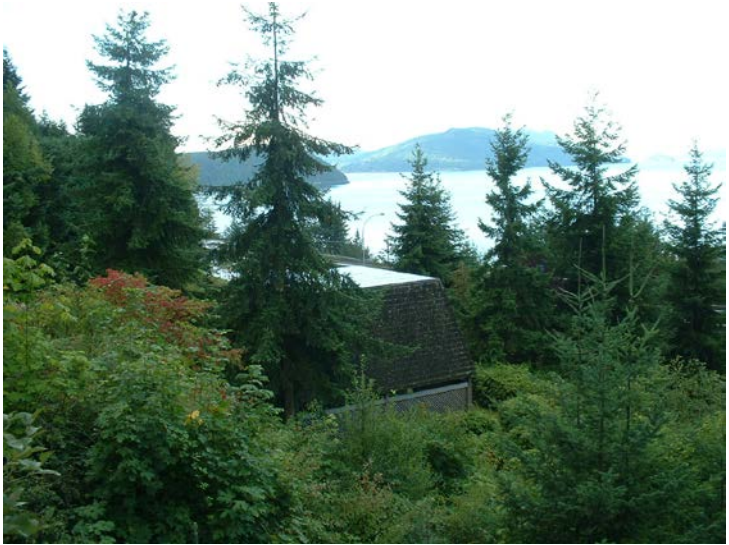
41. General view of roof structure

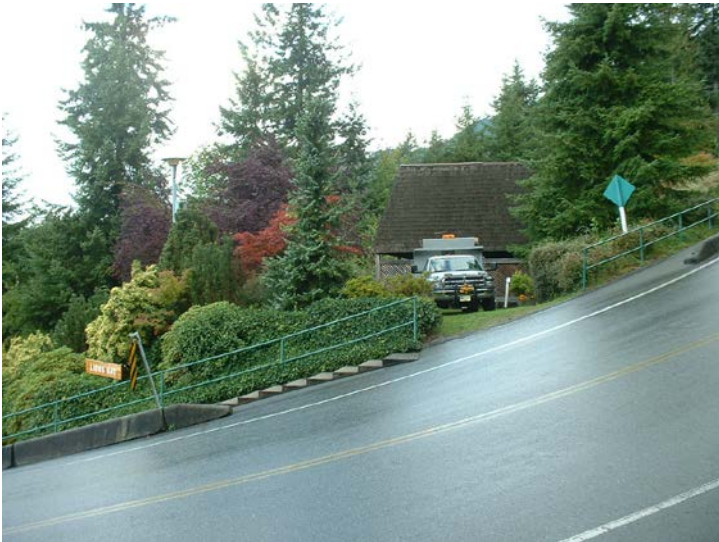
42. General view of roof structure

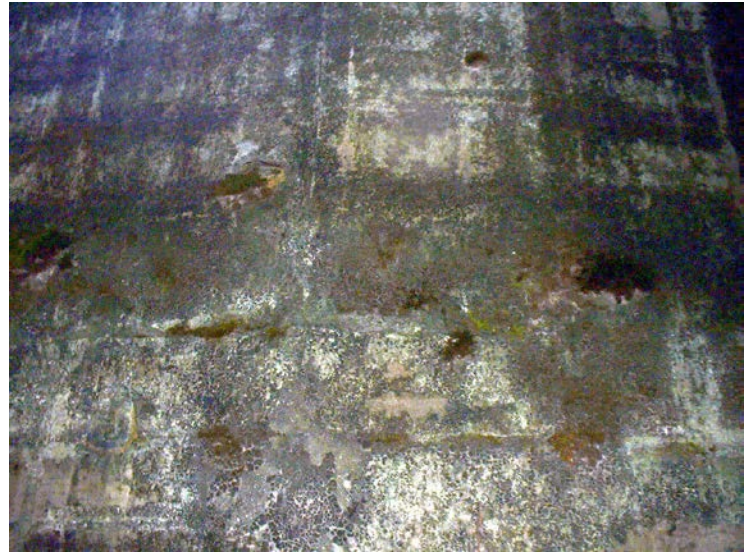
74. Algae growth on wall

Item	Location	Activity description	Qty	Unit	U	Make safe	Comments	Rep Photo	Mon freq
3.2		Altitude valve - rebuild	1	No	R			76	
3.1		Walls - paint	6	m2	2			80	
3.1		Door - adjust	1	No	R			80	
1.12		Hydro poles – replace	2	No	R			71	
1.10		Hatch – replace	1	No	2			78	
1.1		Cracks – seal / repair	4	m	3		Seal from inside with a protective and waterproofing slurry seal with glass fiber reinforcement from the inside of tank if possible (SikaTop Seal 107 or similar approved)	72	
1.1		Honeycombed concrete – repair	0.05	m3	M		Outer surface of wall has shallow honeycombing which is not affecting the tanks integrity	73, 75	2yrs
1.2		Debris / vegetation – remove and power wash	3	m3	R			77, 79	
1.1		Algae / vegetation – remove and power wash	60	m2	R		Power wash the outer face of the tank	74	
1.12		Power wash the inside of the tanks	1	LS	R

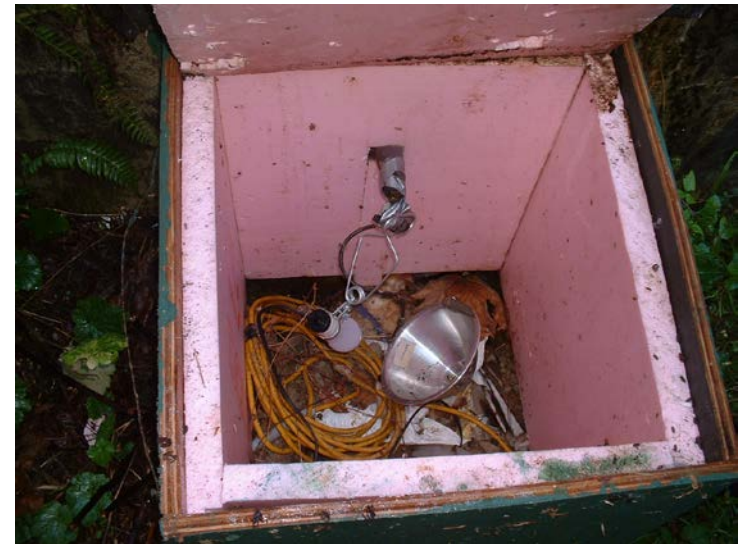
76. Insulated valve sensing line box

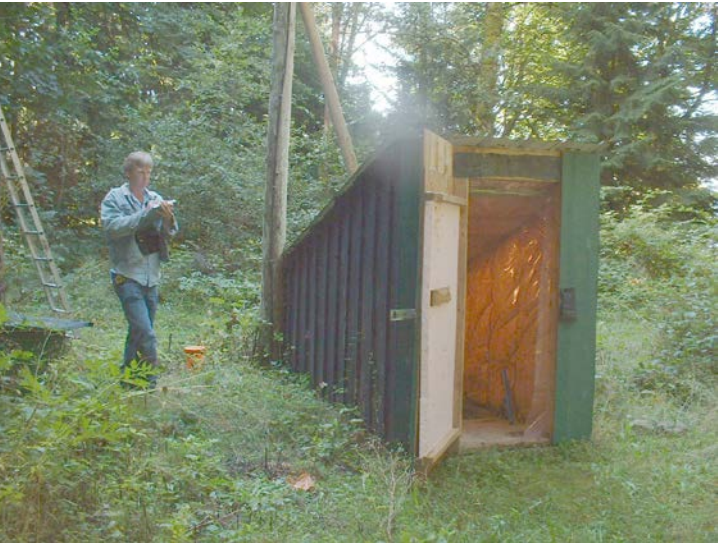
80. General view of valve chamber

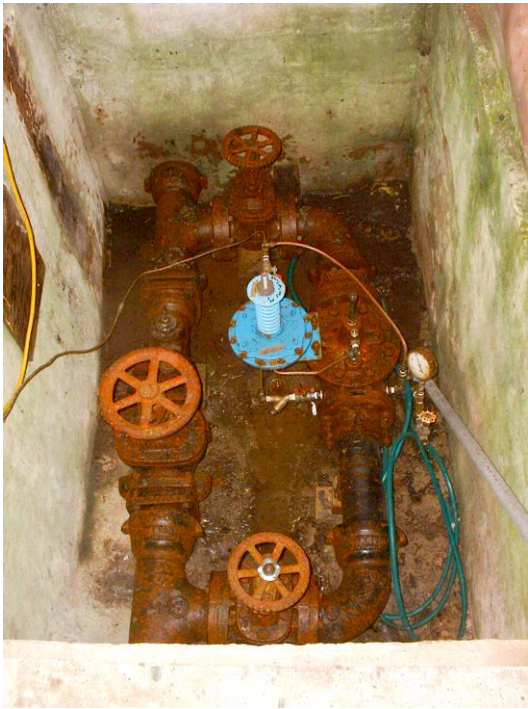
81. View of fill station valves

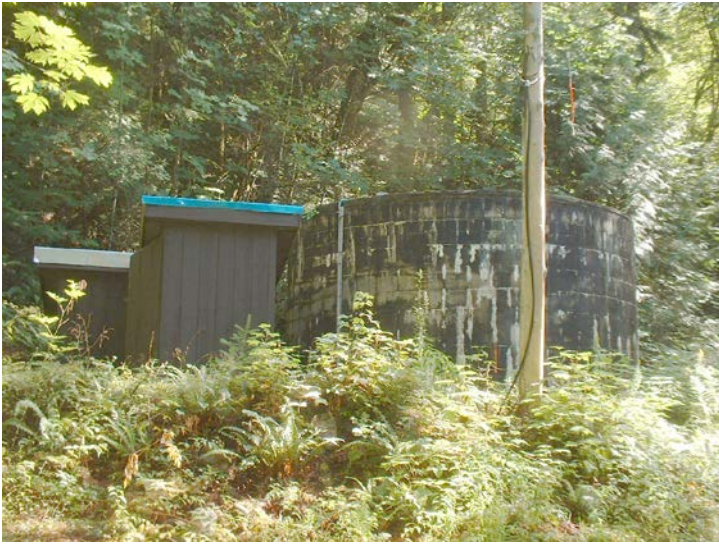
82. General view of tank

3.5	IS	Wire brush & Power tool - paint	2	m2	2		Corroded overflow pipe	170,172	
1.1		Power wash / clean	75	m2	R		General cleaning up of walls required	82, 83, 92

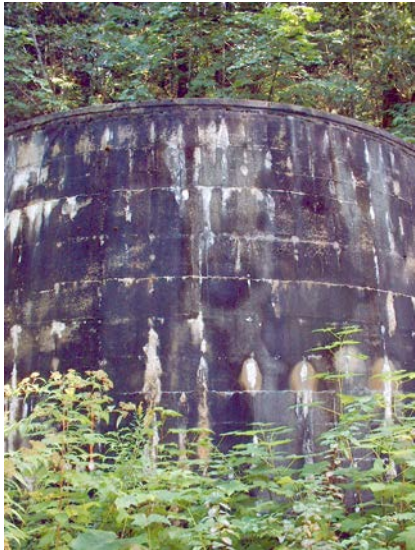
83. Vertical and transverse cracks

1.1		Algae / vegetation – remove and power wash	20	m2	R		Algae on outside of tank wall	84, 85	
1.1		Protective and water proofing slurry seal – apply to walls on inside of tank	75	m2	4		Many cracks are observed on the outer face of the tank wall. It is best to seal from the inside (SikaTop Seal 107 or similar approved)	83, 92

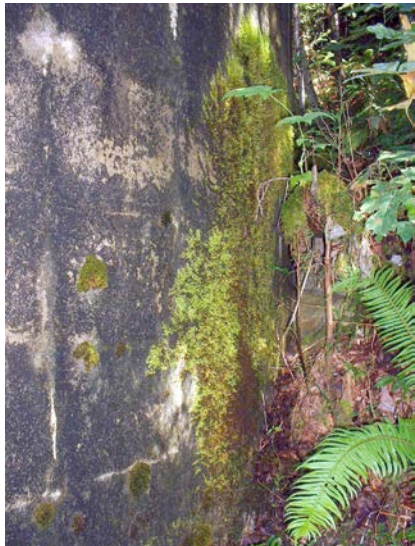
85. Algae growth on tank wall

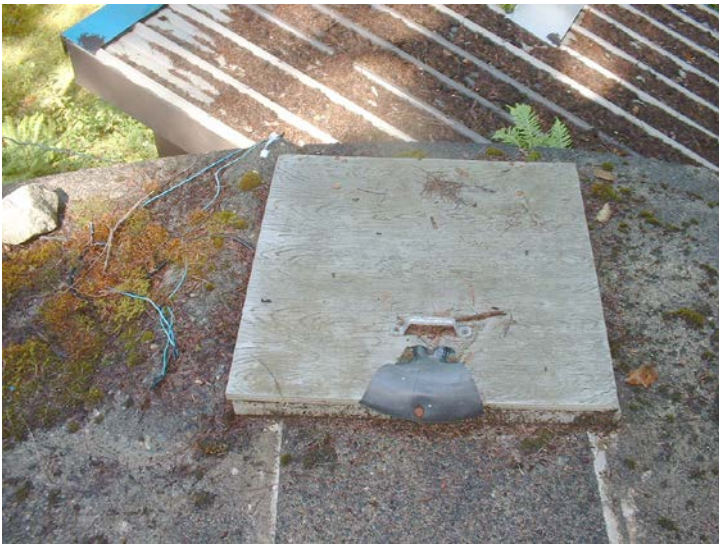
88. View of hatch on roof

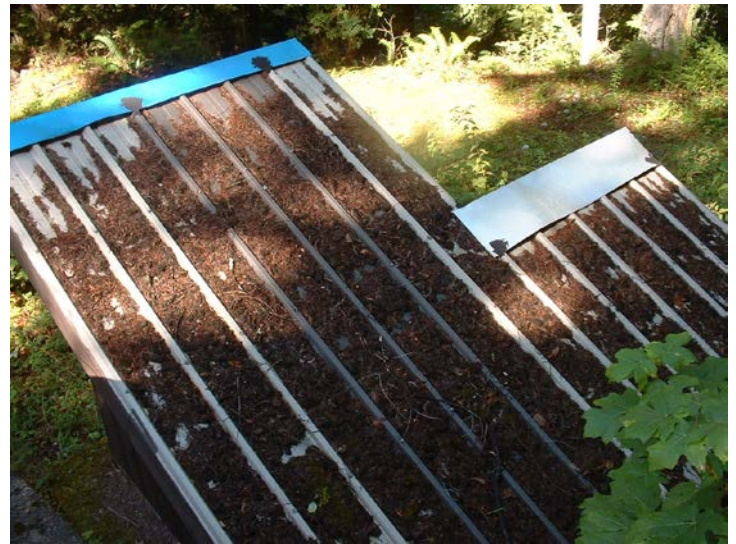
89. Debris on valve chamber roof

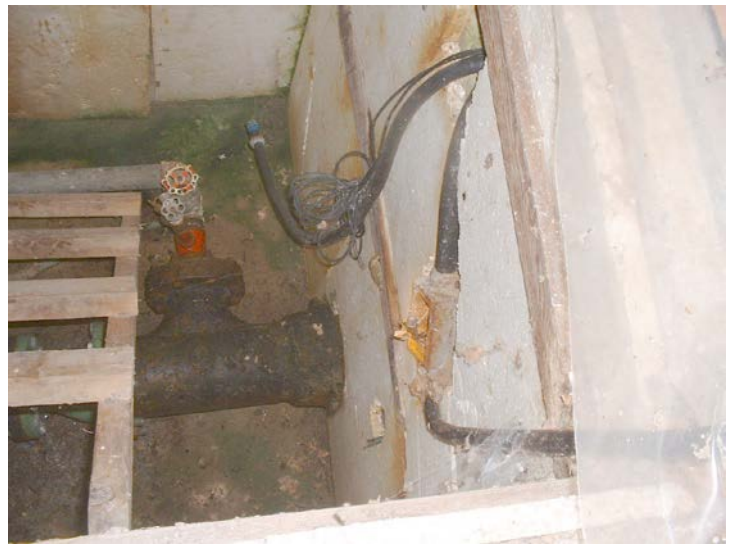
91. View of electrical box inside valve chamber

3.2		Wire brush & Power tool - paint	1	m2	R		Local touching up required to valves	90, 91	
3.3		Wire brush & Power tool - paint	1	m2	R		Corroded Inlet pipe in valve chamber	90, 91
