The Village of Lions Bay: A Natural Hazards Assessment Area Strategy for Coastal, Creek and Hillslope Hazards.

Submitted by
Cordilleran Geoscience
PO Box 612,
Squamish, BC
V8B 0A5

V1: November 30, 2017; V2 December 19, 2017; V3 January 4, 2018; Final V4 January 18, 2018; Final V5 June 25, 2018

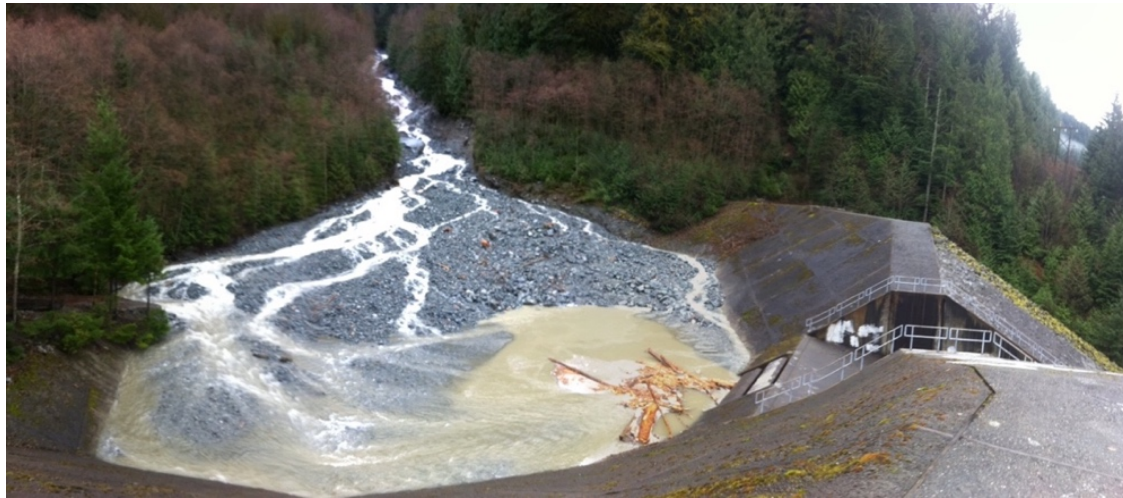
Figure 3. Charles Creek retention structure with debris flow infill. Downloaded from internet (<https://www.flickr.com/photos/tranbc/8510095573>).

A few local examples were examined to assess debris flow frequency-magnitude from similarly sized basins. Charles Creek, with a 1.8 km² watershed area, is the most active of the Highway 99 mitigated creek channels (Figure 3). Morgan et al. (1992) presented a reanalysis of Charles Creek data (n=10 events) using probabilistic methods and judgment. They estimated the 500-year event to have a volume on the order of 50,000 m³, somewhat exceeding the former design event of 29,000 m³. Jakob (2012) again reanalysed Charles Creek (n= 19 events) by fitting and evaluating multiple probability distributions, and concluded the 1000-year return event might have a volume on the order of 50,000-60,000 m³, but with the uncertainty ranging from 20,000 to 300,000 m³. The caveat was provided that this includes only debris flows from mobilised talus, and not large point source events. Jakob (2012) also reported on Jones Creek, with a 6.8 km² watershed area, located in the Cascade Mountains, Washington State. Based on analysis of data derived from test pitting and radiocarbon dated stratigraphy, Jakob estimated volumes for the 500-year and 2500-year events of 100,000 m³ and 200,000 m³, respectively. This review suggests that small steep watersheds with areas of 1-7 km² could have 500-year to 2500-year return period volumes that exceed the design volumes of 15,500 m³ to 62,500 m³ for Harvey, Alberta and Magnesia creeks.

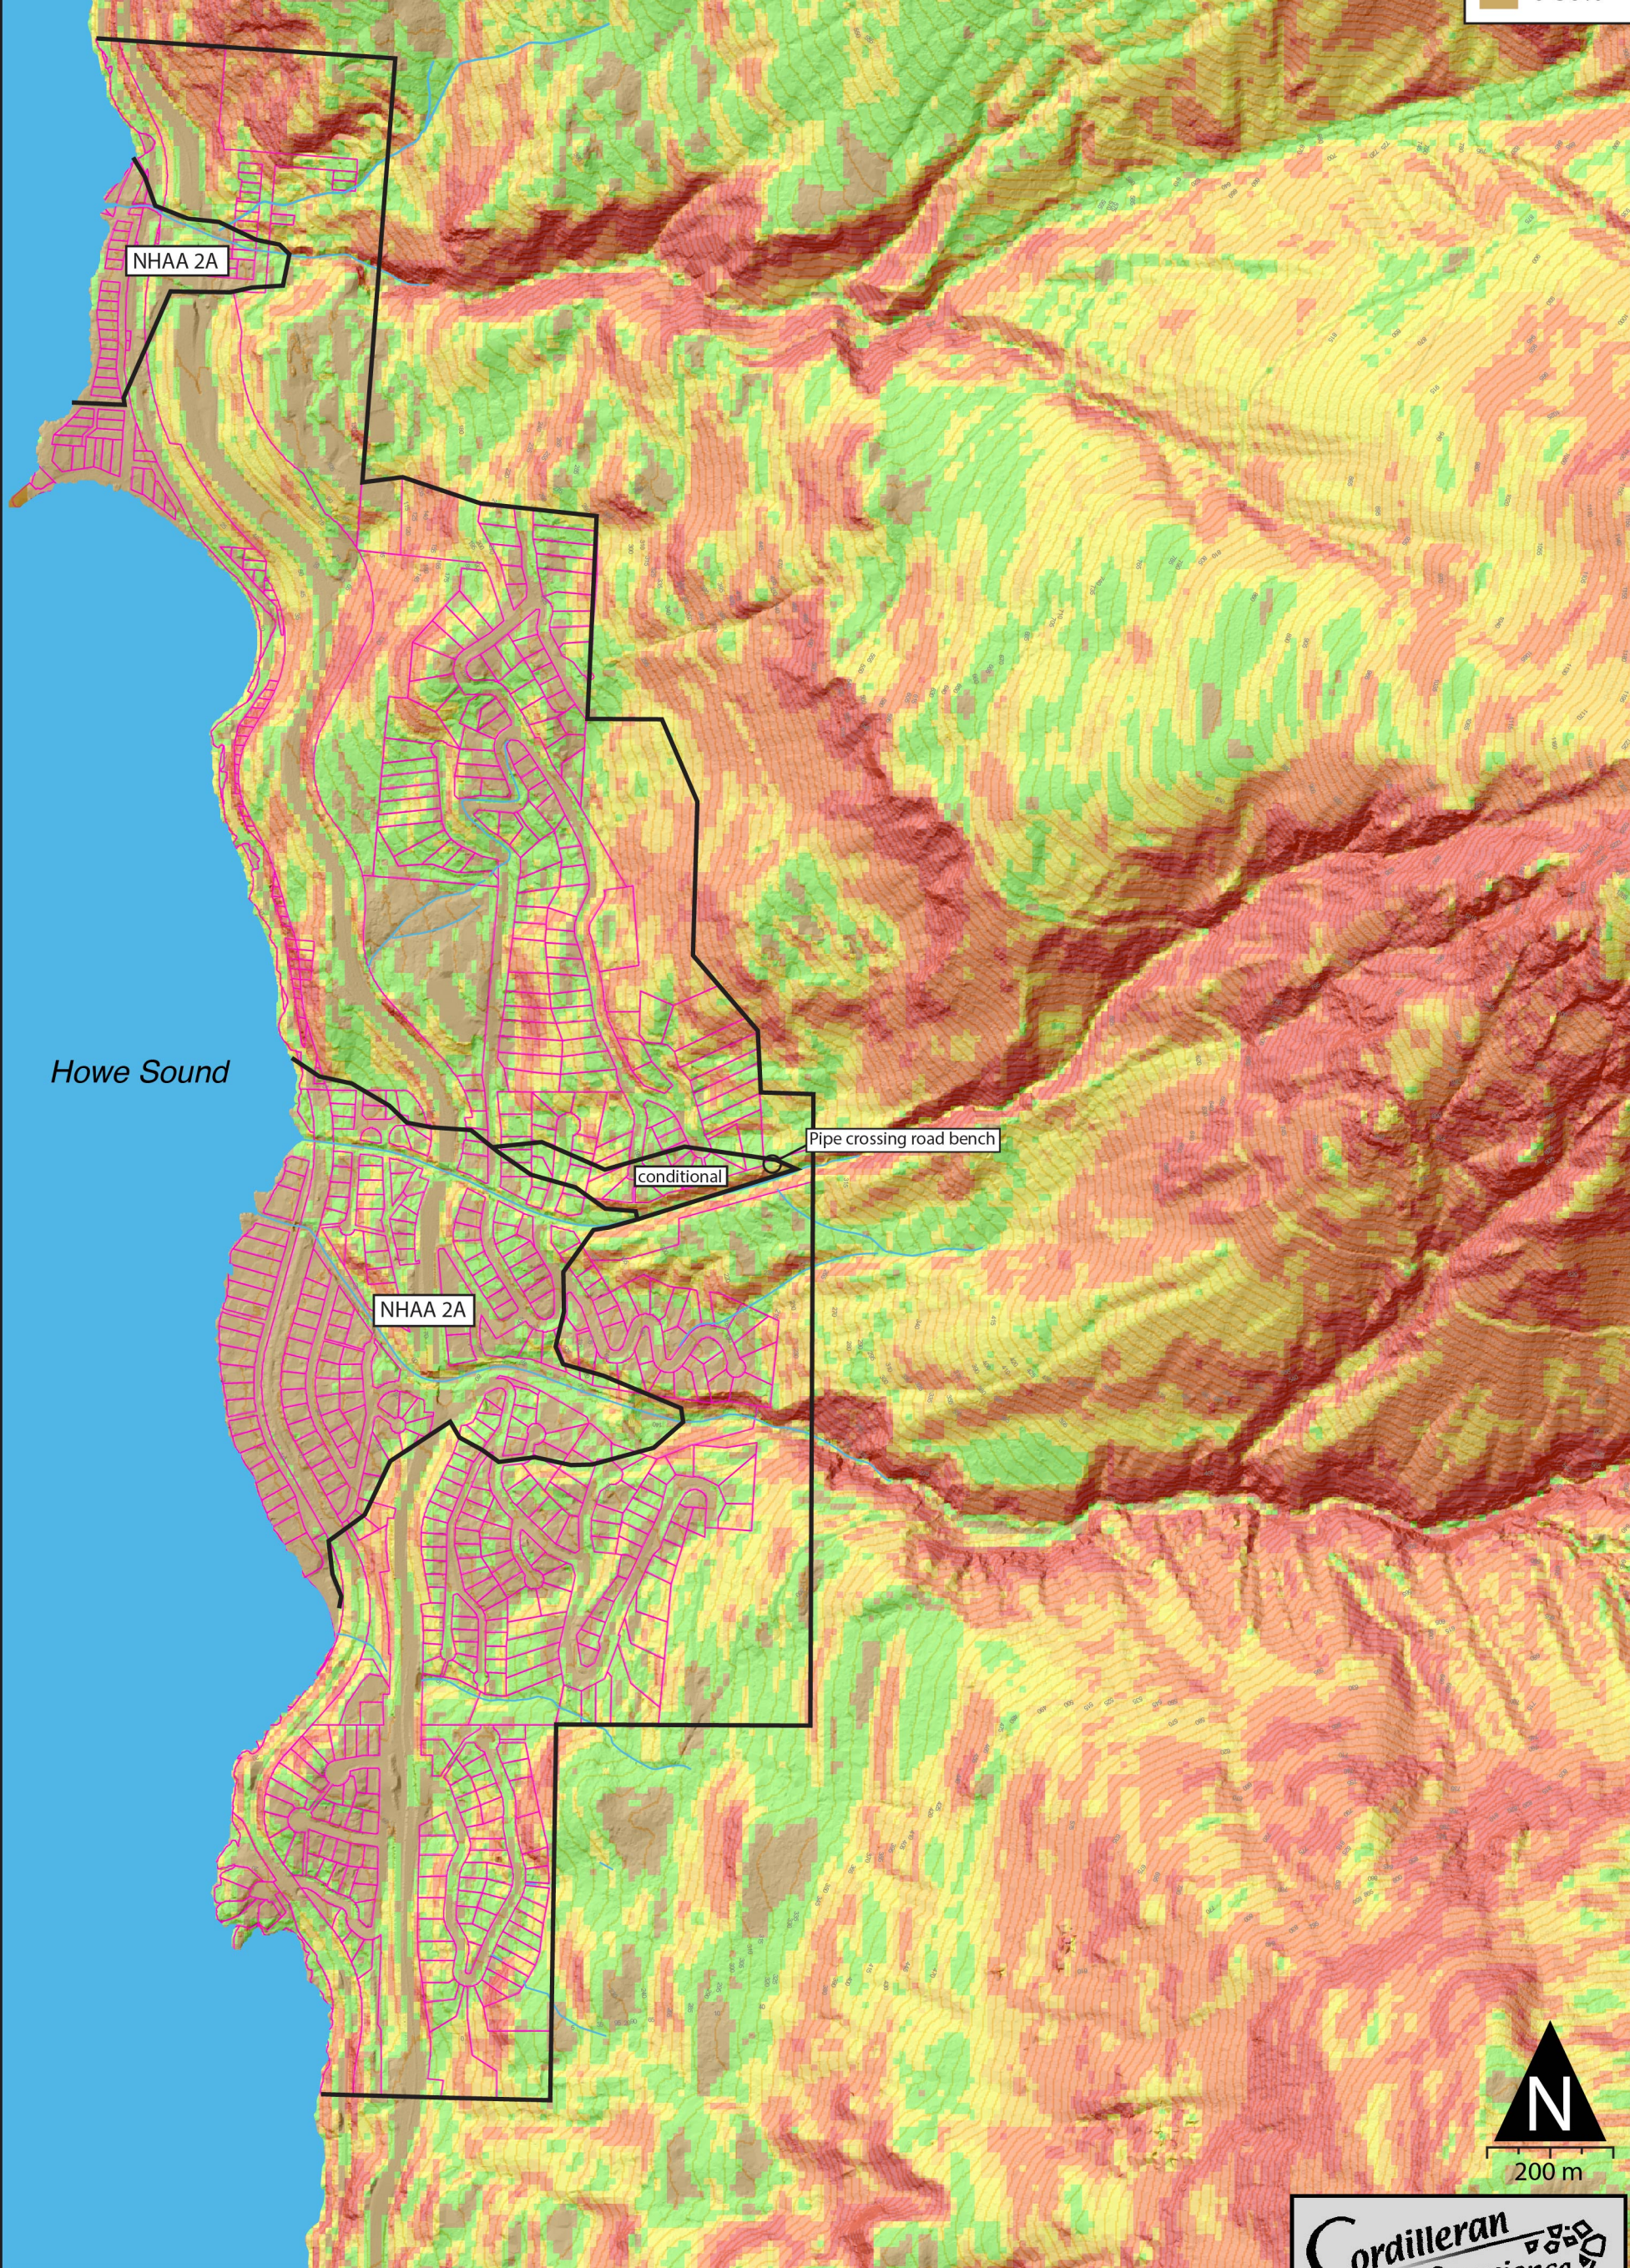
Map 4. Lions Bay NHAA 2A Debris fans of mitigated channels

NHAA 2A, includes debris fans formed by Magnesia, Alberta and Harvey Creeks. The area potentially affected reflects the fact that existing mitigation on these channels was not designed to a known return period standard, and engineered structures could be overwhelmed by rare events. Measures are required to mitigate residual risk. Conditional area may be removed once pipe crossing grade on left bank is assessed and mitigated.

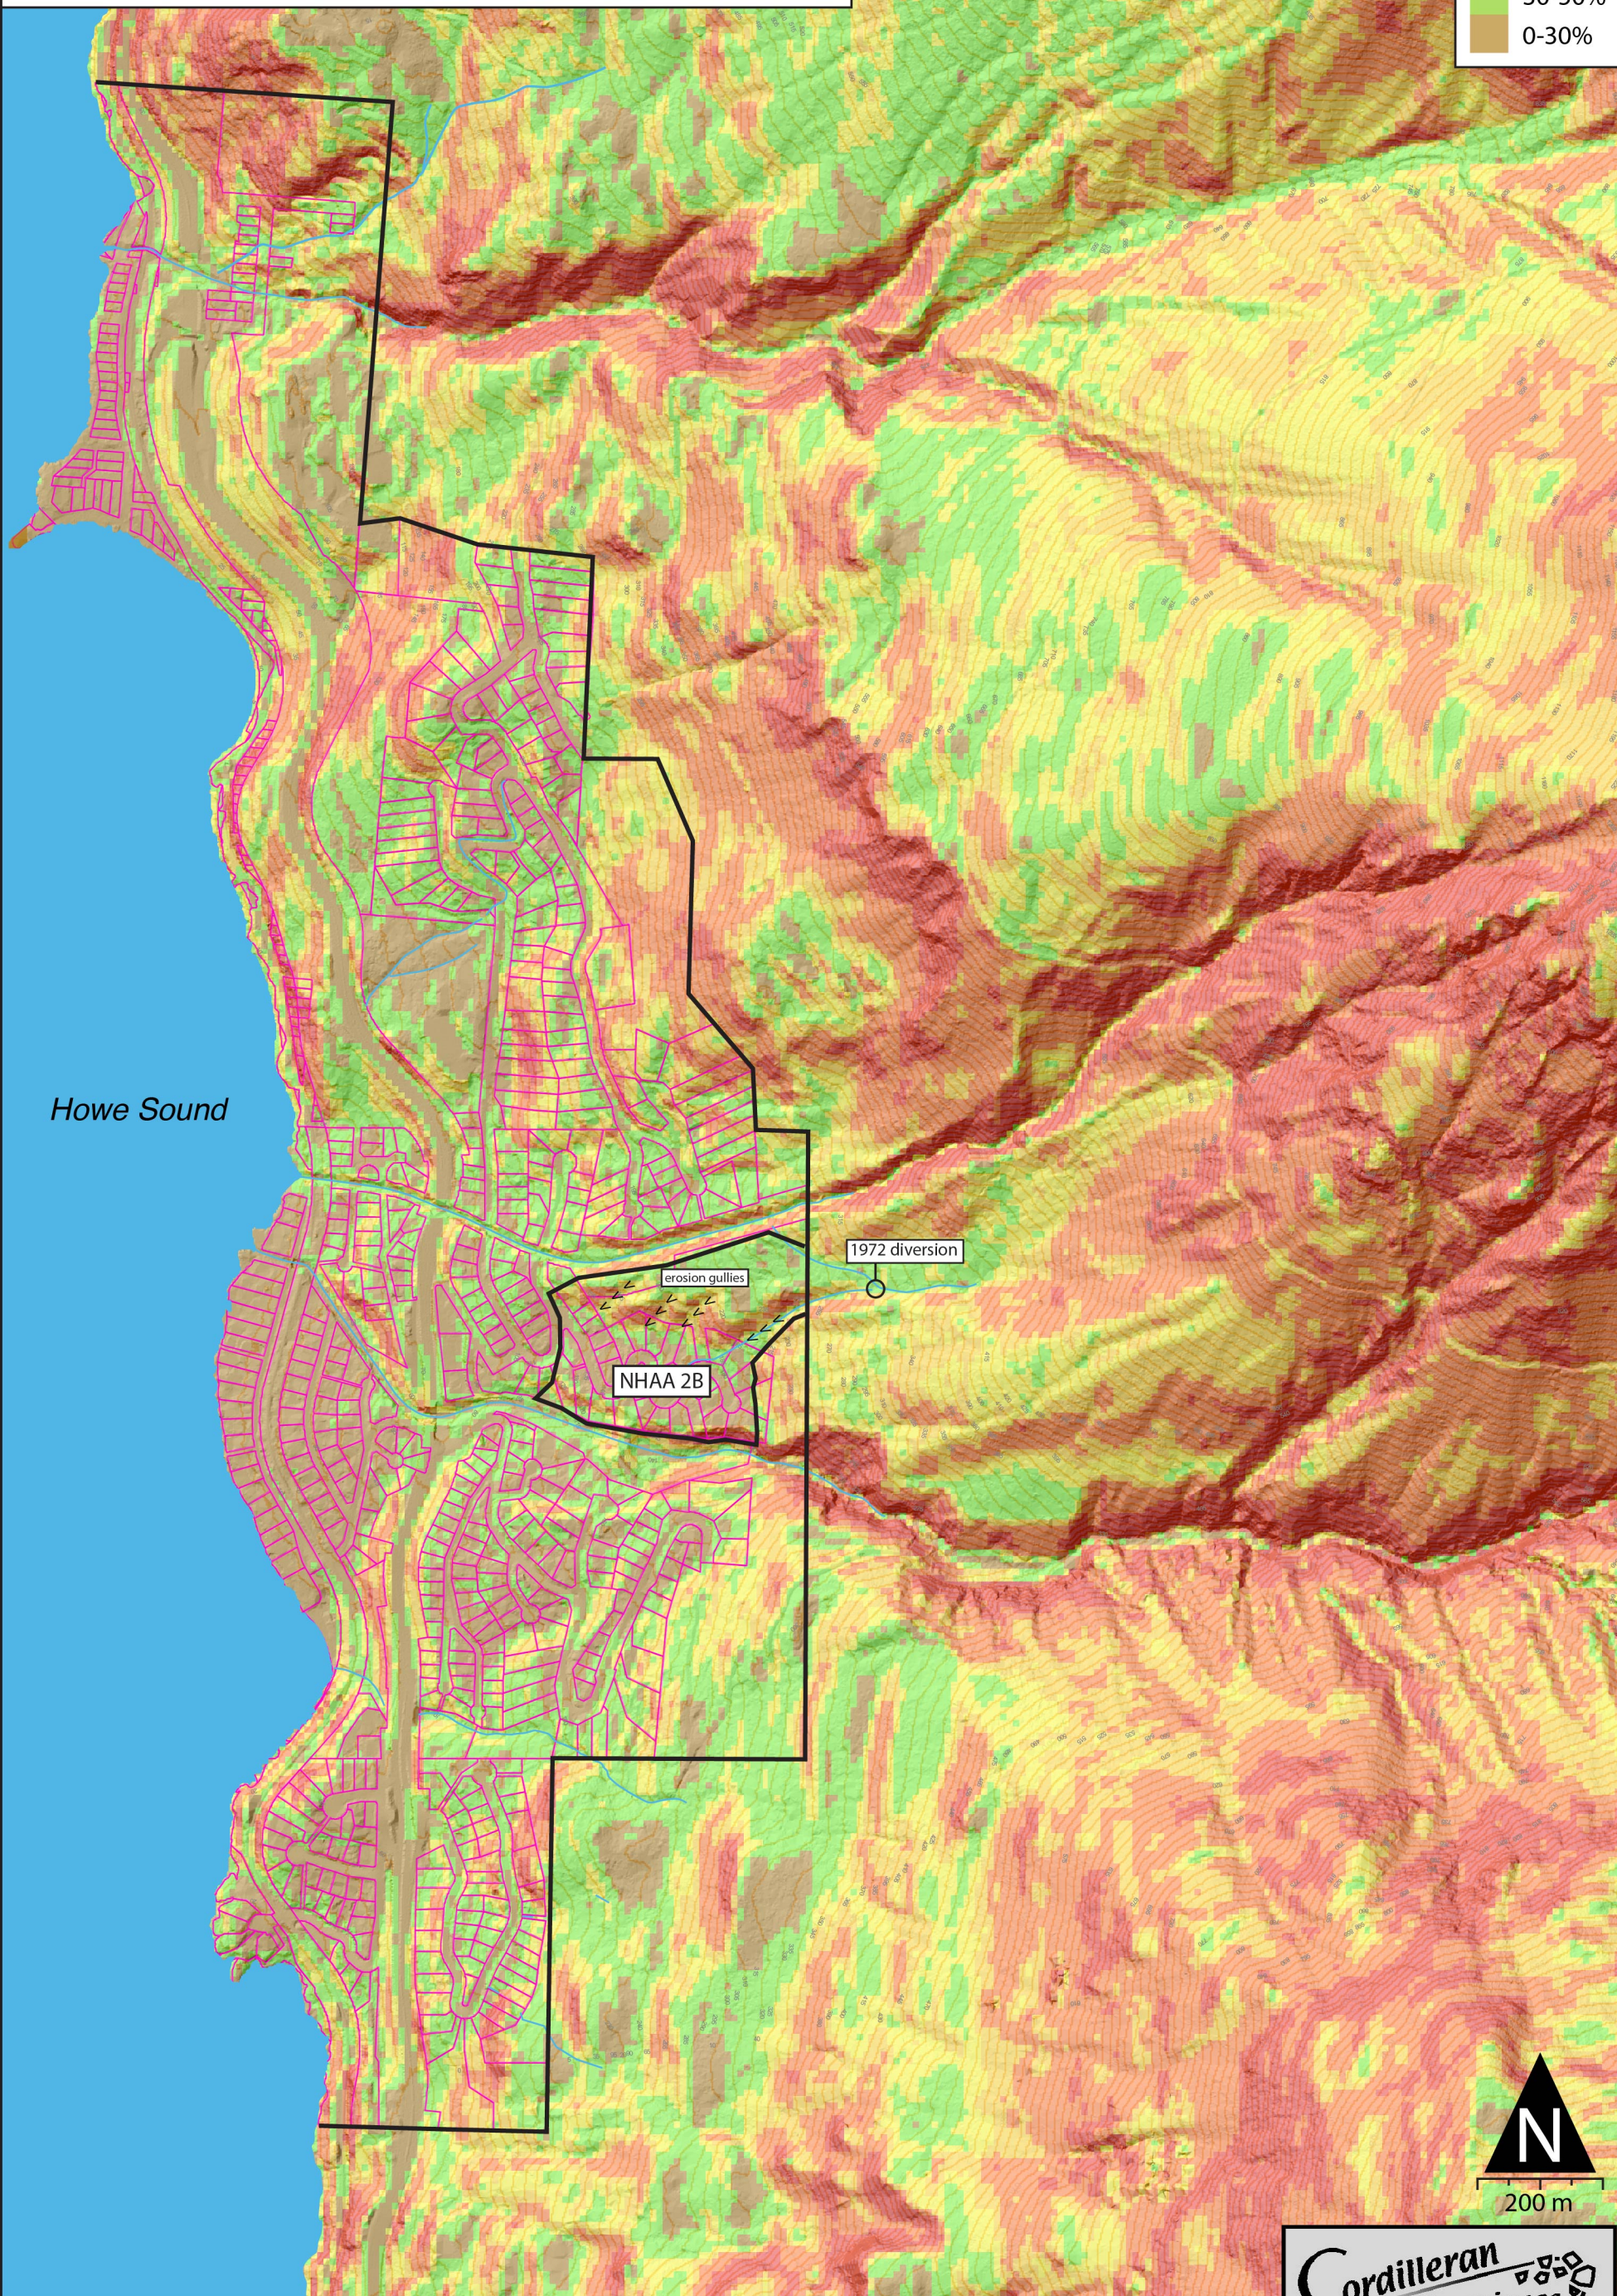
Map 5. Lions Bay NHAA 2B Upper Bayview fan

NHAA 2B, includes the debris fan built by Upper Bayview Creek. Hazards affecting include debris flows and debris floods and floods caused by misaligned drainage. BGC (2013) recommended structural mitigation of hazards affecting the Upper Bayview Creek fan: to date no mitigation has occurred. Measures are required to reduce residual risk.

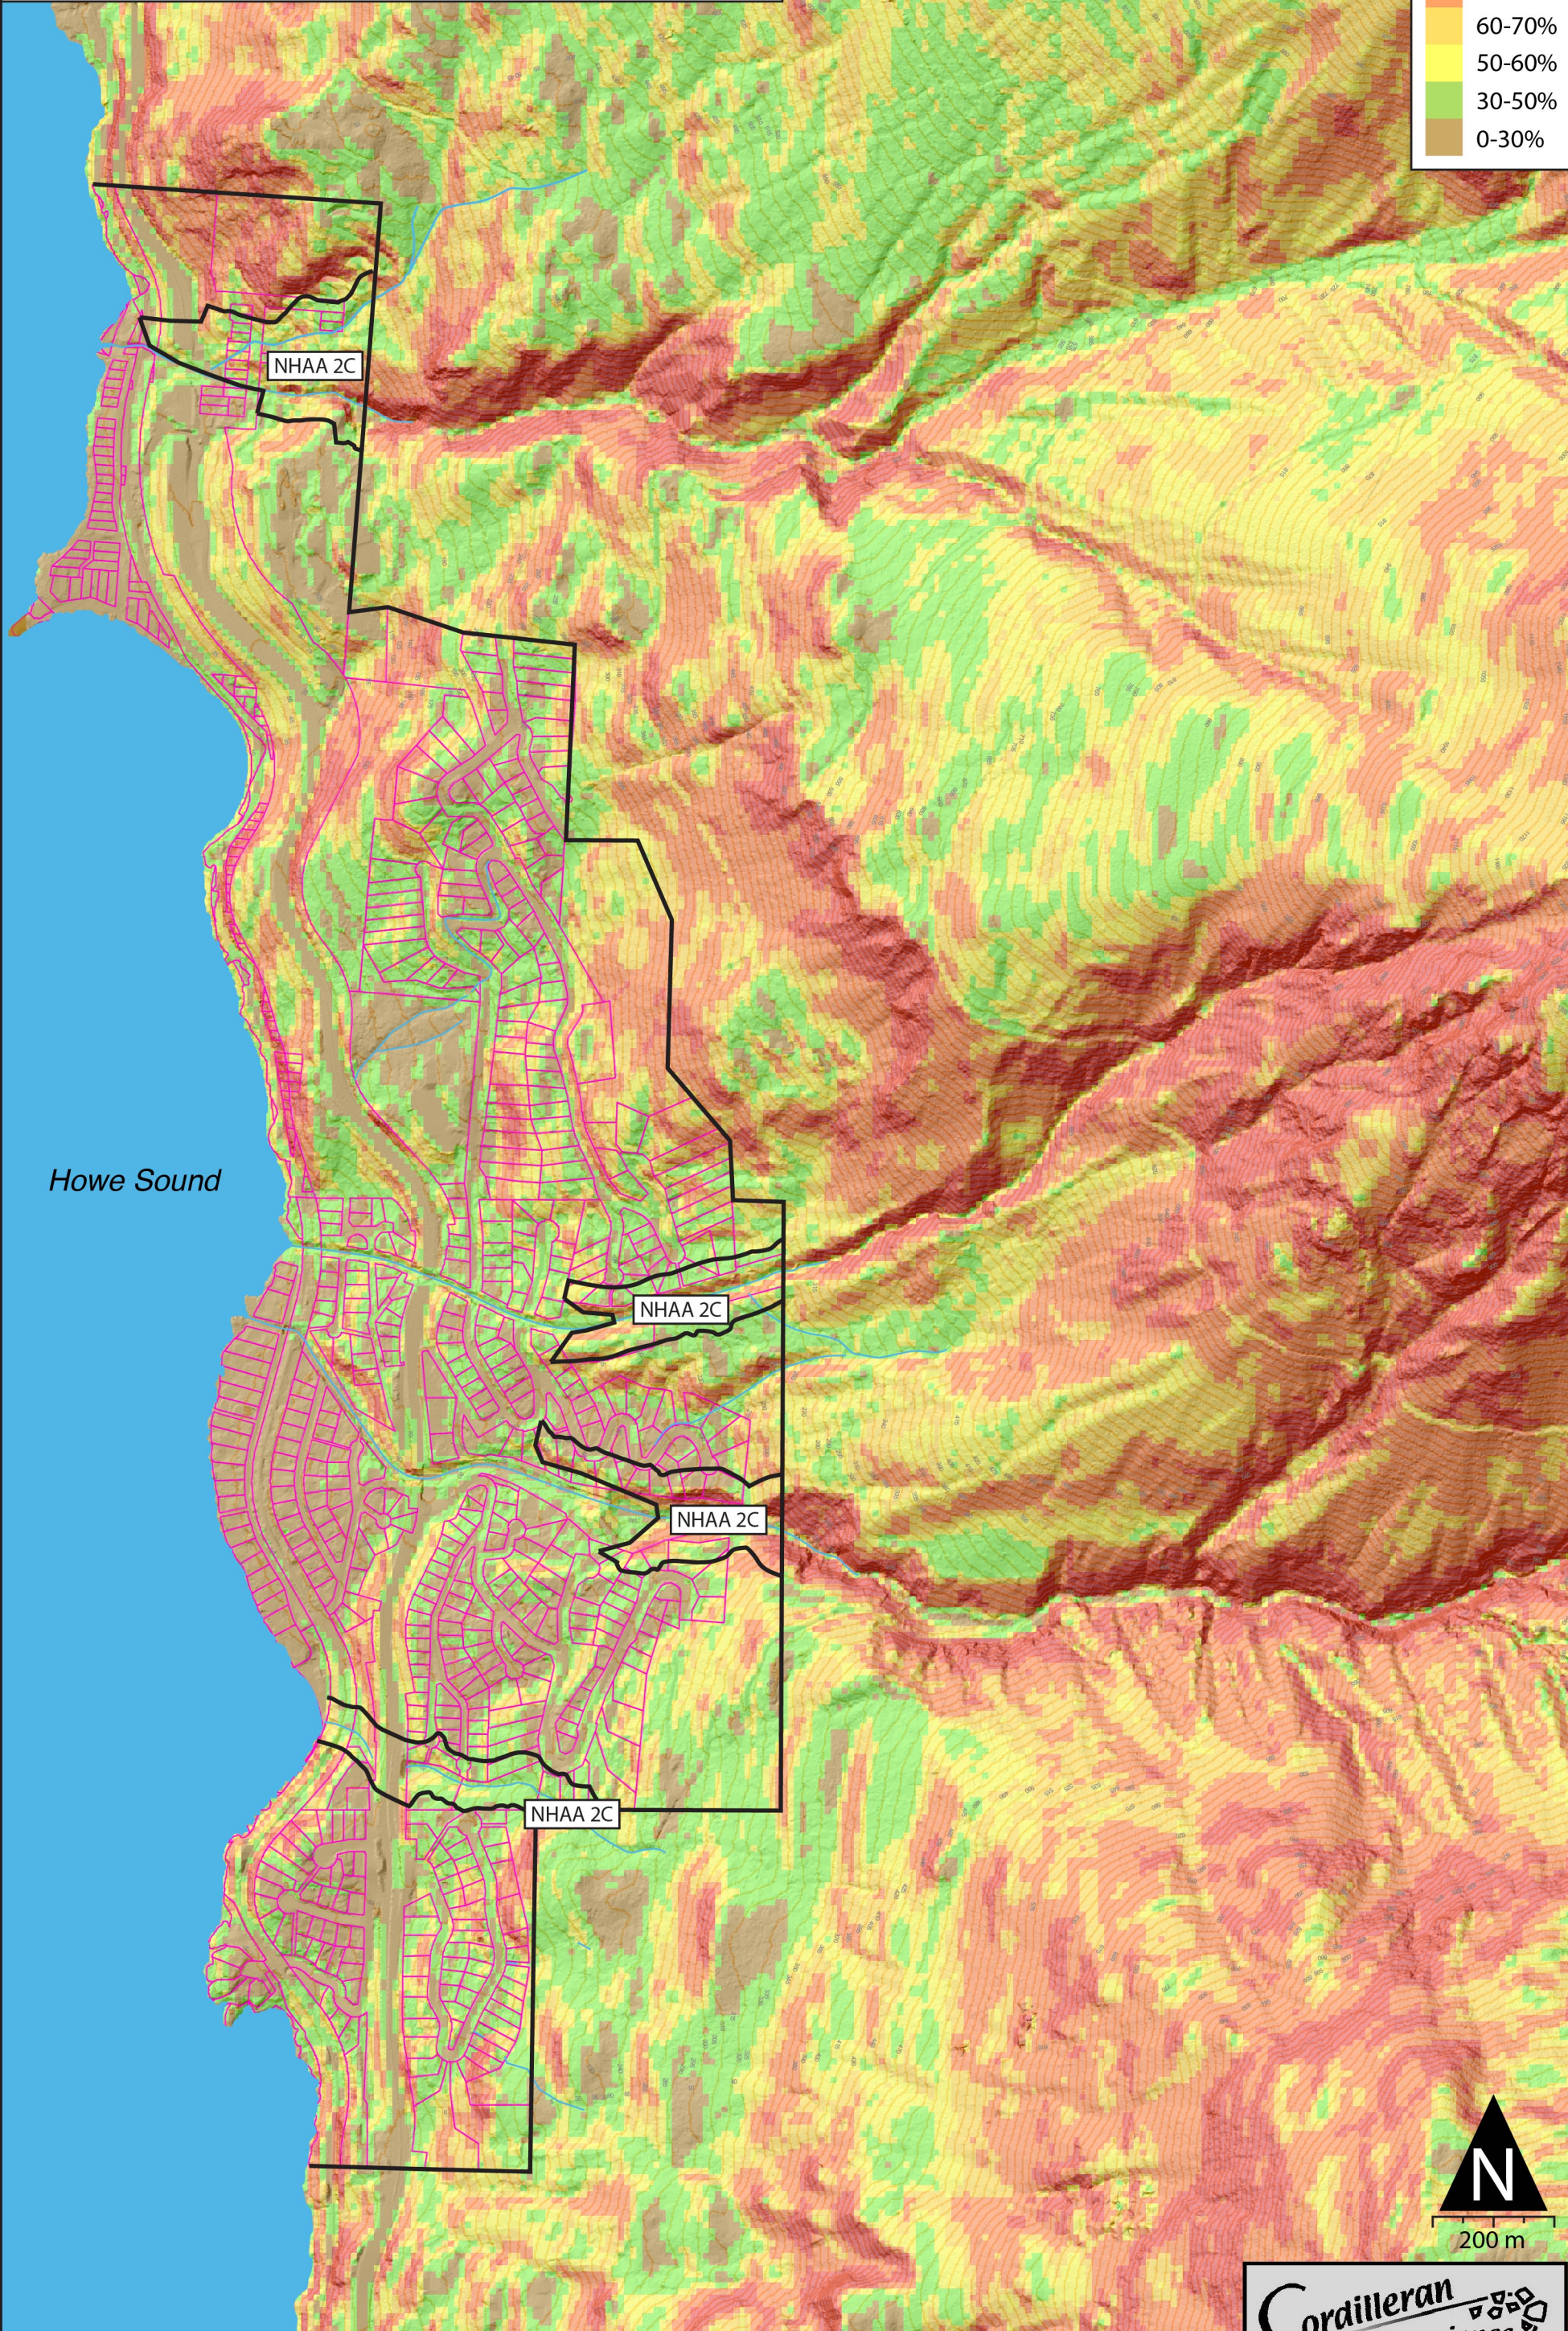
Map 6. Lions Bay NHAA 2C Ravines

NHAA 2C includes ravines and terrain within 30 m of the ravine crest. Ravine setbacks can be reduced on a site-specific basis following the advice of a Qualified Professional.

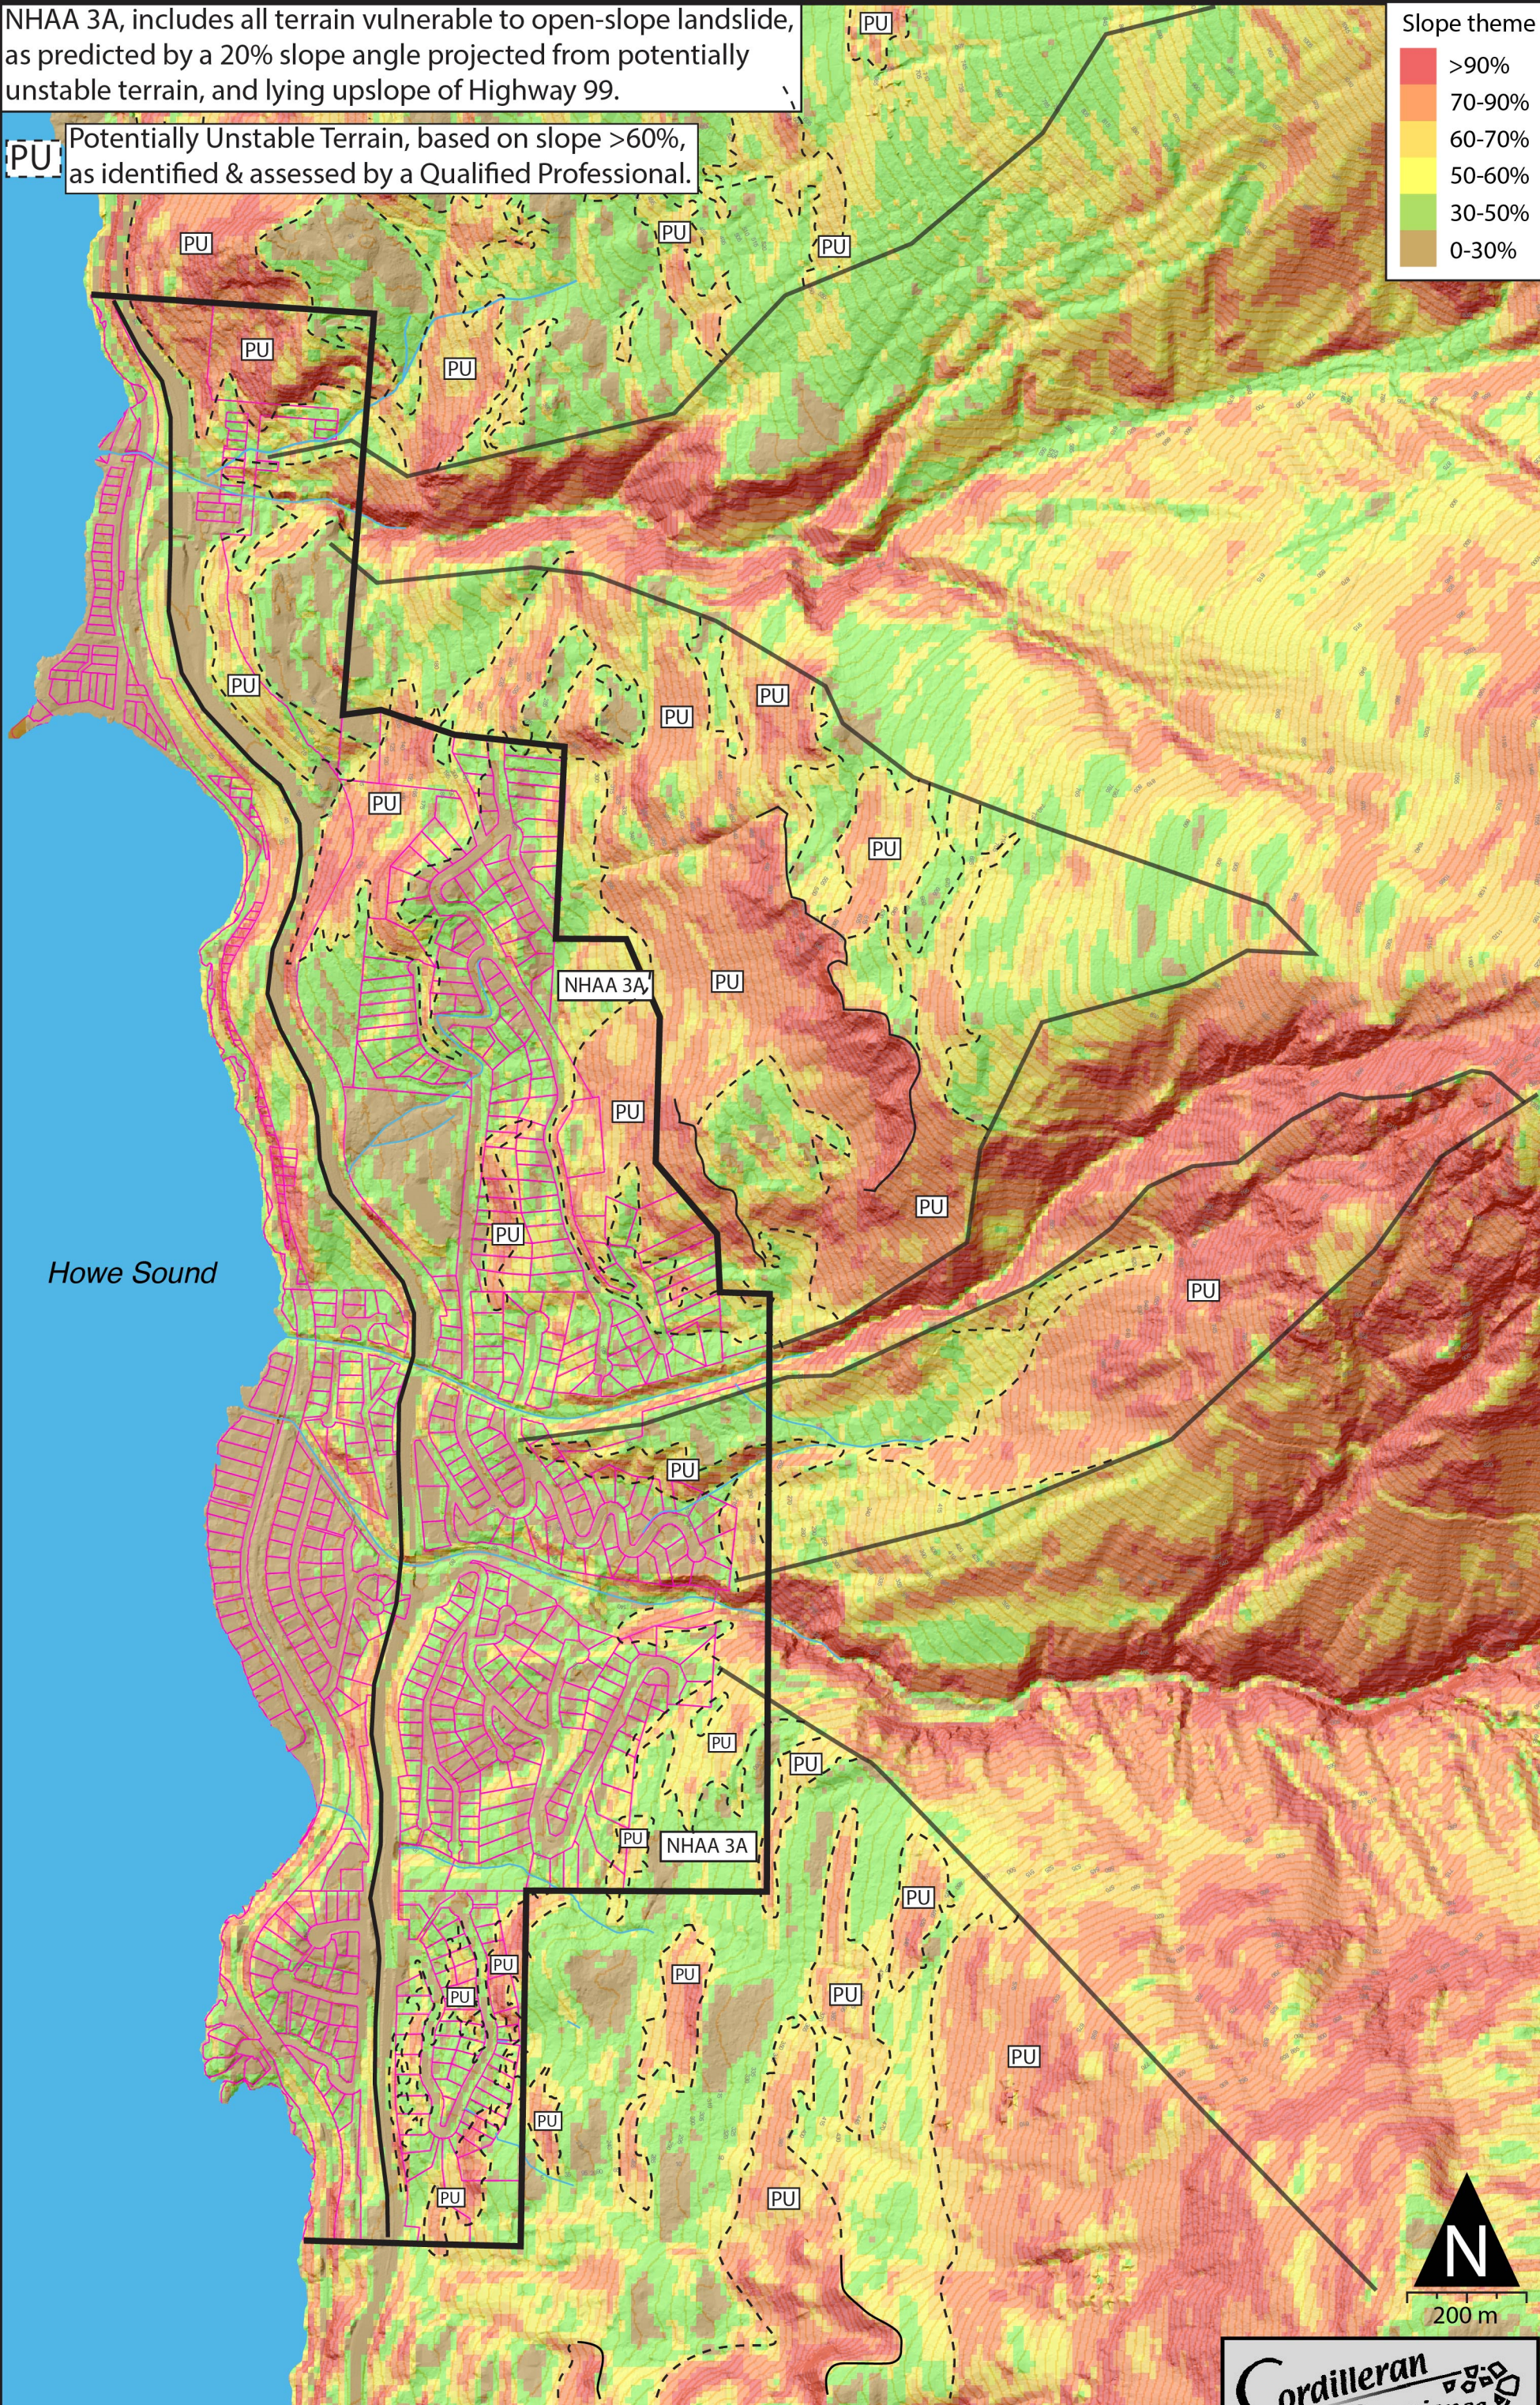
Map 7. Lions Bay NHAA 3A Areas affected by potential open-slope landslides

NHAA 3A, includes all terrain vulnerable to open-slope landslide, as predicted by a 20% slope angle projected from potentially unstable terrain, and lying upslope of Highway 99.

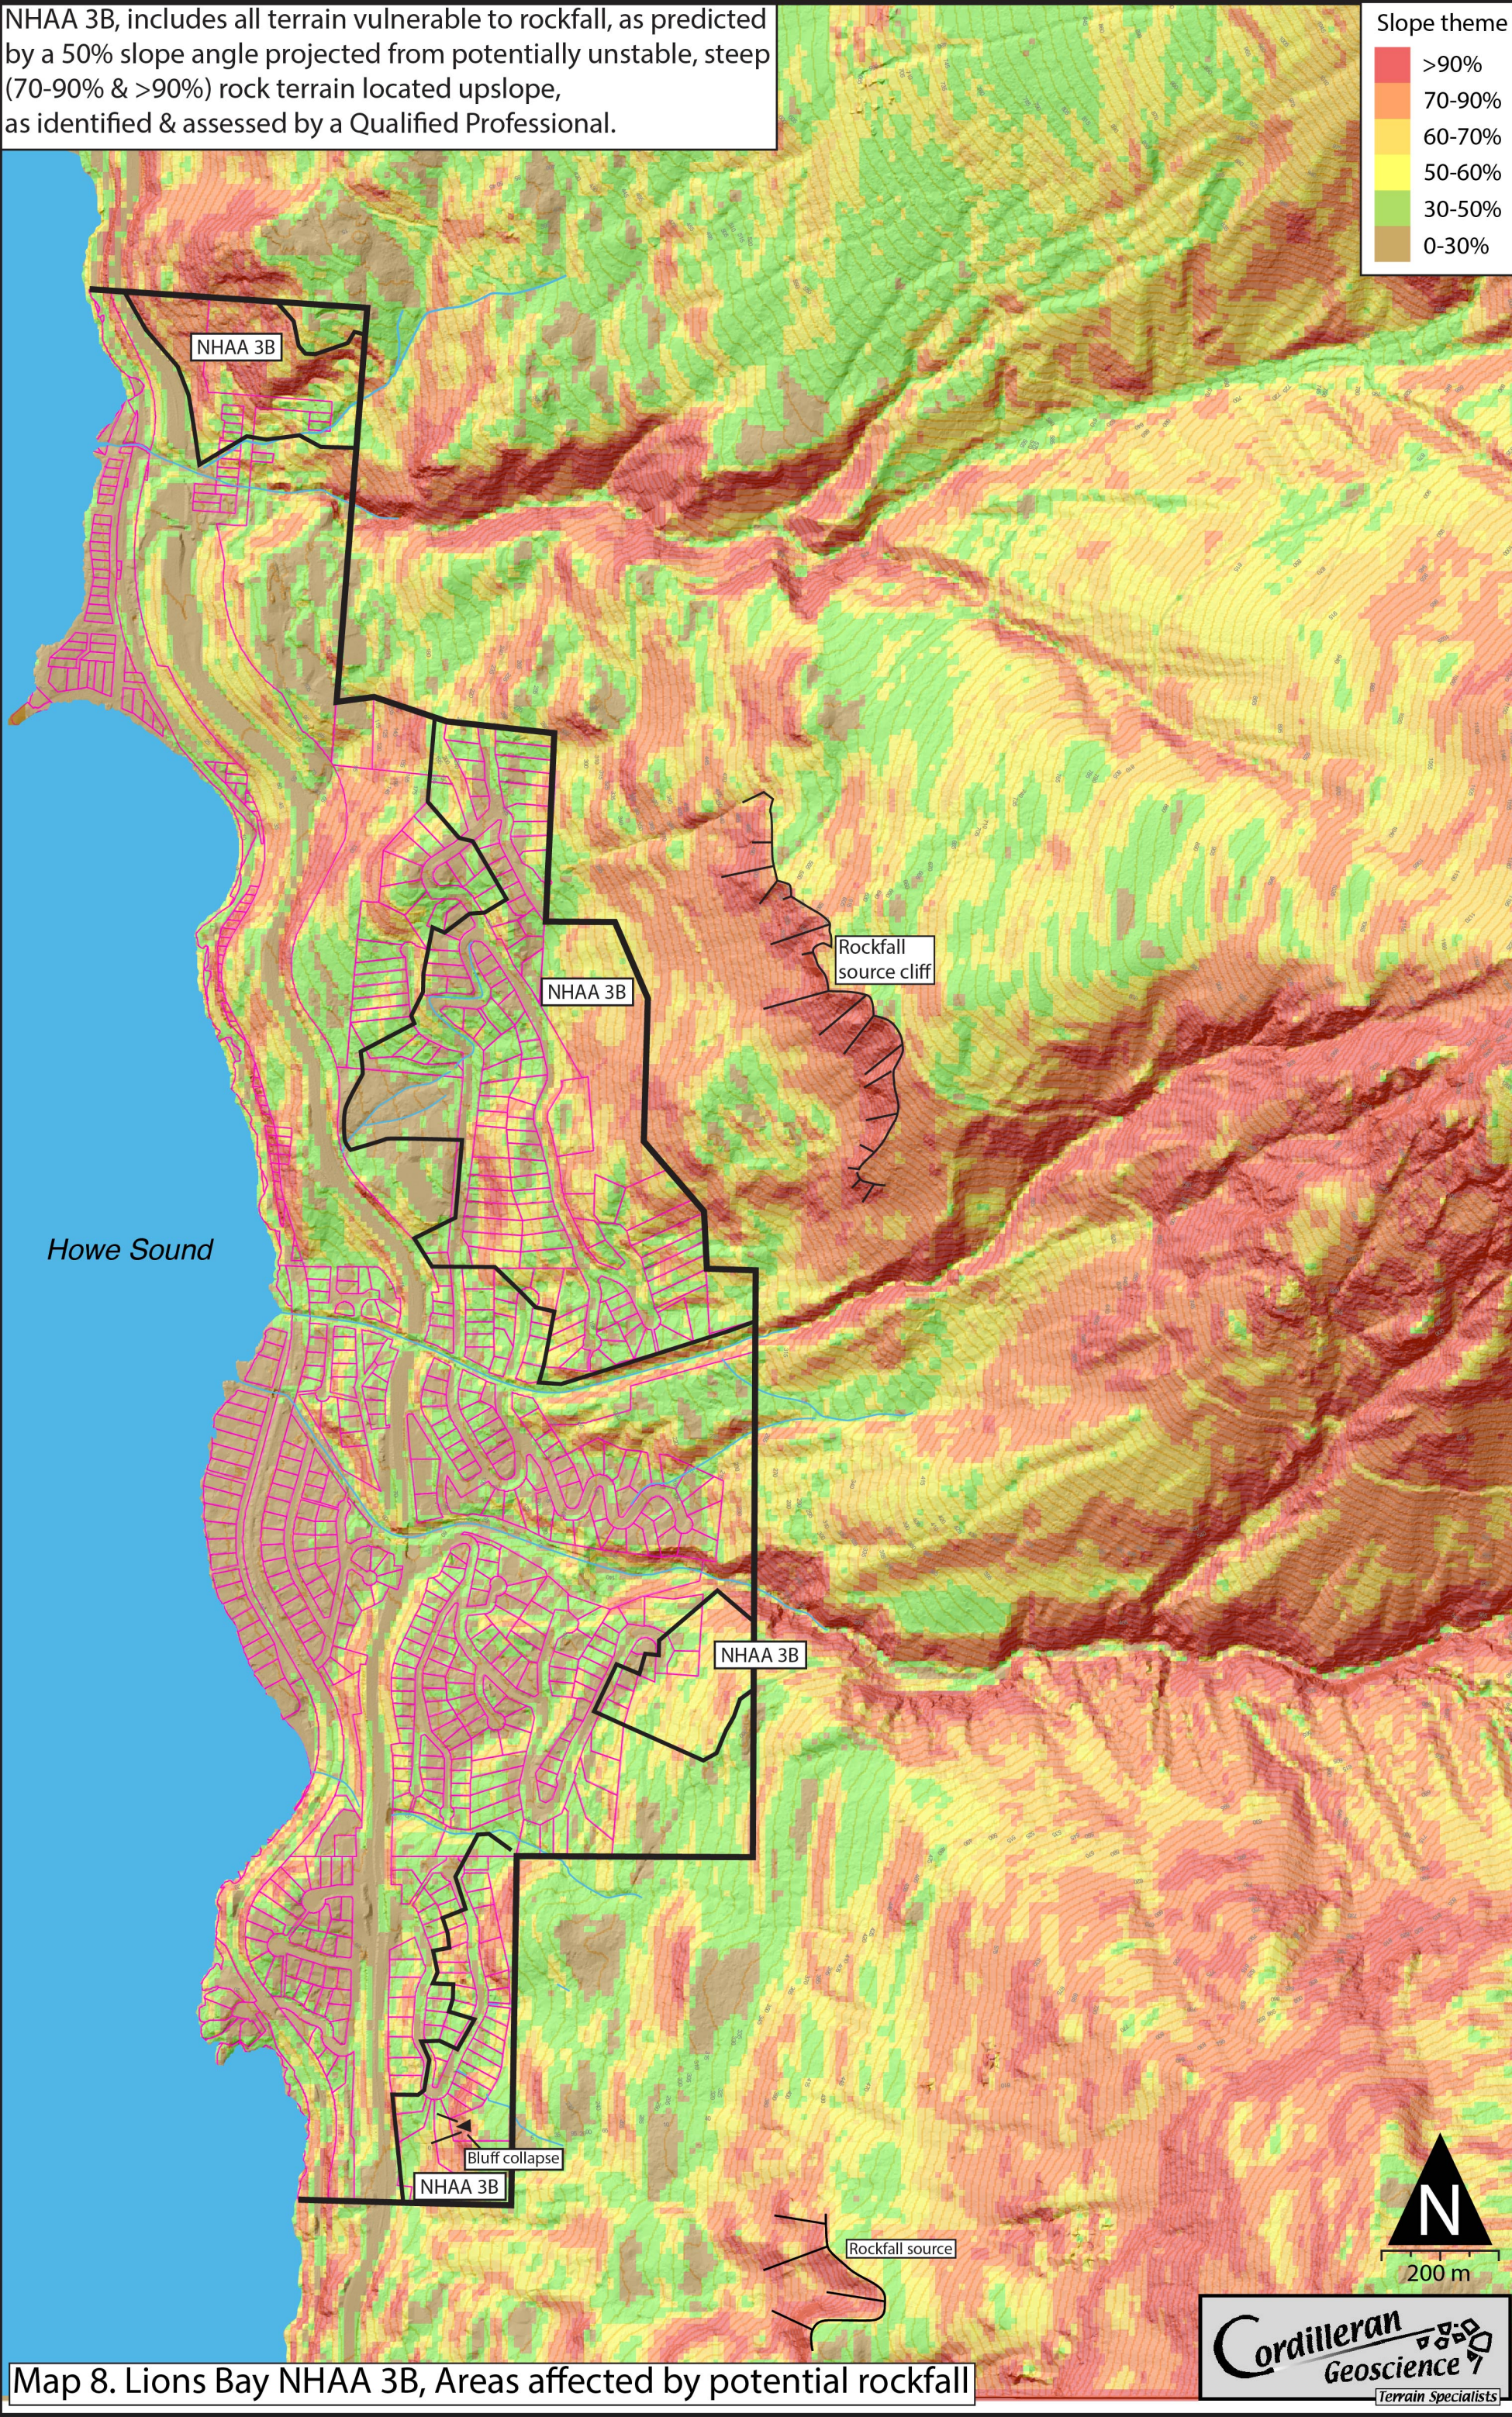
Map 8. Lions Bay NHAA 3B, Areas affected by potential rockfall

NHAA 3B, includes all terrain vulnerable to rockfall, as predicted by a 50% slope angle projected from potentially unstable, steep (70-90% & >90%) rock terrain located upslope, as identified & assessed by a Qualified Professional.
