The Village of Lions Bay: A Natural Hazards Assessment Area Strategy for Coastal, Creek and Hillslope Hazards.

Submitted by
Cordilleran Geoscience
PO Box 612,
Squamish, BC
V8B 0A5

V1: November 30, 2017; V2 December 19, 2017; V3 January 4, 2018; Final V4 January 18, 2018; Final V5 June 25, 2018

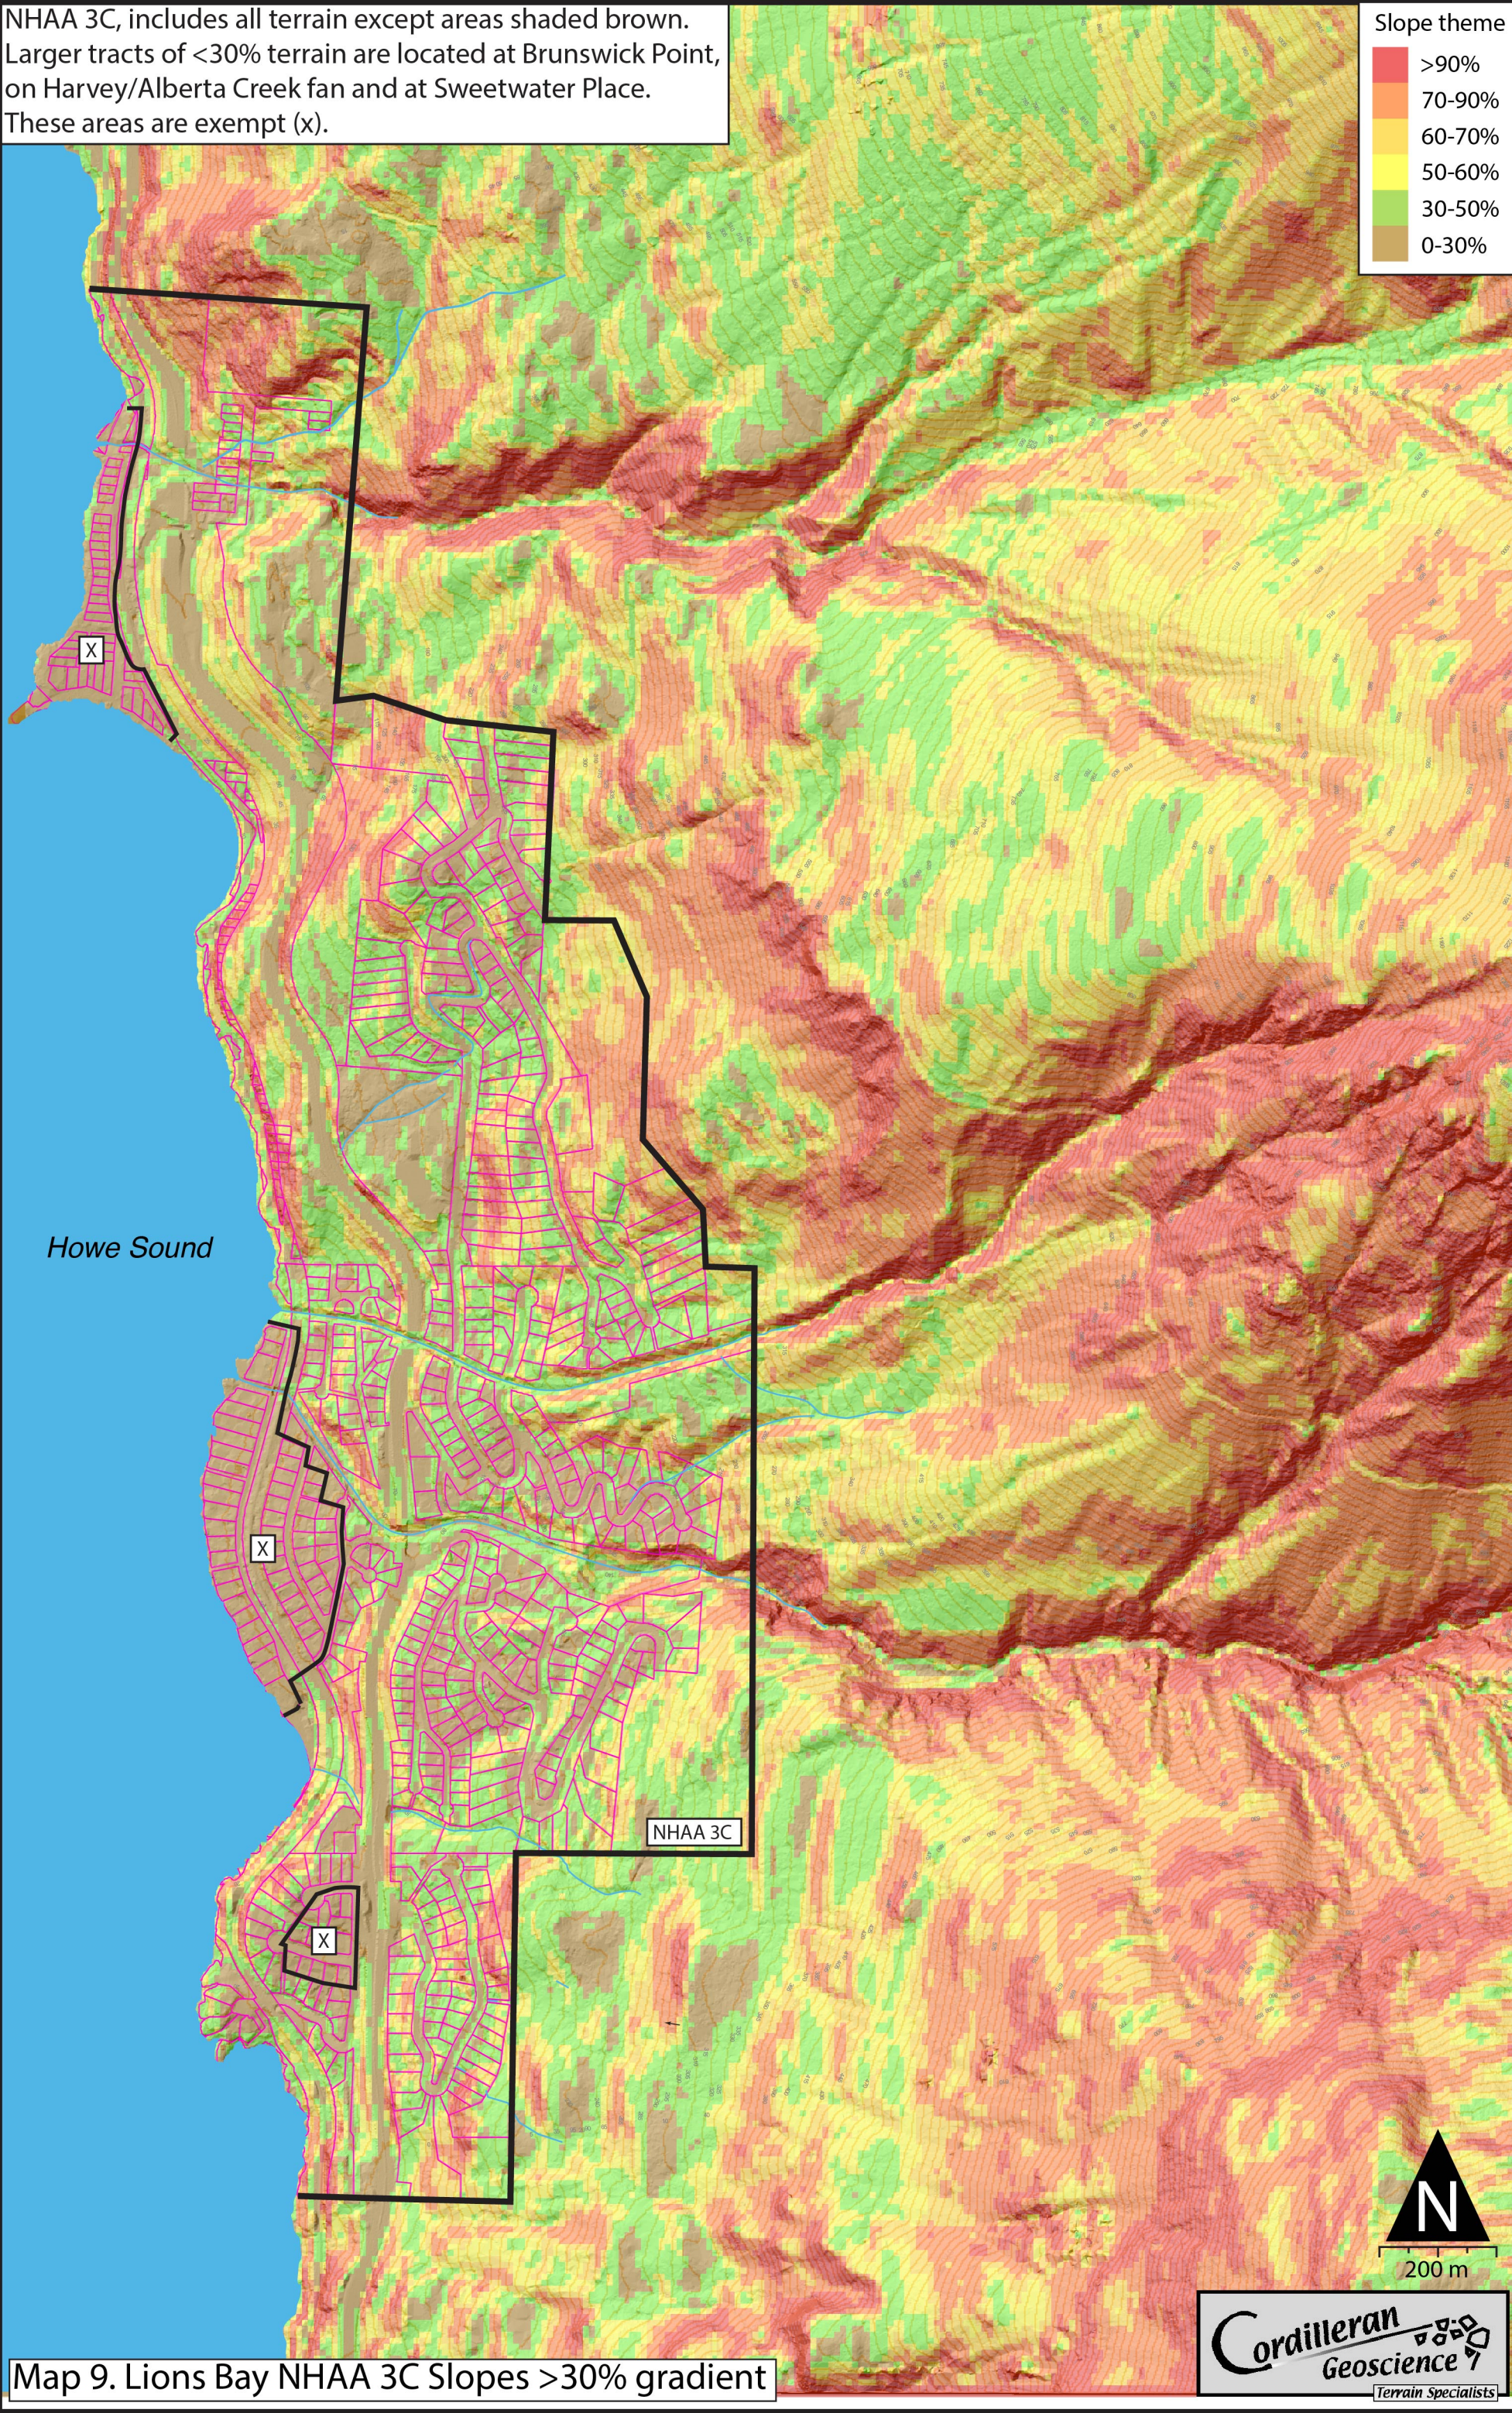
Map 9. Lions Bay NHAA 3C Slopes >30% gradient

NHAA 3C, includes all terrain except areas shaded brown.
Larger tracts of <30% terrain are located at Brunswick Point,
on Harvey/Alberta Creek fan and at Sweetwater Place.
These areas are exempt (x).
