Village of Lions Bay

Infrastructure Master Plan

60437708

July 28, 2016

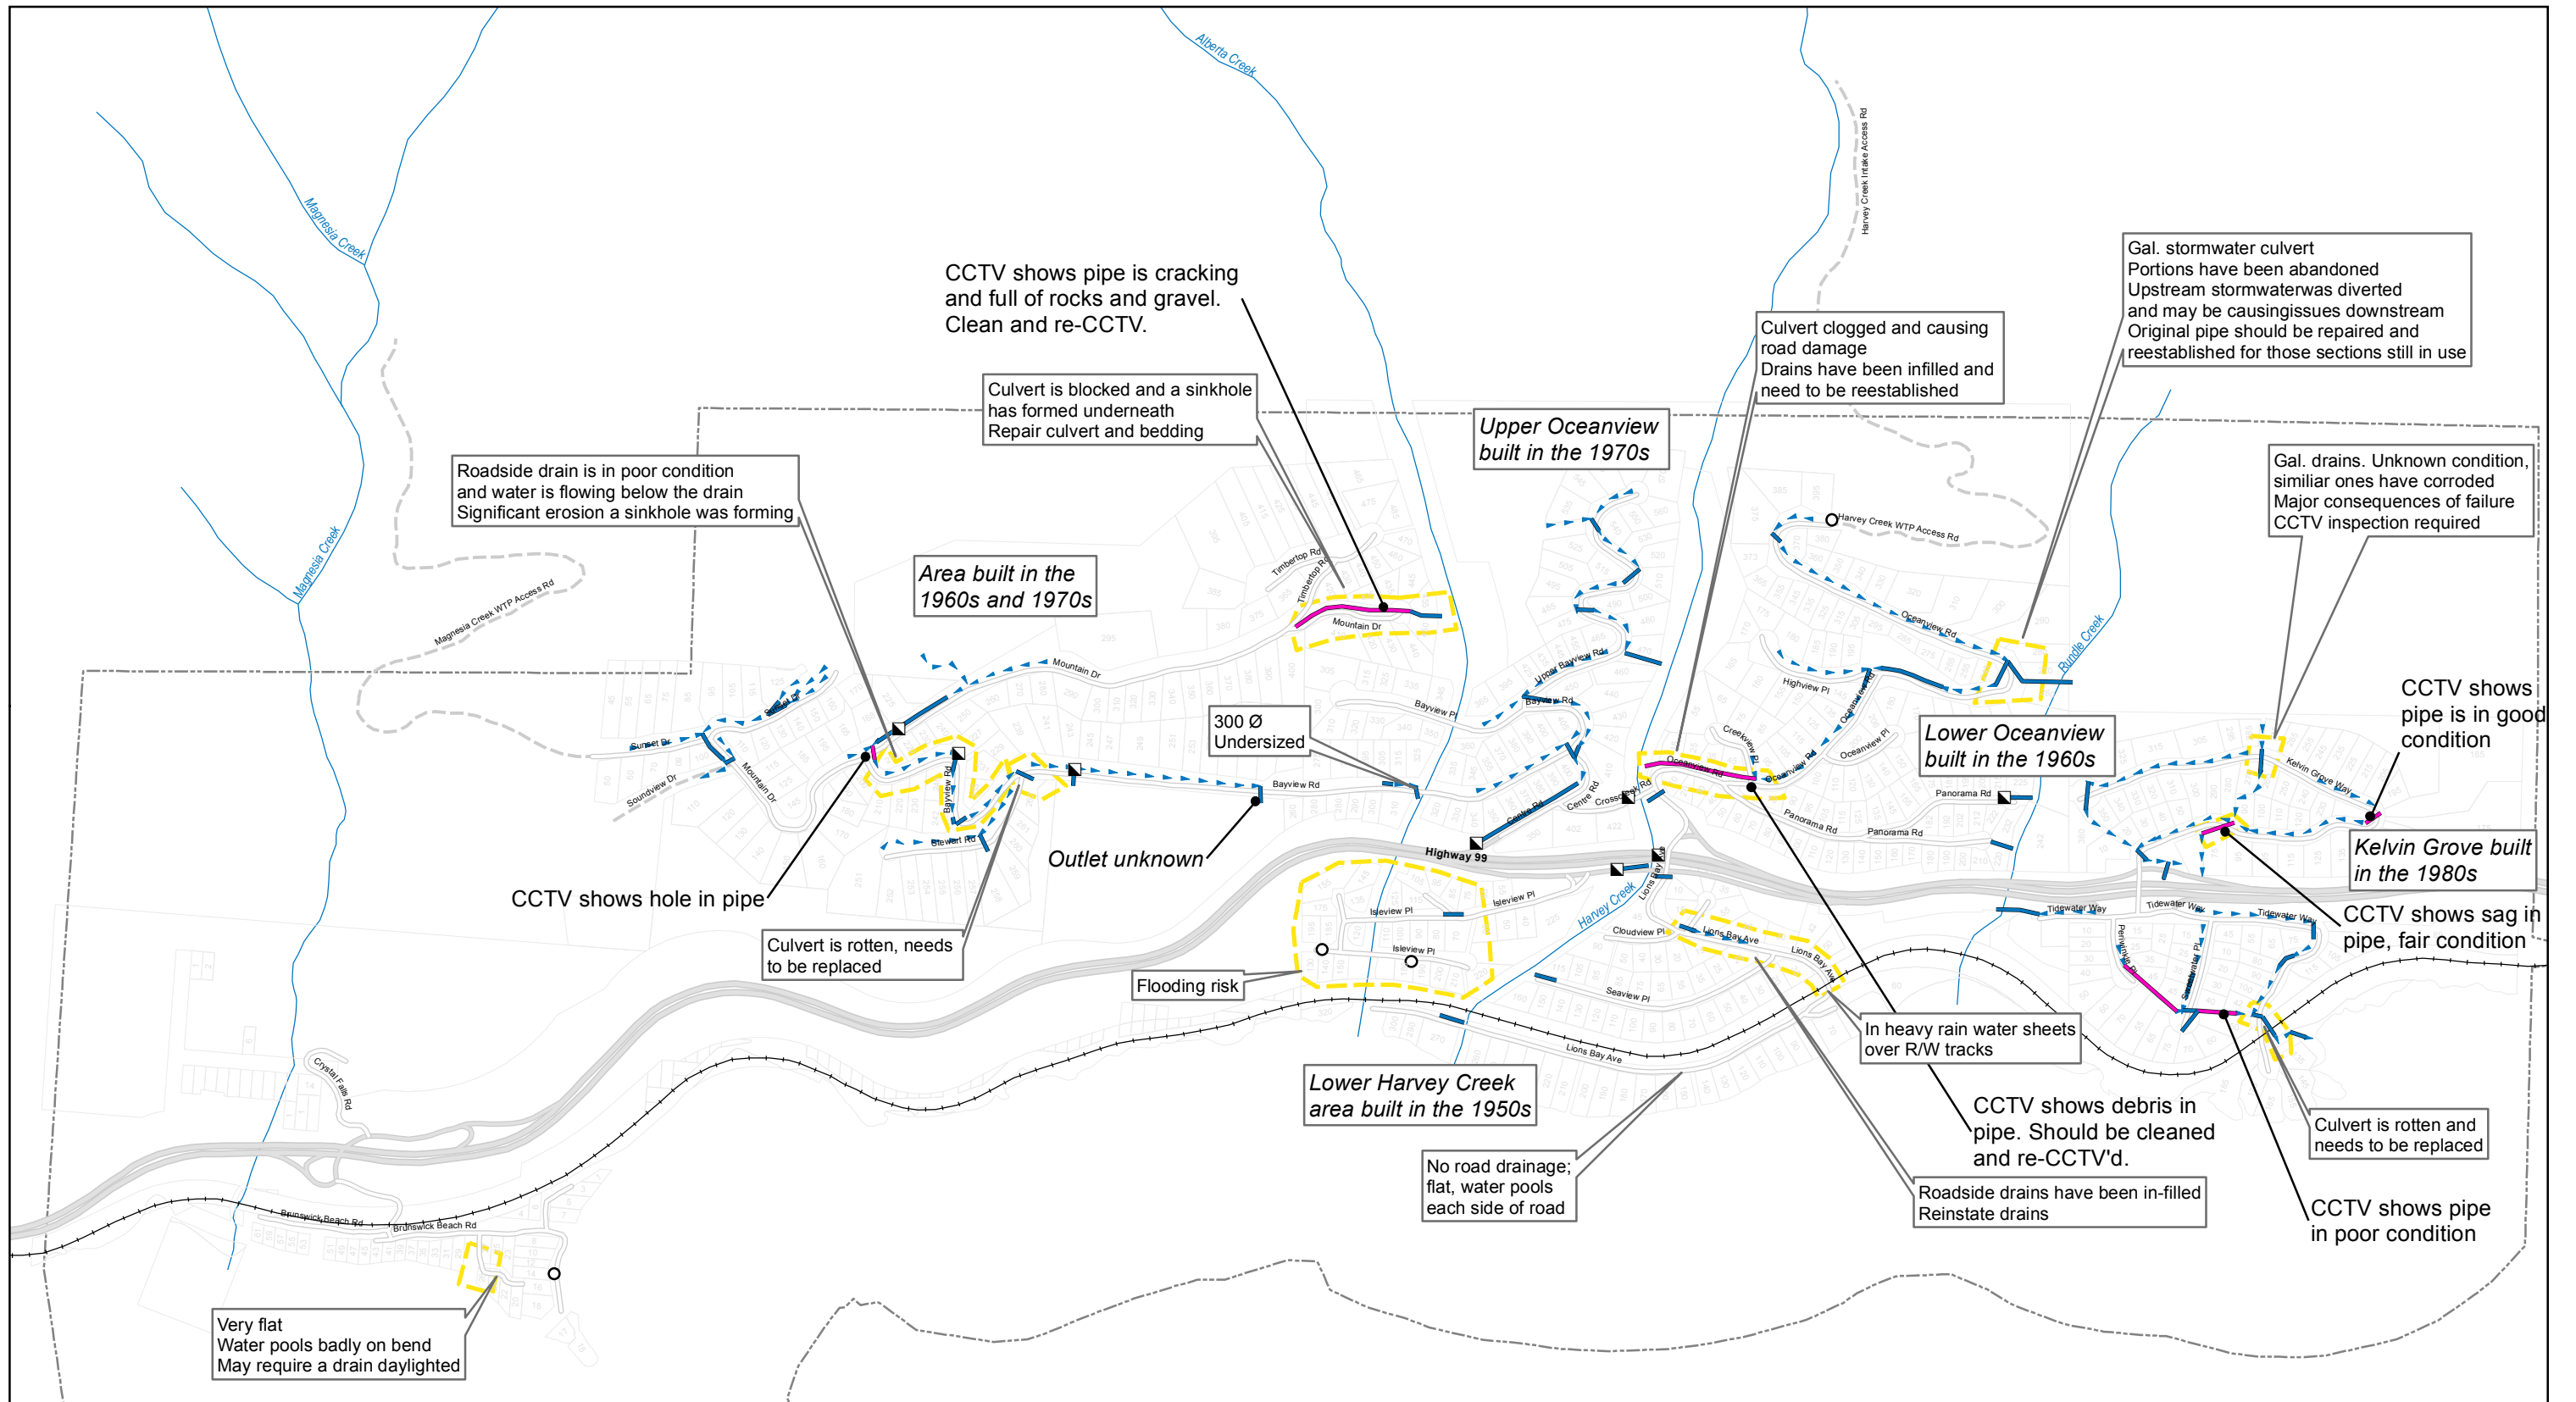
Infrastructure Master Plan
Drainage
Figure 4-3 Drainage Condition

Specific locations of concern are summarised in Table 4-2 and in Figure 4-3.

Priority	Location	Observation	Potential Resolution
Very High	Bayview Rd	Galvanised steel half-pipe drain has severely corroded and stormwater flows below the invert of the drain. This has caused significant erosion and presents a safety risk.	Remove and replace existing drain. Repair subgrade.
Very High	Oceanview Rd / Panorama Rd	Clogged culvert resulted in water discharging through the surface of the asphalt and causing significant pavement damage. Drains have been infilled.	Reinstate roadside drains. Remove and replace culvert.
Very High	Kelvin Grove Area	Culverts in Lower Kelvin Grove are in poor condition and need replacing. CCTV culverts in upper and Lower Kelvin Grove that have not yet been inspected. Failure of the culverts will have severe consequences due to the high flows, steep grade and proximity to houses.	Repair/replace culverts in poor condition. Perform CCTV Inspection of culverts that have not yet been inspected.

High	Oceanview Rd	A stormwater culvert that previously discharged to Rundle Creek was clogged, and the upstream flows were diverted down Oceanview Rd. They are now likely causing capacity issues downstream.	Original pipe should be repaired and re-established
High	Mountain Dr	Existing concrete pipe has deteriorated to the point that there is no bottom and a large sinkhole has formed.	Repair/replace culvert and bedding.
Medium	Lions Bay Ave	Roadside ditches have been infilled	Reinstate roadside ditches.
Medium	Brunswick Beach Rd	Very flat, low lying area consistently floods	Daylight drain.

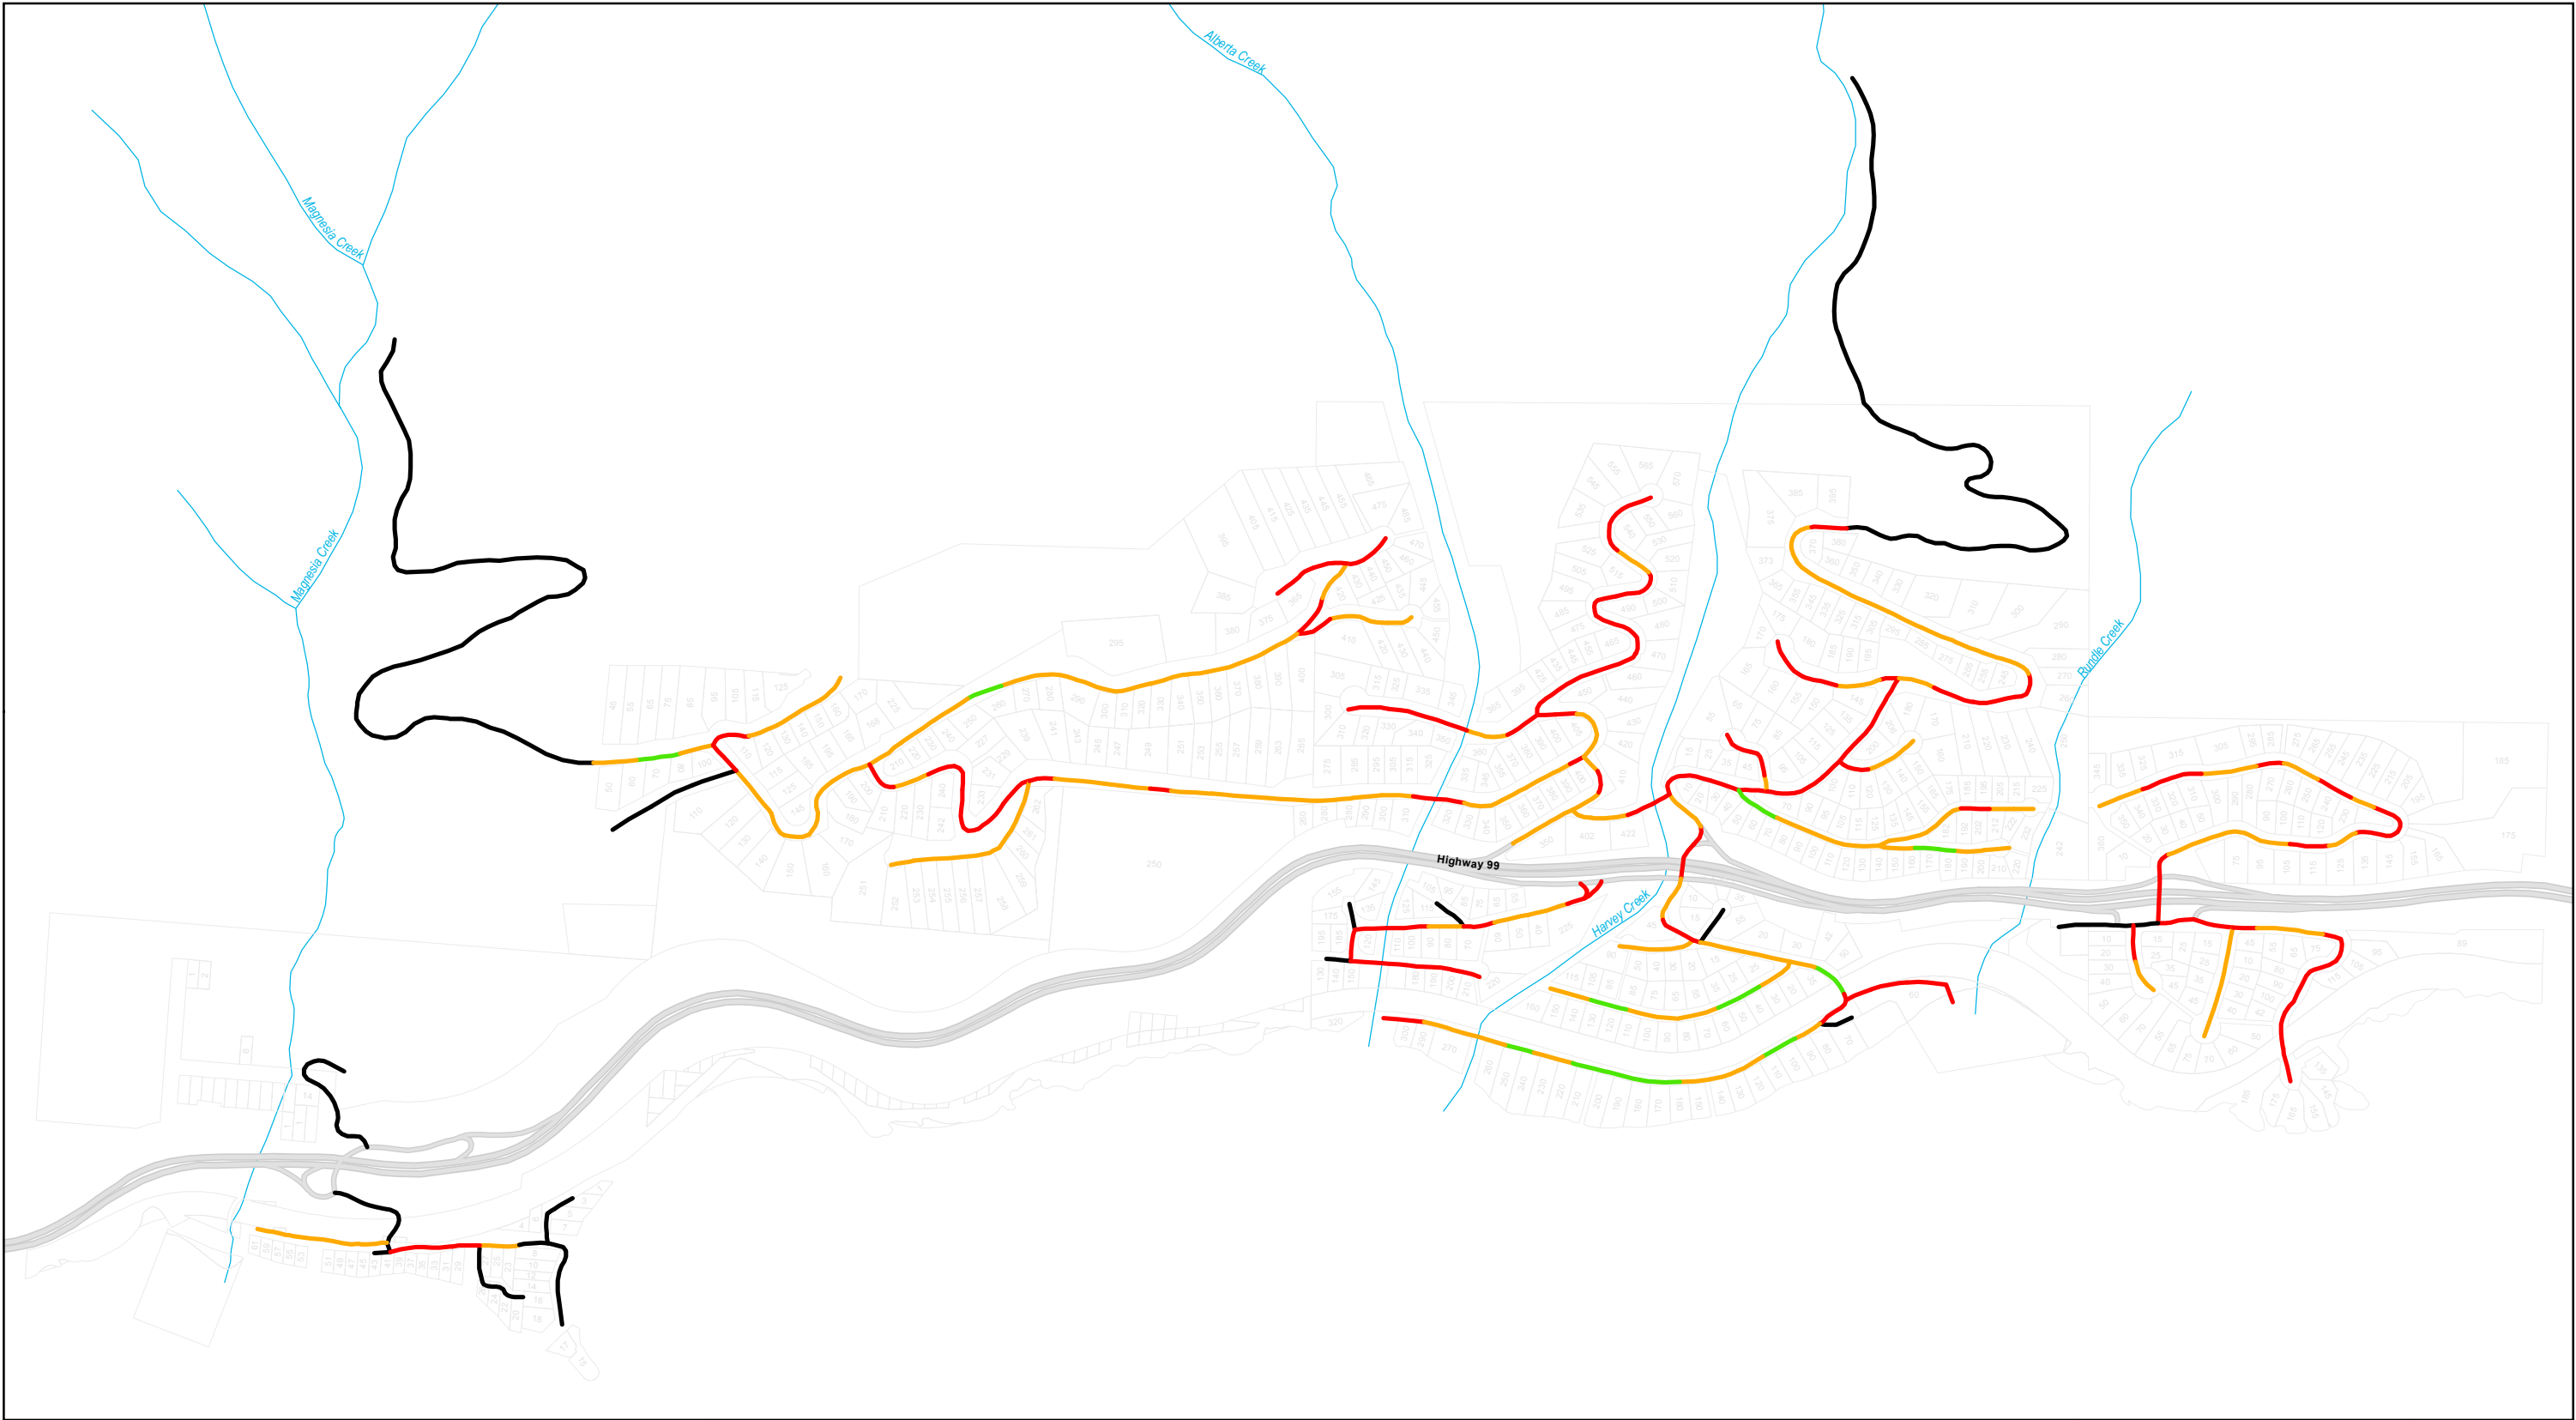
Pavement roughness and rut data (IRI) was collected to provide a measure of rider comfort on all Village roads as shown below in Figure 5-3.

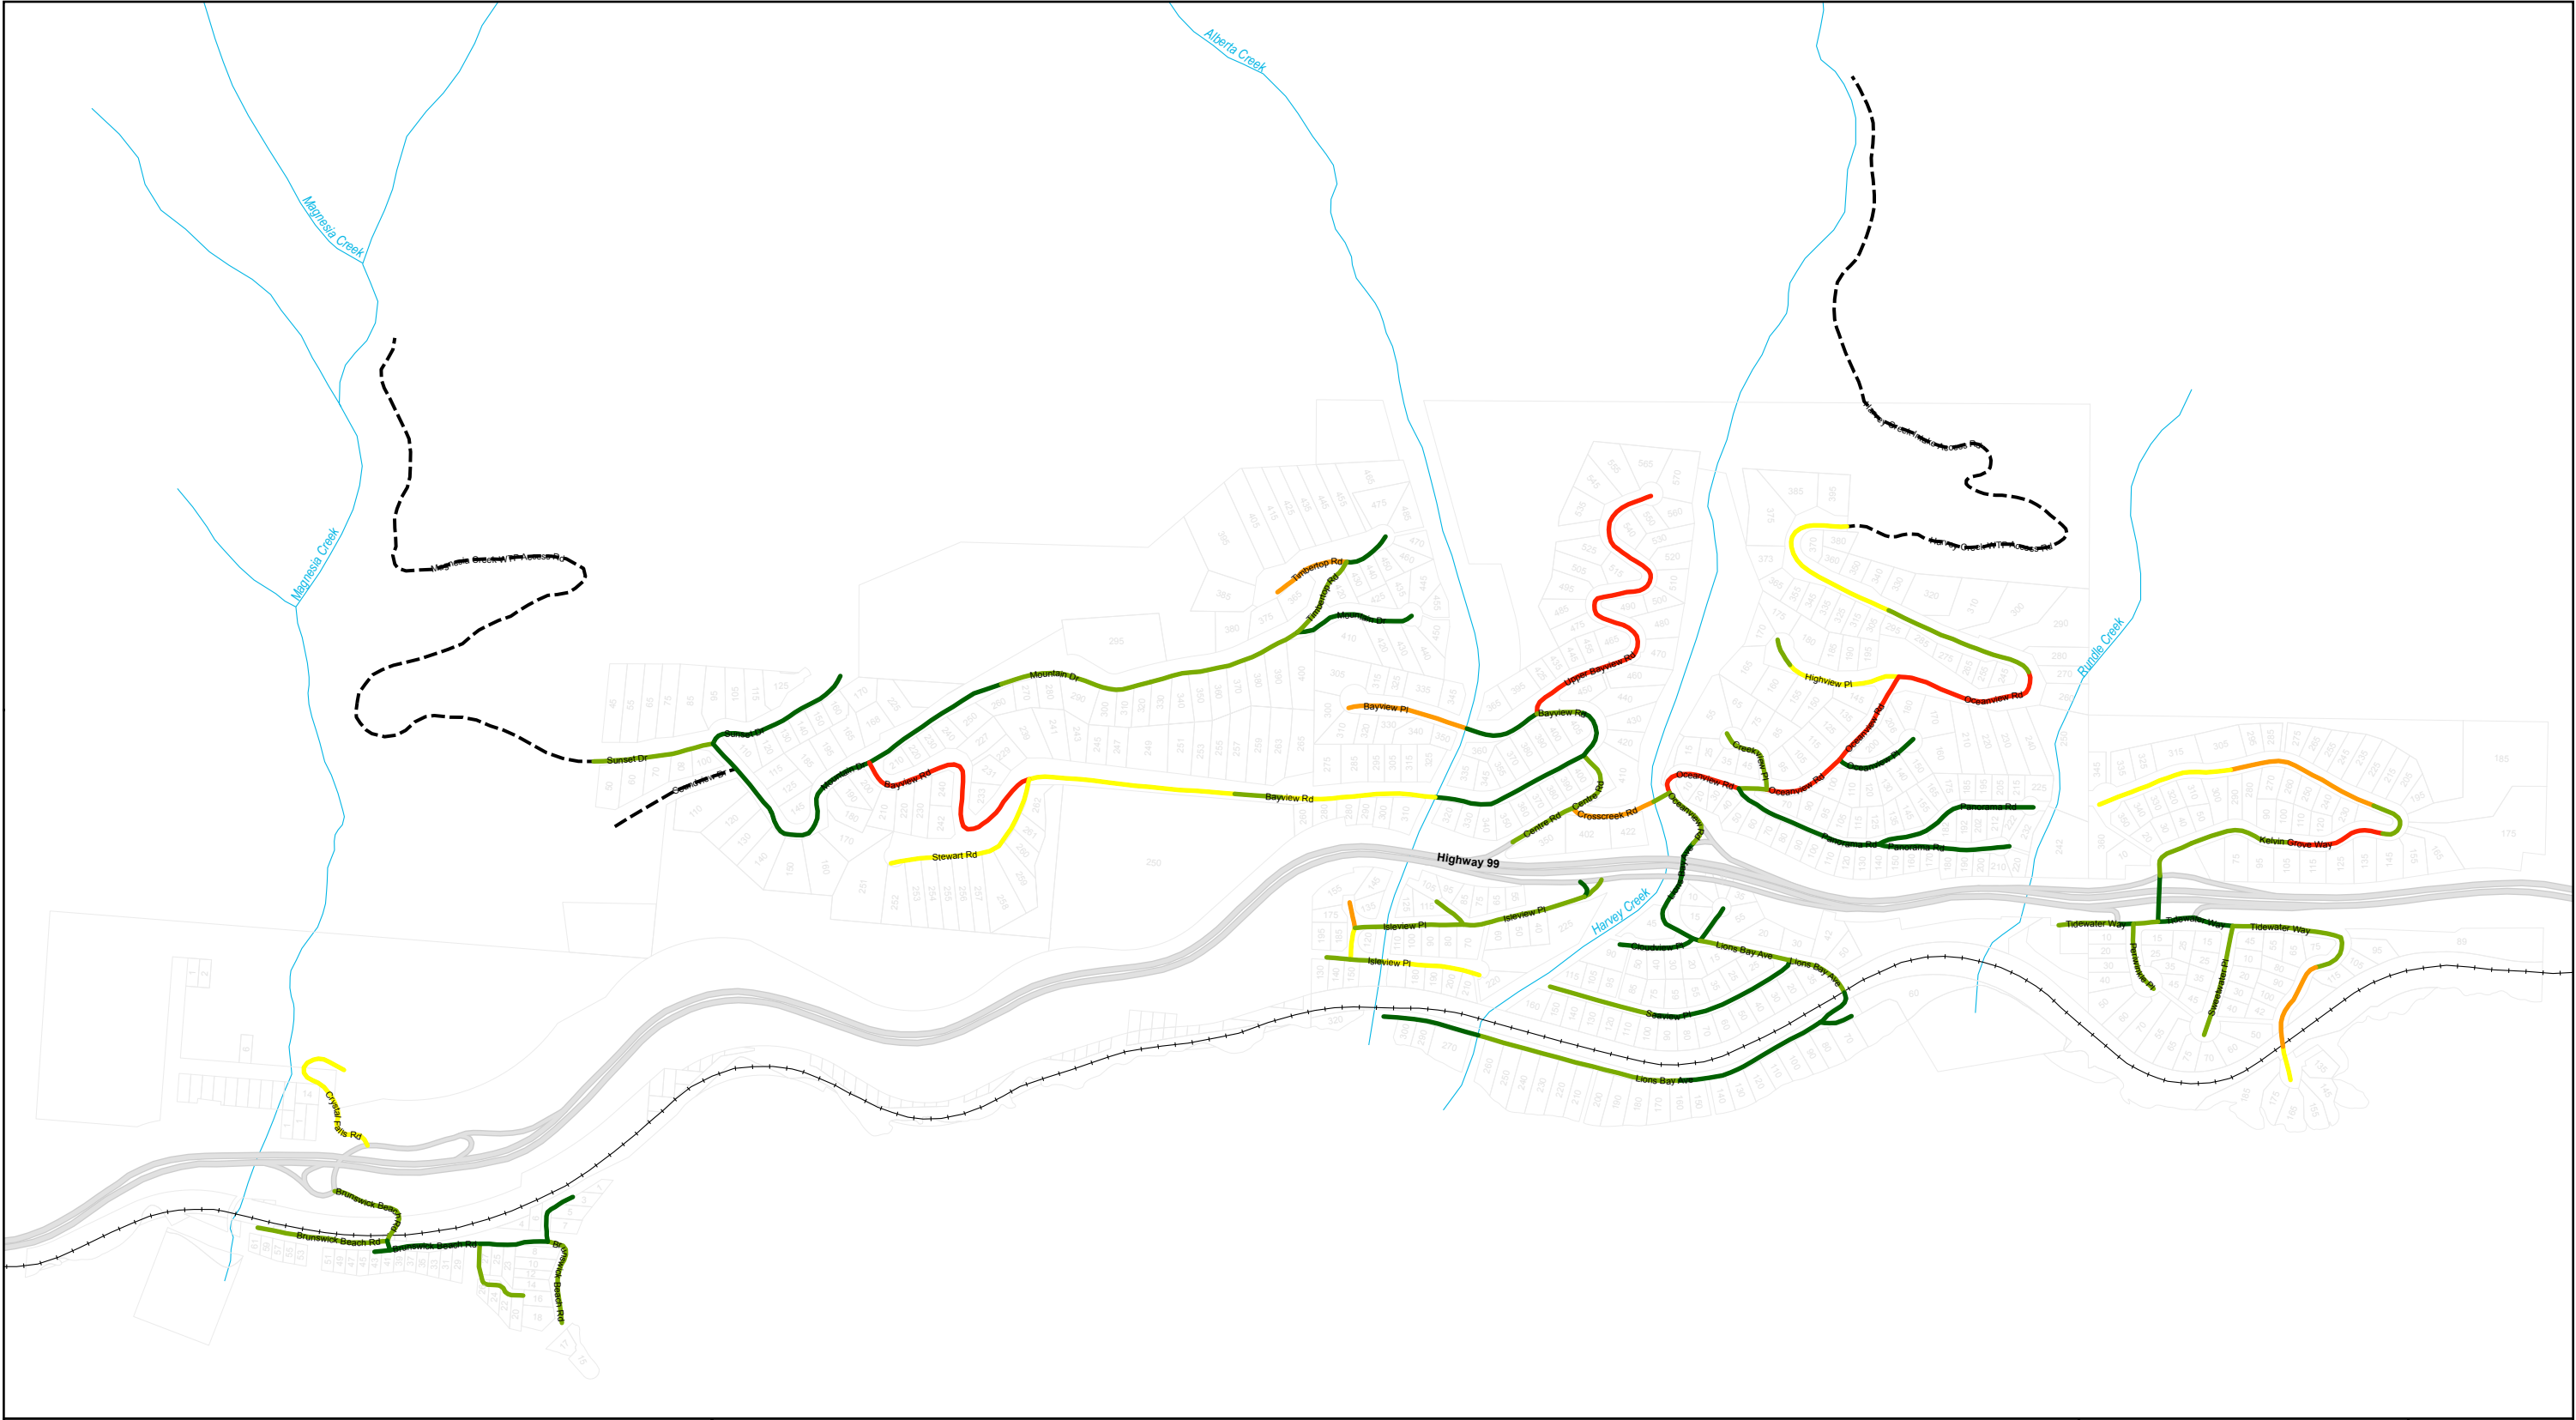
<p>VILLAGE OF LIONS BAY Infrastructure Master Plan Figure 5-4 Tetra Tech Pavement Condition Assessment</p> <p>AECOM</p>	<p>Legend</p>

The findings of this pavement assessment are shown in Figure 5-4 which shows the condition of each section of roadway based on the pavement condition index (PCI). The ratings are categorised as:

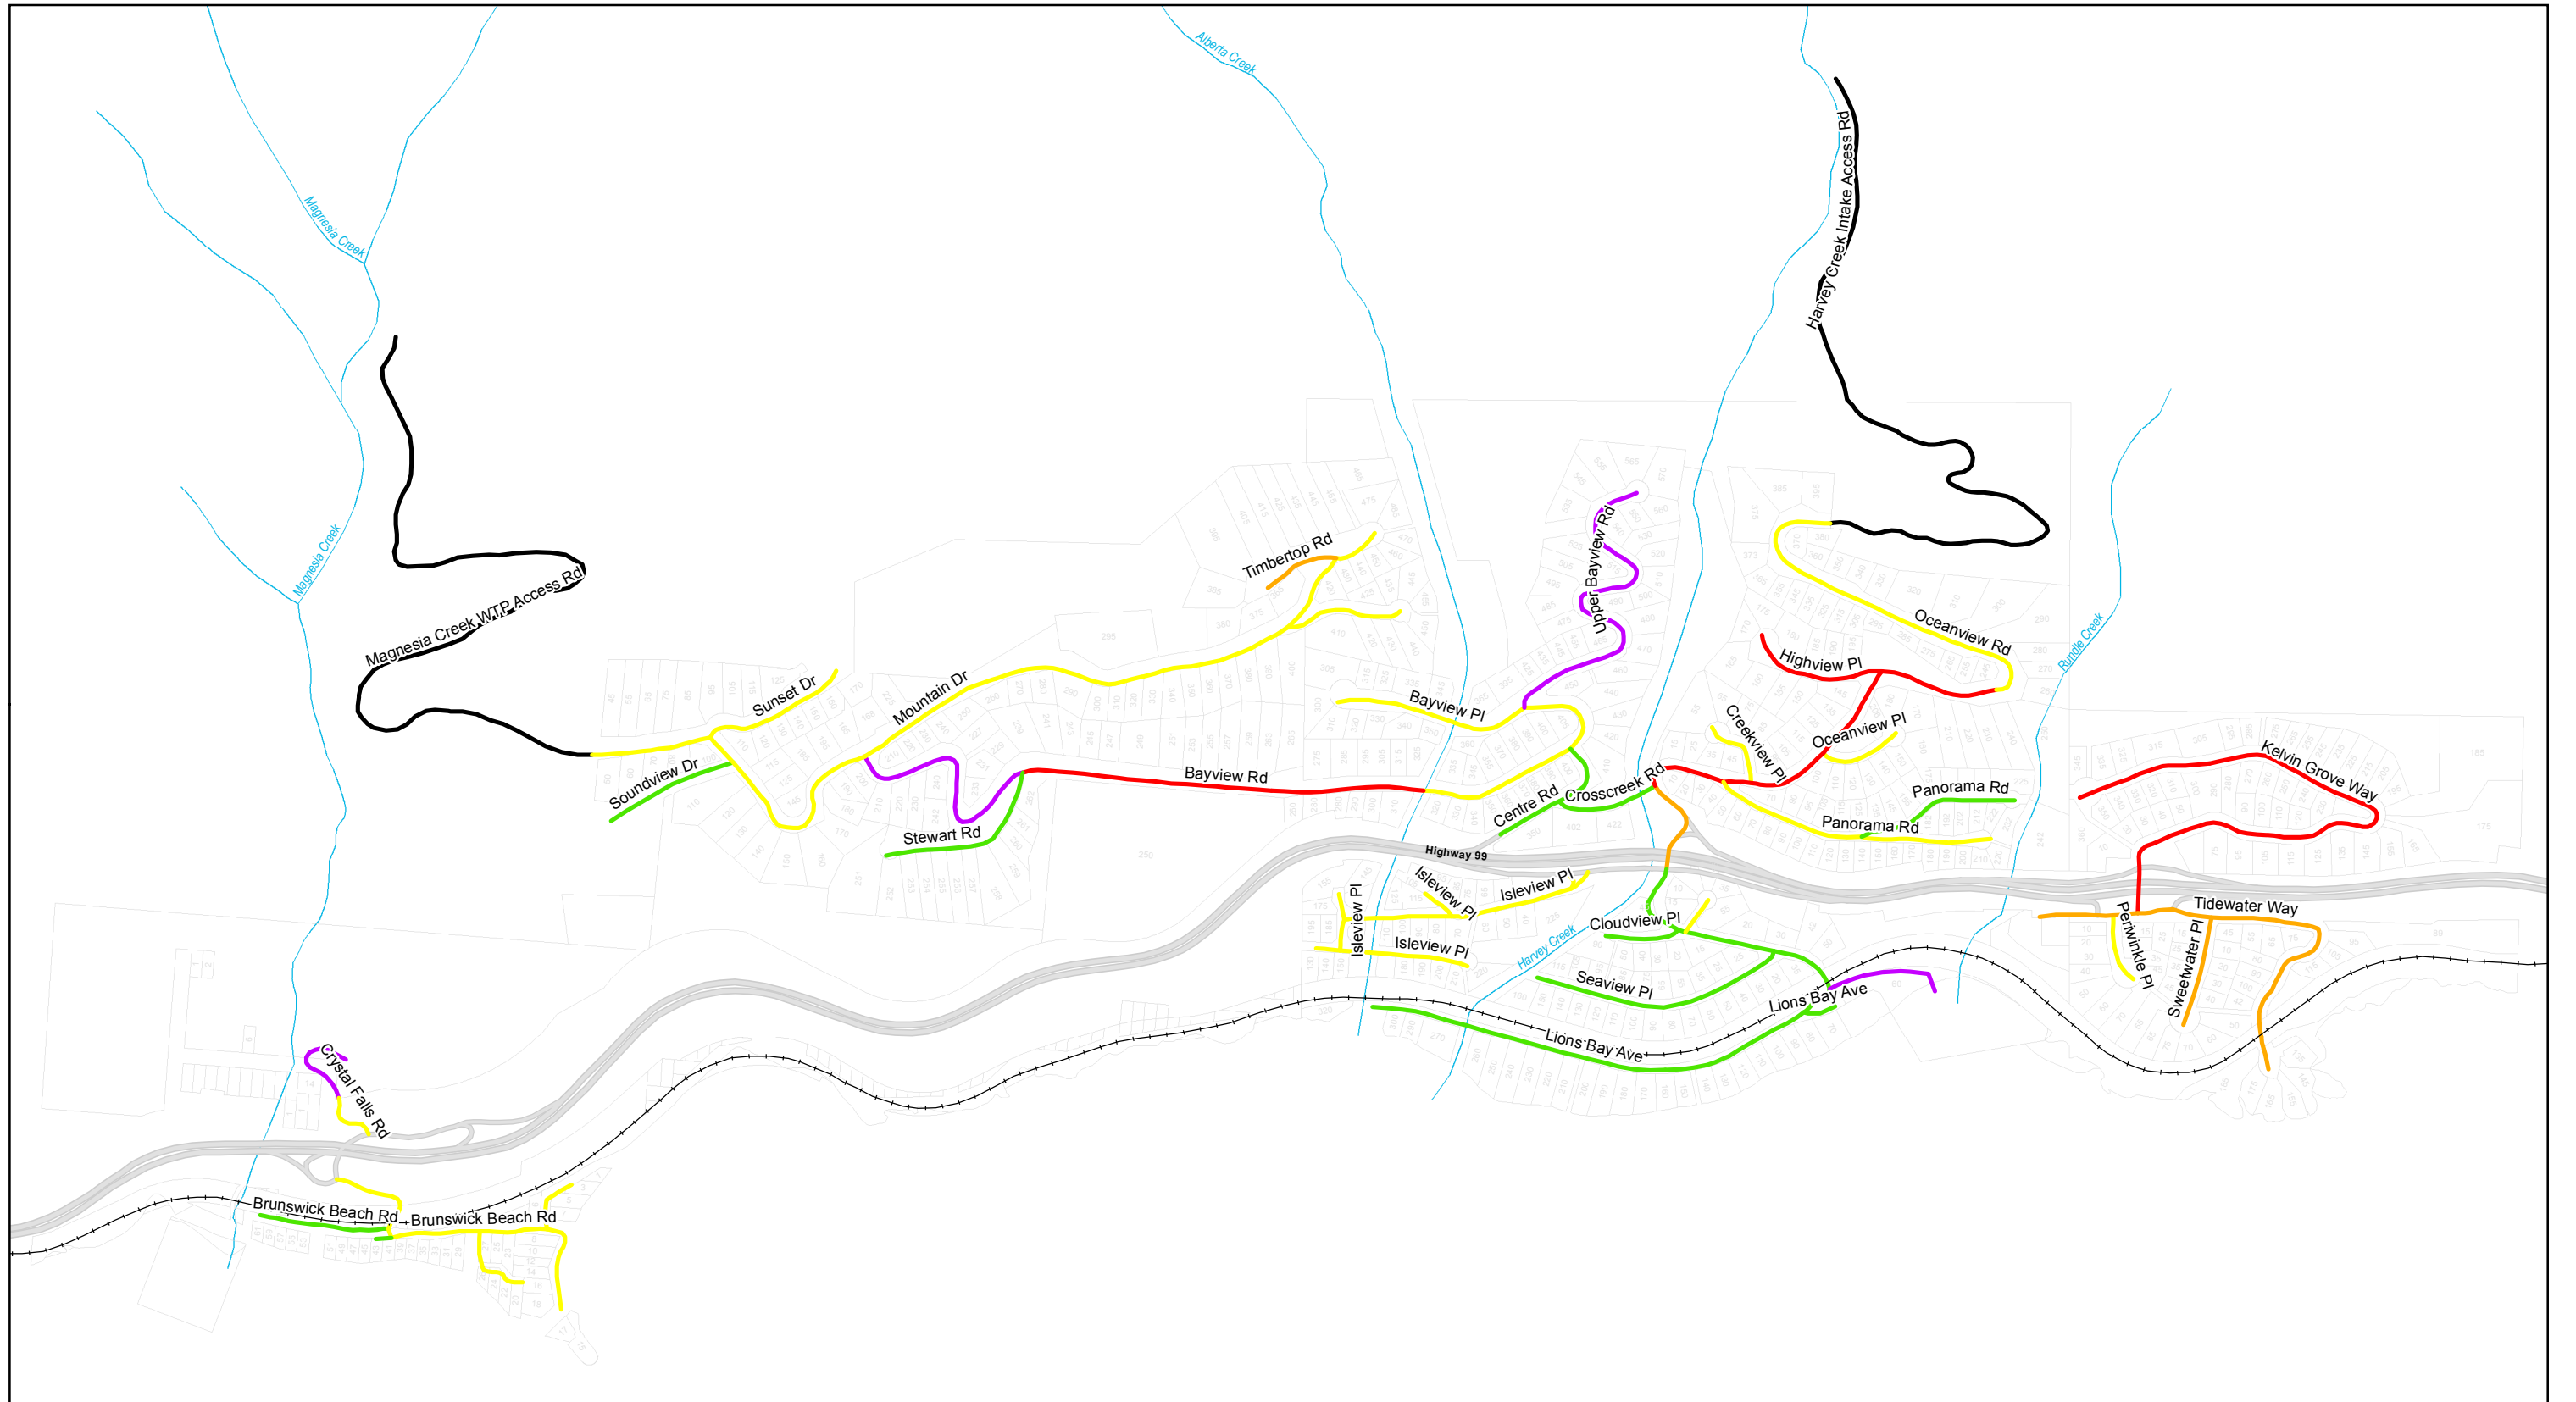
VILLAGE OF LIONS BAY
Infrastructure Master Plan
 Figure 5-5 Recommended Road Treatments

Recommended road rehabilitation work based on the condition assessment can be found in Figure 5-5. These recommendations were considered and prioritised with other infrastructure needs (i.e. water main and sewer works) in the development of the capital project list in **Section 7**. Where possible, works were coordinated to reduce overall infrastructure renewal costs.

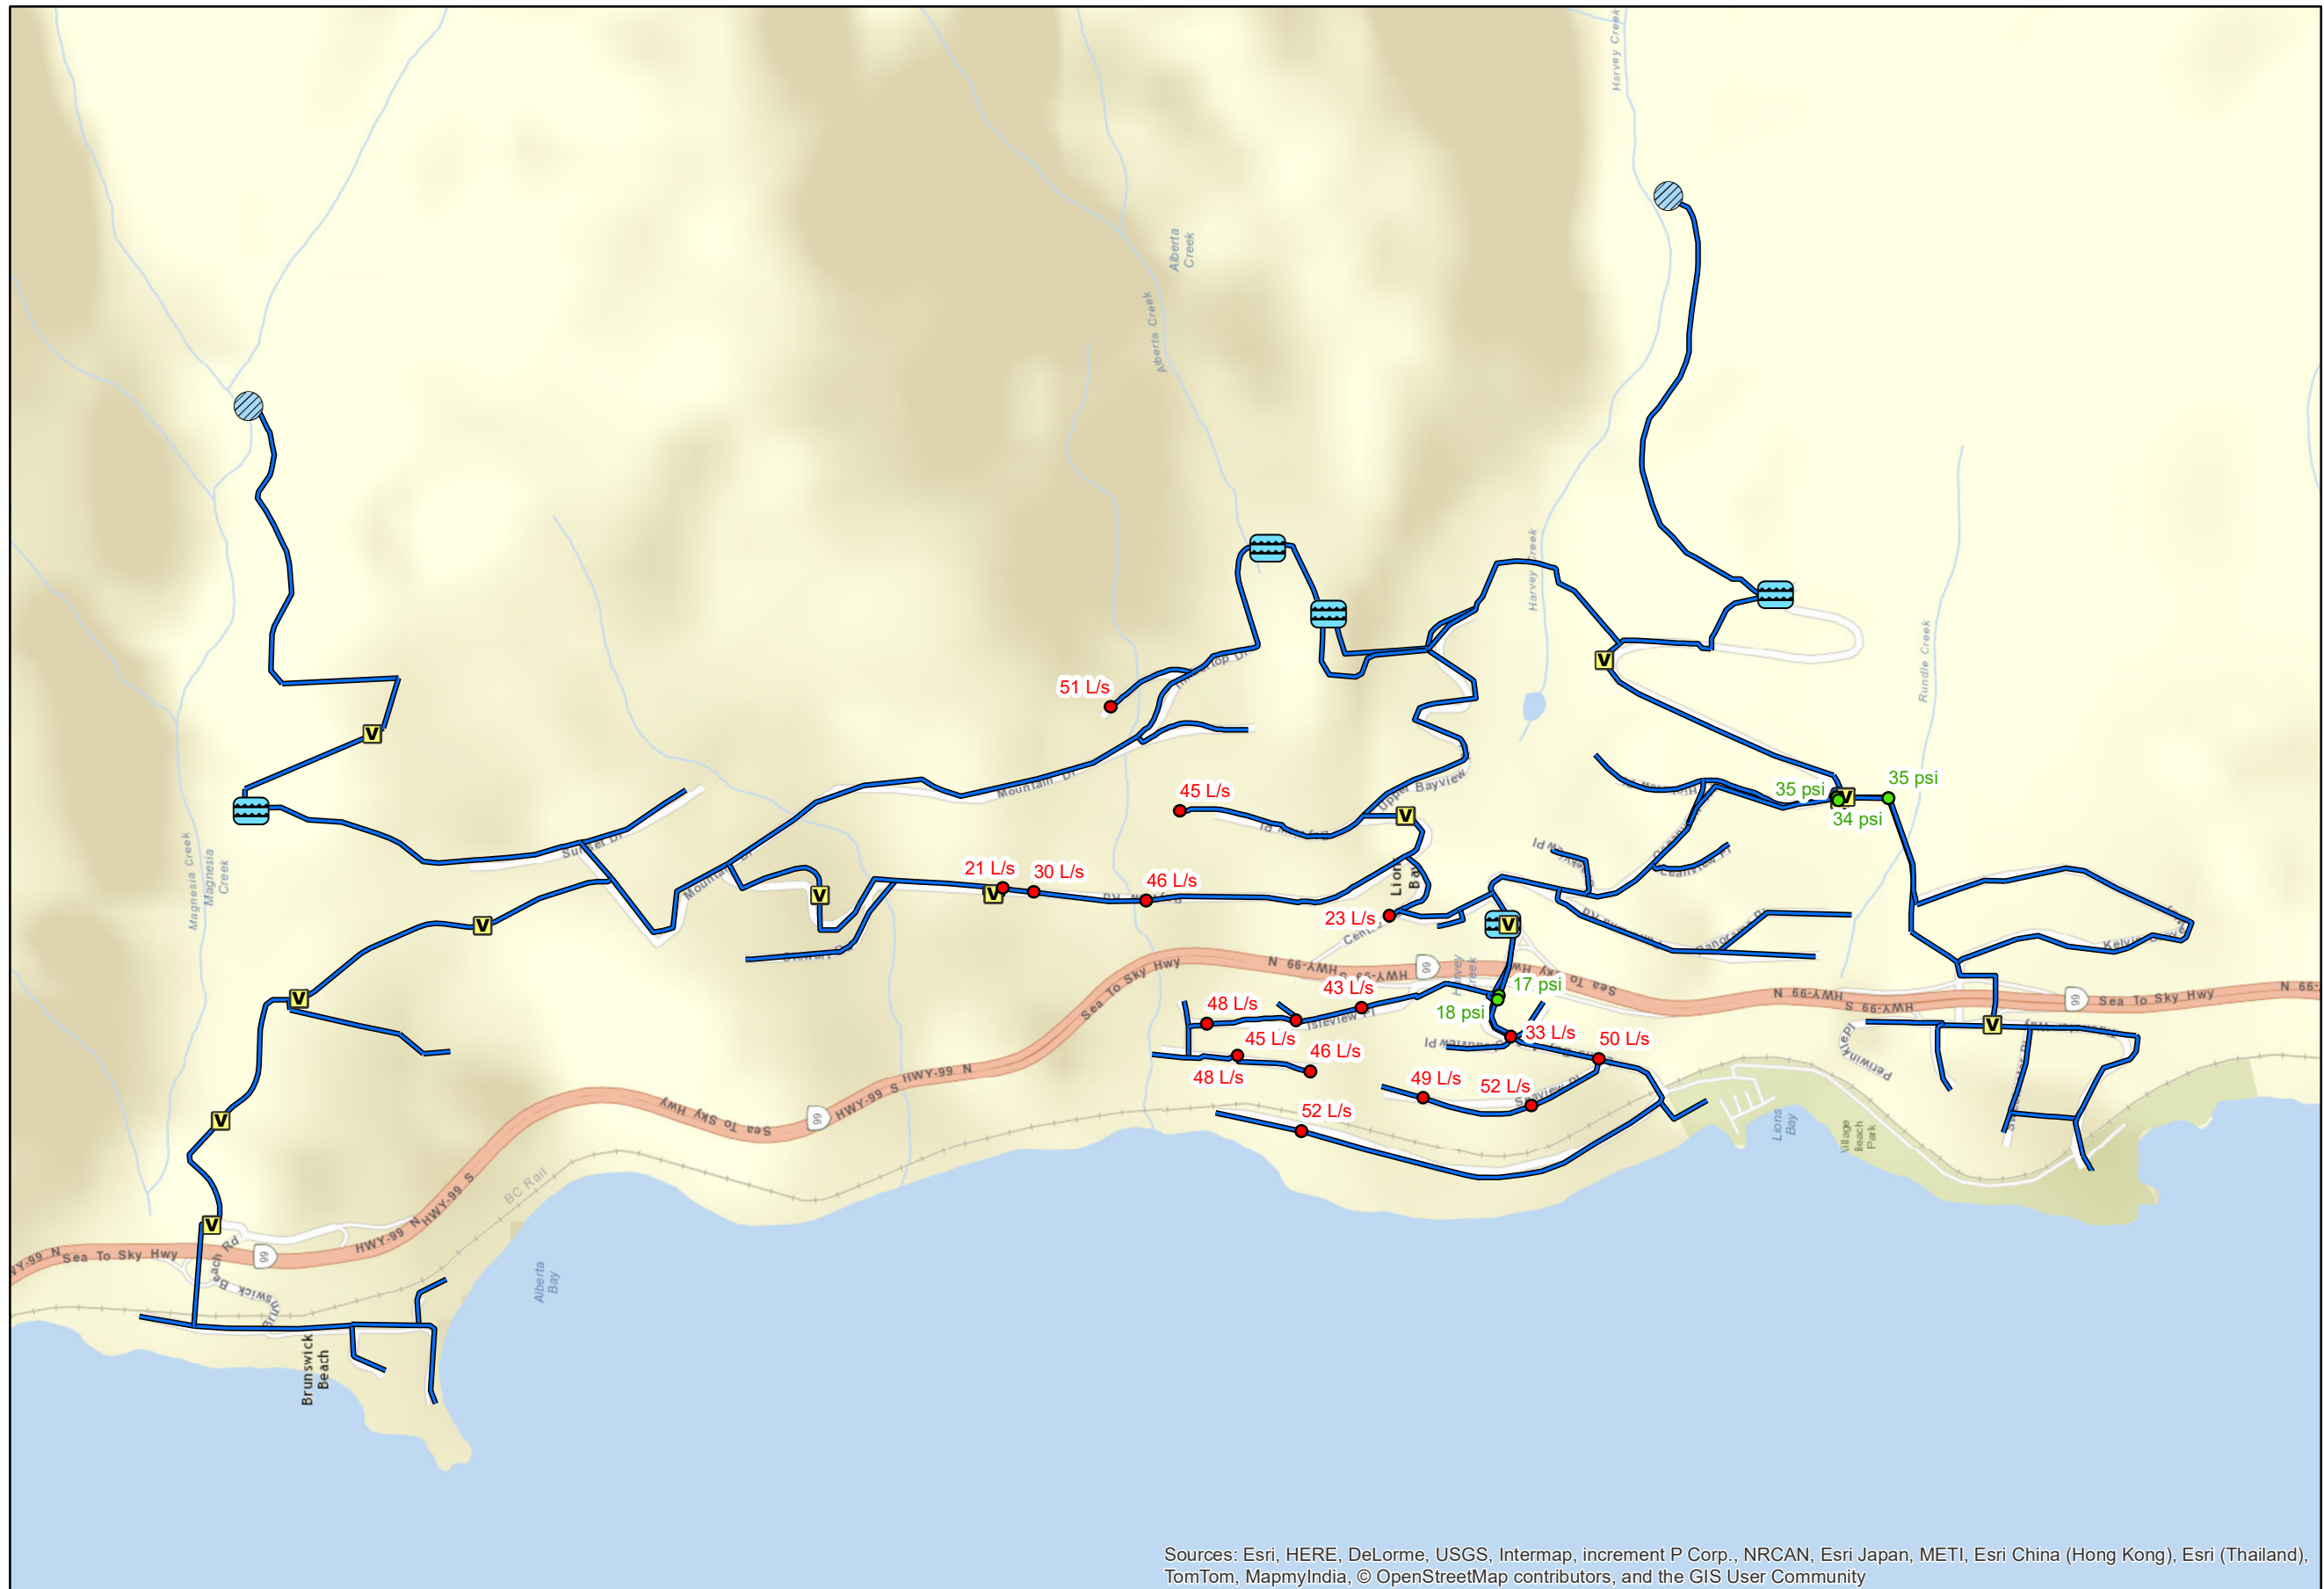
Peak Hour and Fire Flow
Deficiencies

Fire Flow Deficiency (<20 L/s)

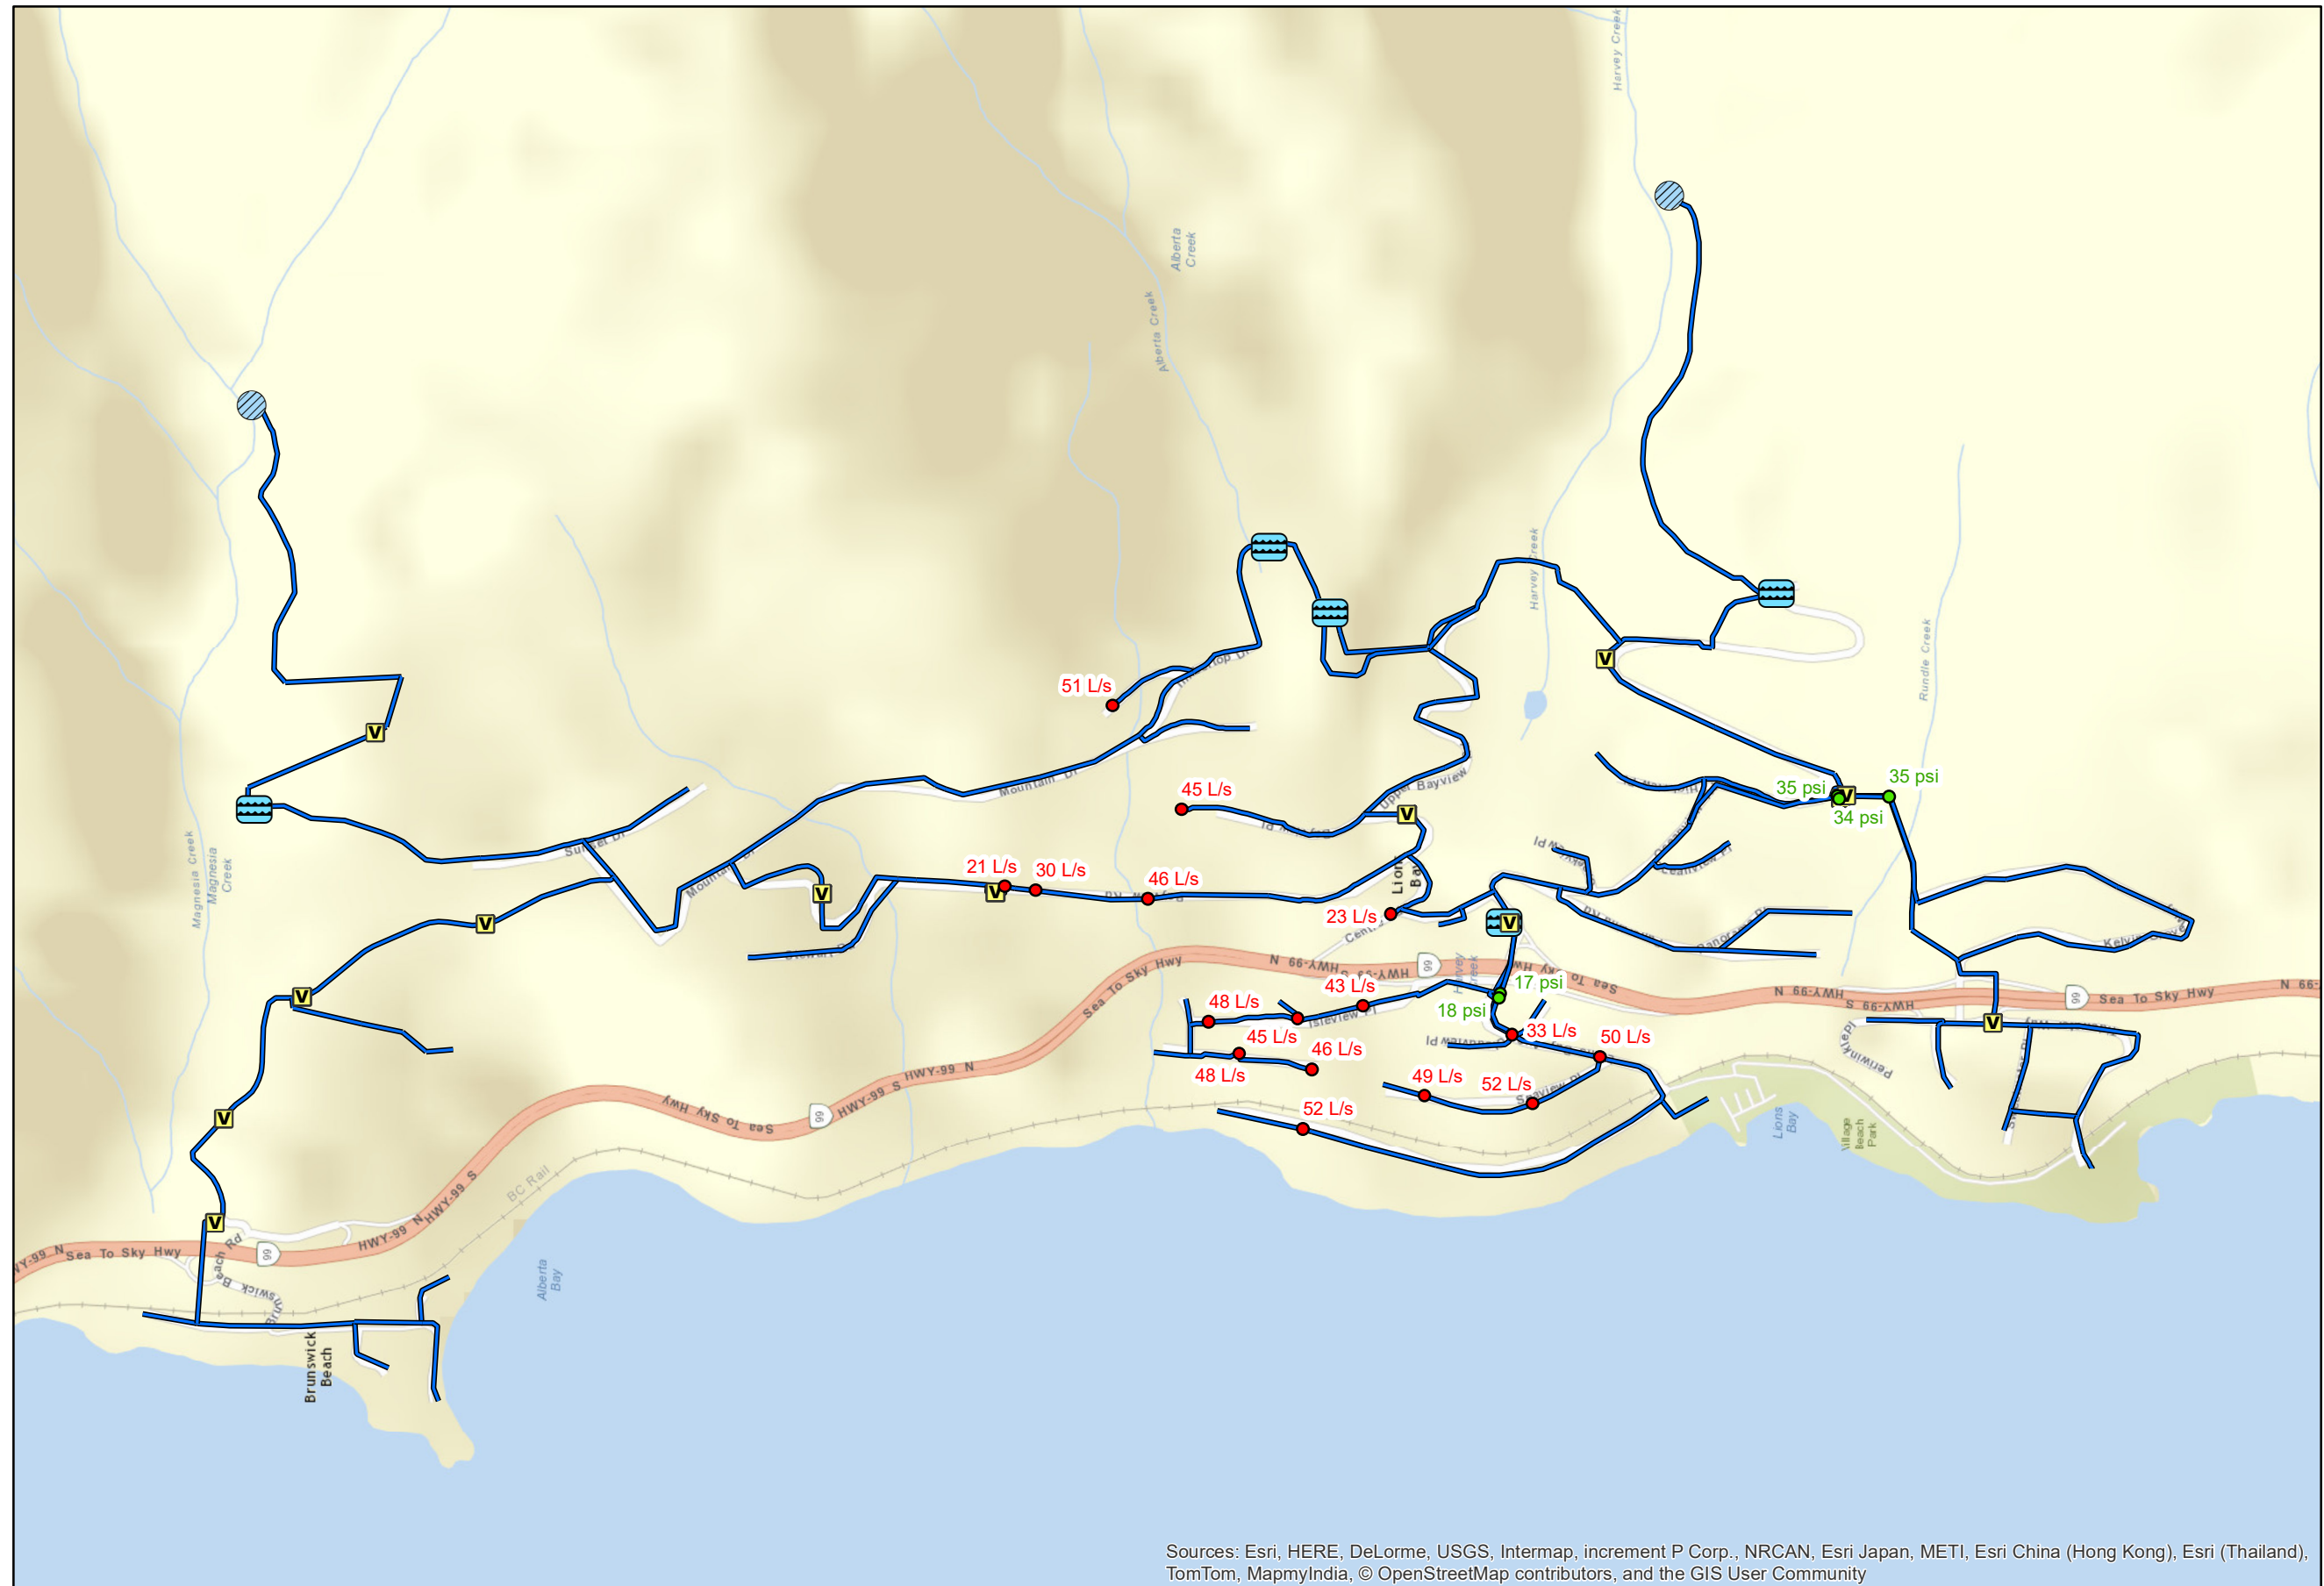
Peak Hour and Fire Flow Deficiencies

Fire Flow Deficiency (<20 L/s)
