Village of Lions Bay

Infrastructure Master Plan

60437708

July 28, 2016

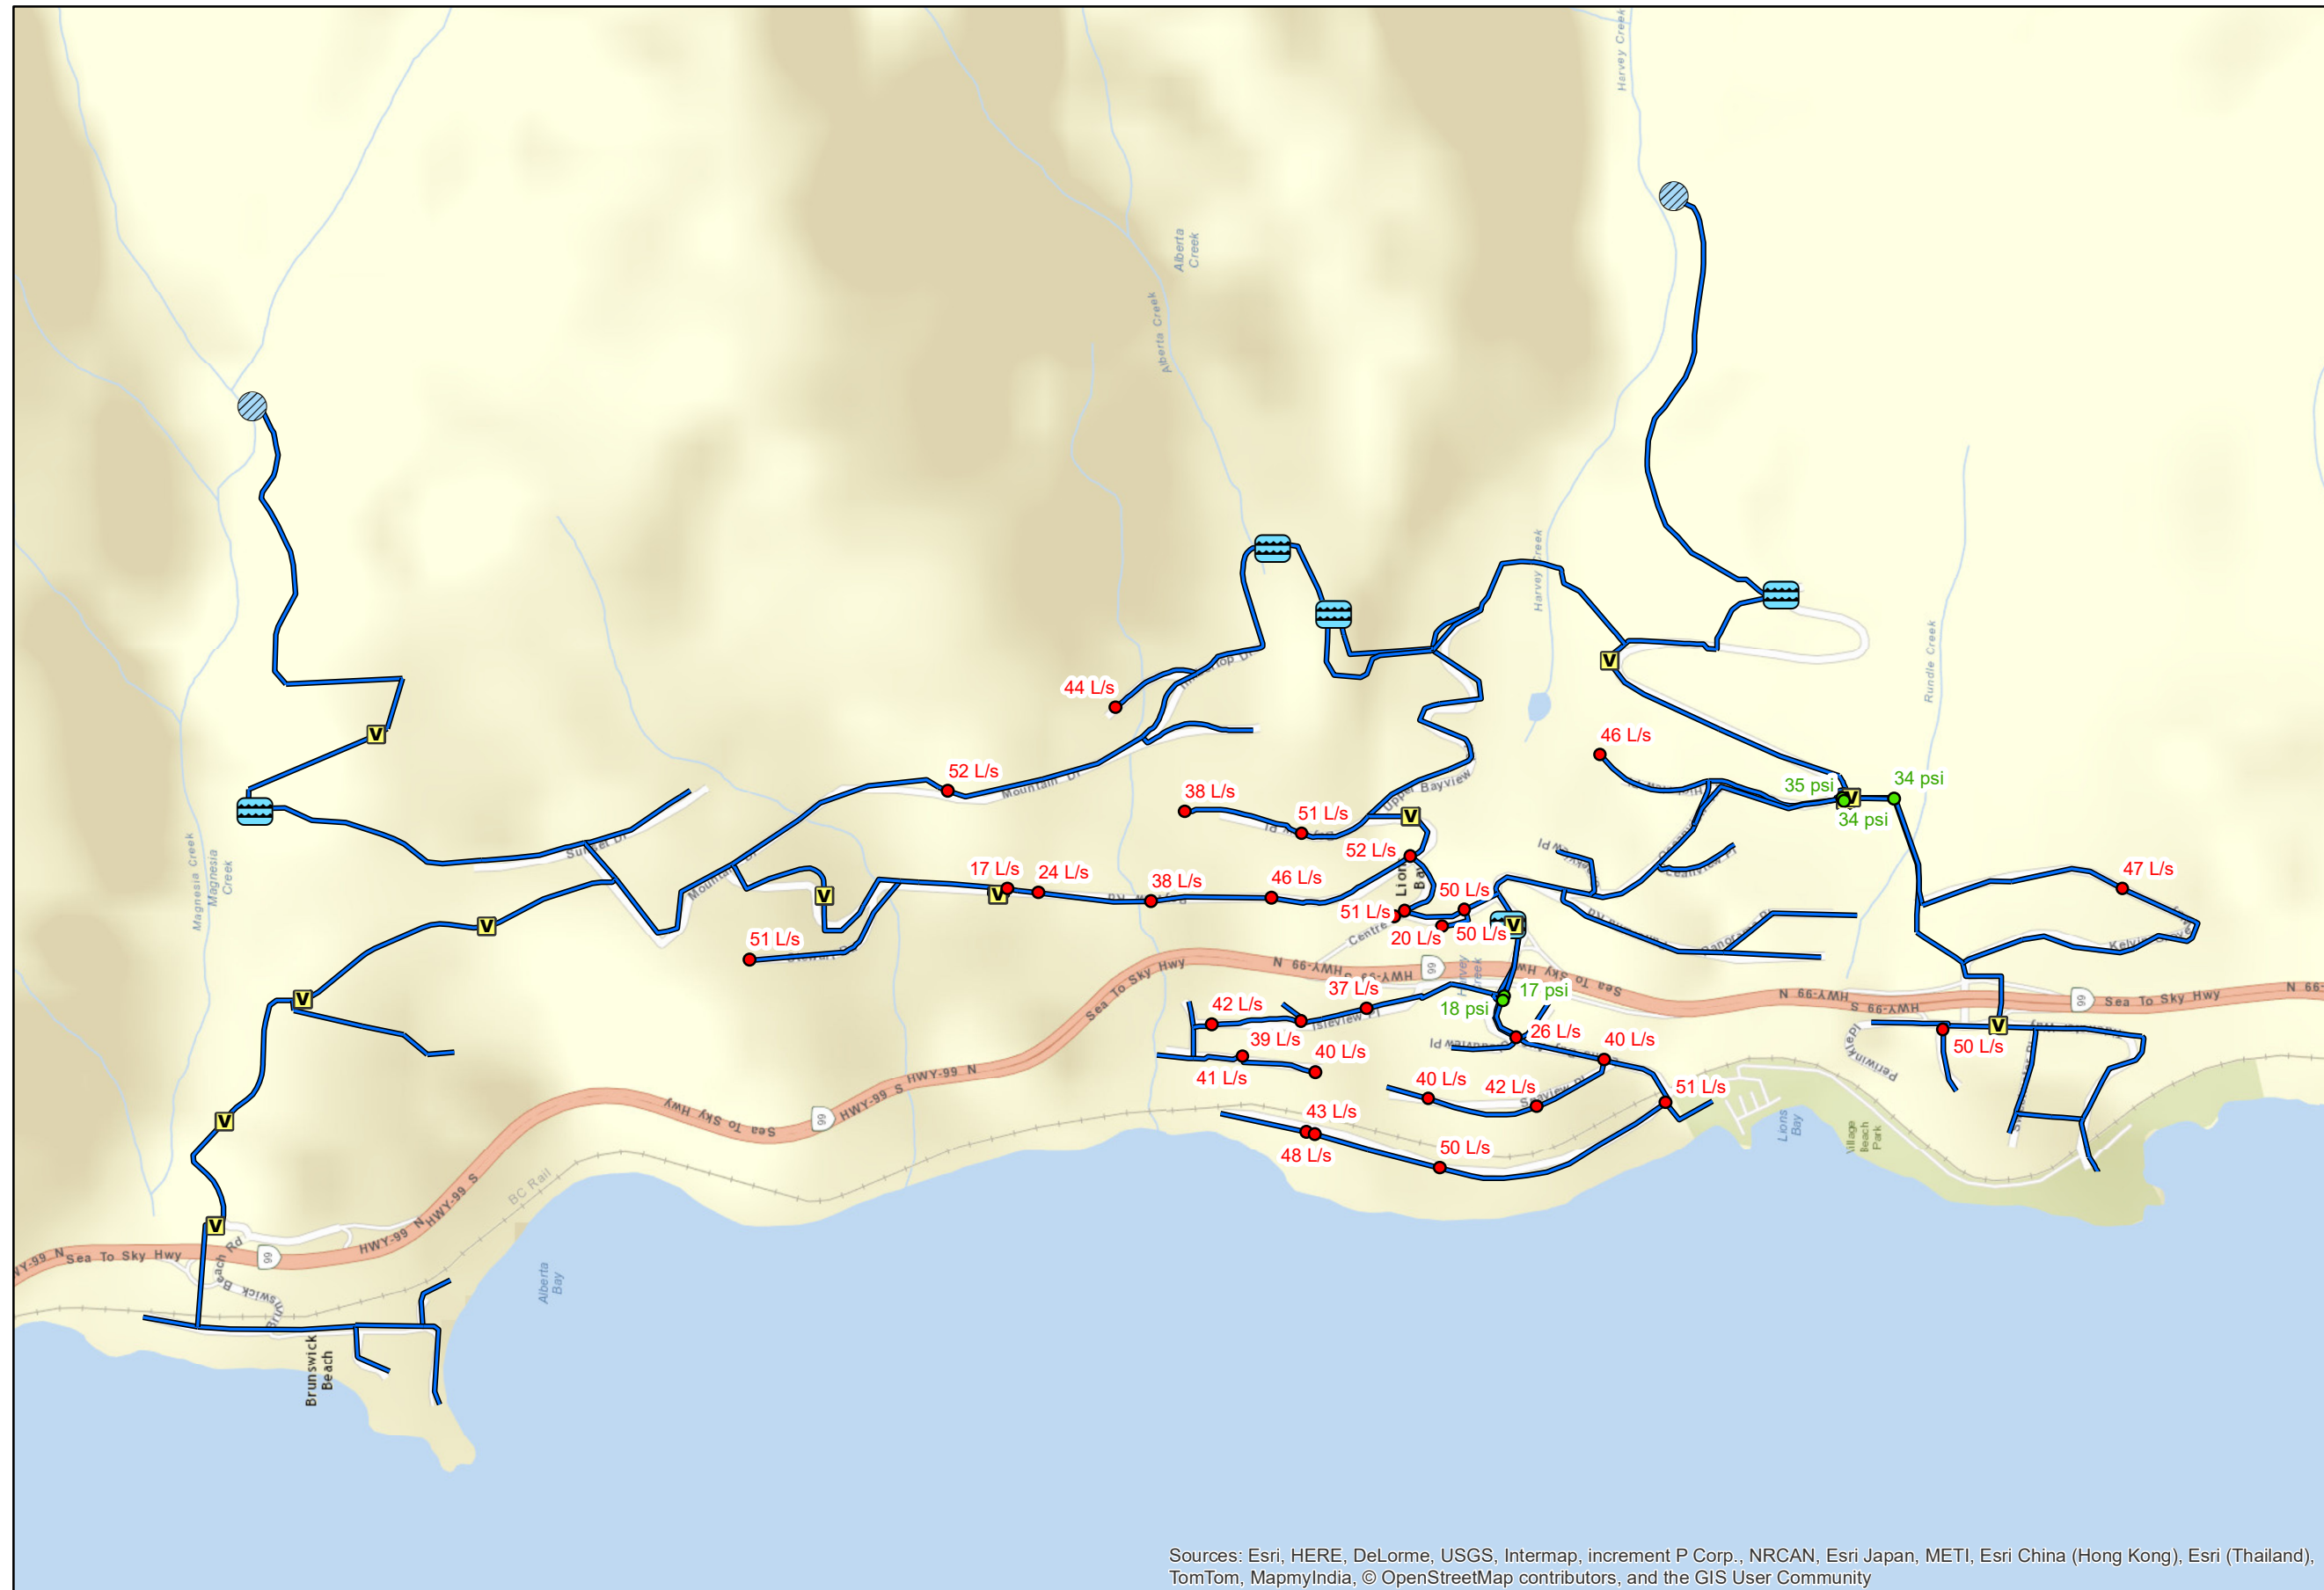
Peak Hour and Fire Flow Deficiencies

Fire Flow Deficiency (<20 psi)

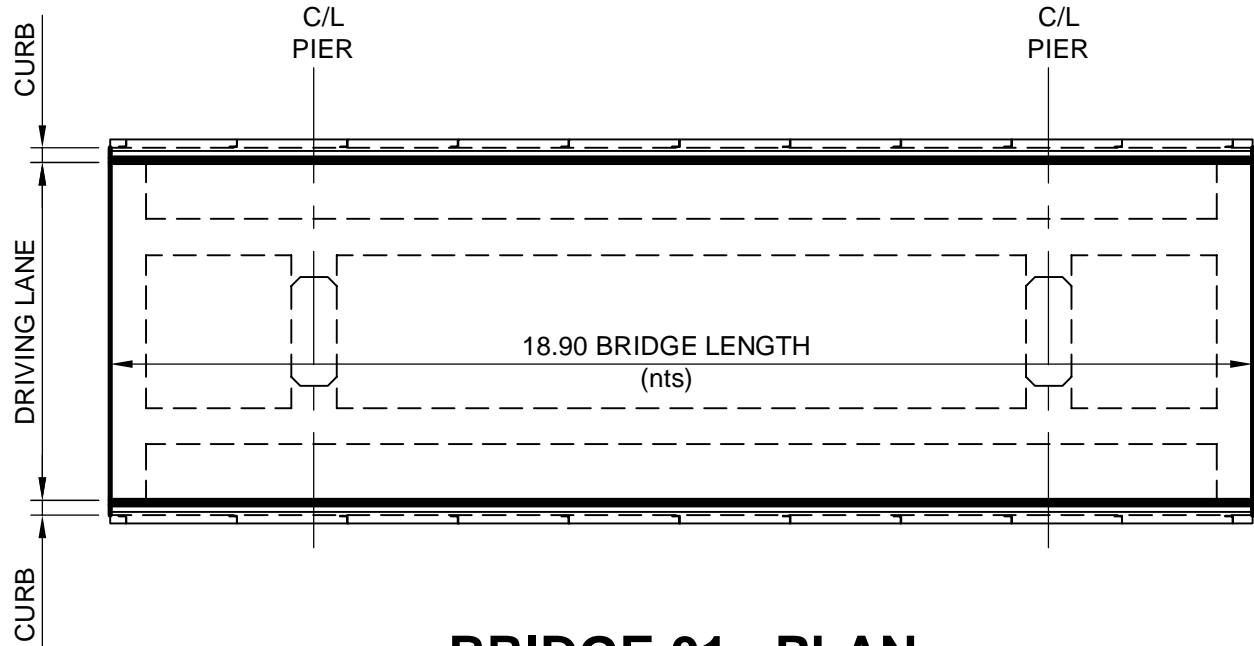
BRIDGE 01 - PLAN

Issue	Resolution	Approx. Cost
Very High (Resolve <1yr)			
High (Resolve <5yr)	Joints between end of bridge and approach roadway need to be re-sealed	Remove vegetation and dirt. Seal the joints.	\$1,500
	Crack and spall of interior deck underside near west longitudinal beam (about 3.0 m south of north column)	Remove spalled concrete. Clean and patch.	\$2,000
	Crack and spall of interior deck underside above south face of north column	Remove spalled concrete. Clean and patch.	\$2,000
	Minor decay – horizontal members of wooden railing	Check the railing condition (annually)	\$200
Medium (Resolve <10yr)

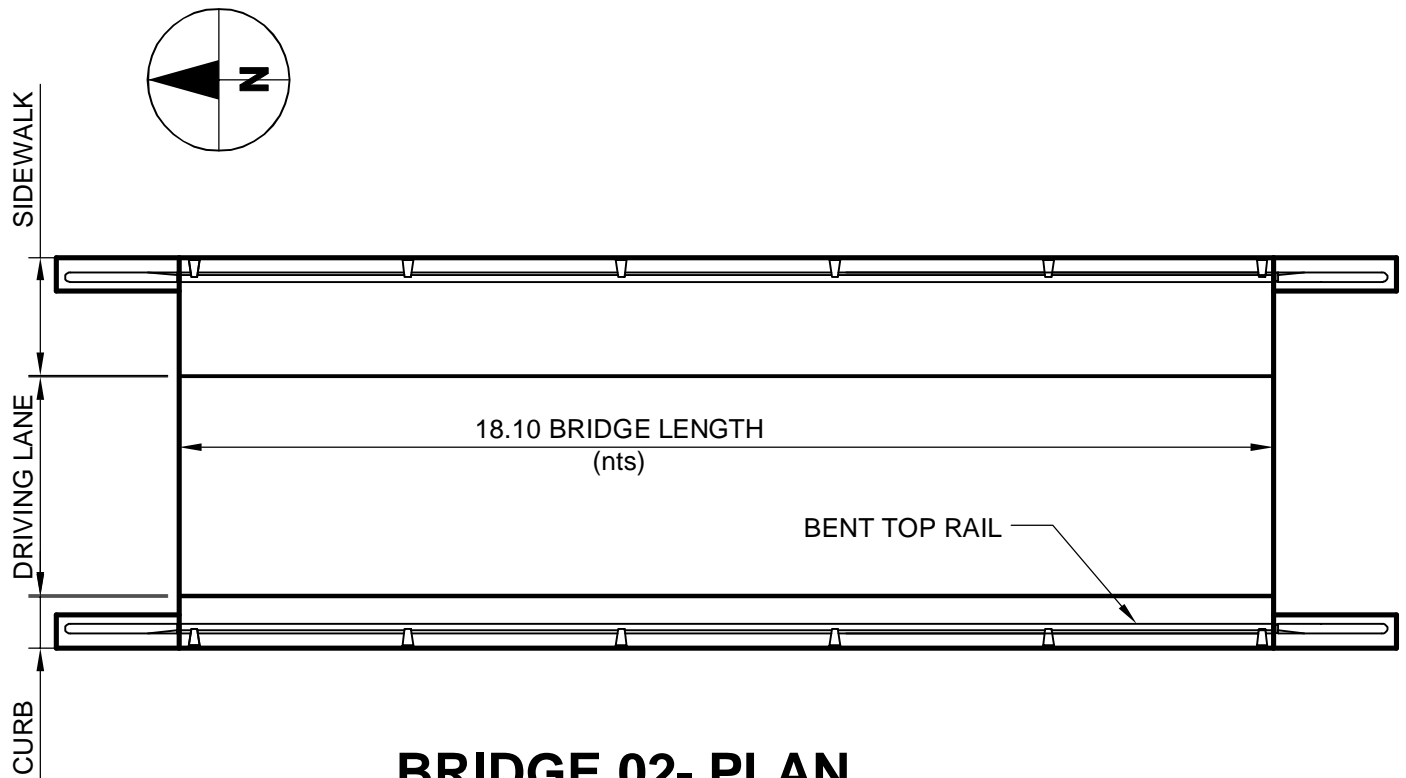
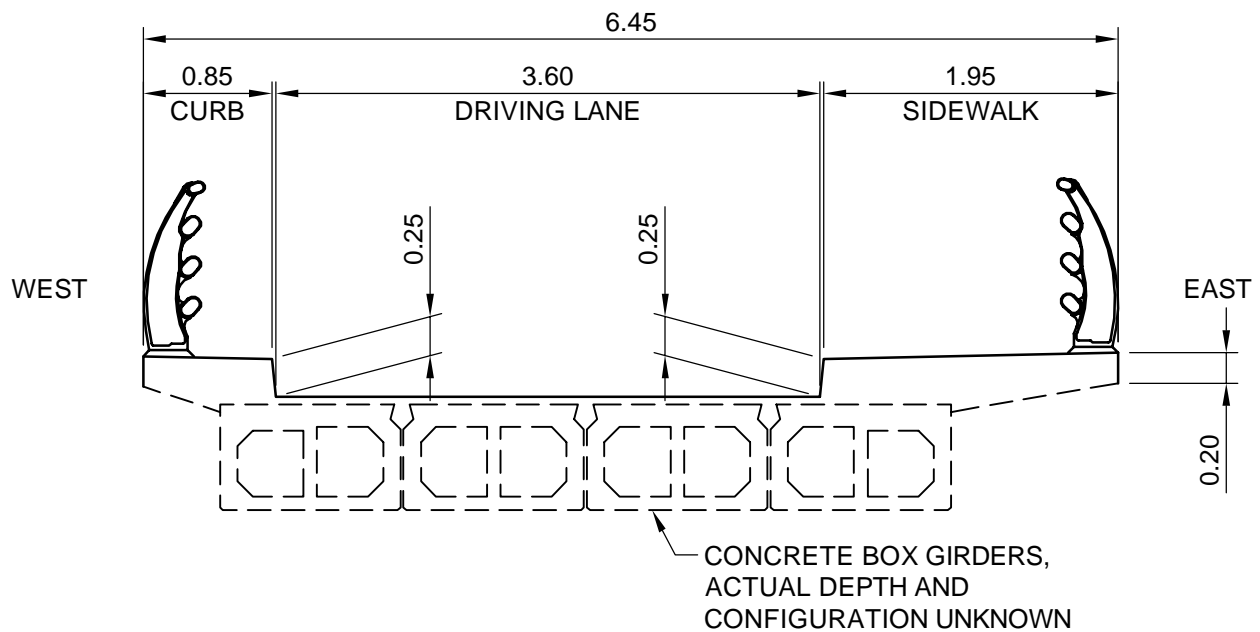
Issue	Resolution	Approx. Cost
Very High (Resolve <1yr)	Tripping hazard due to unevenness between bridge sidewalk and sidewalk approaches	Regrade (asphalt) sidewalk approaches	\$1,500
High (Resolve <5yr)	Vegetation growing into abutment seats (at both abutments) with potential of growing into girder underside longitudinal joints	Remove vegetation	\$1,000
	Vegetation overgrowing ends of bridge and barriers with potential of growing (or having its roots growing) into the joints between abutment and MSE wing-walls or between MSE wall facial panels	Remove vegetation	\$1,000
	Cracked approach pavement and broken edge of bridge deck near northwest corner	Seal the crack, patch, or remove (& rebuild) the cracked portion and its adjacent areas. Remove and patch the broken deck edge. Seal the joint	\$1,500
	Vegetation growing in joints both ends of deck	Remove vegetation and dirt. Seal the joints.	\$1,000

Medium (Resolve <10yr)	Series of transverse cracks (differential shrinkage cracks) on the sidewalk and curb undersides	Locate the cracks on the top of sidewalk and curb. Seal the cracks.	\$3,000

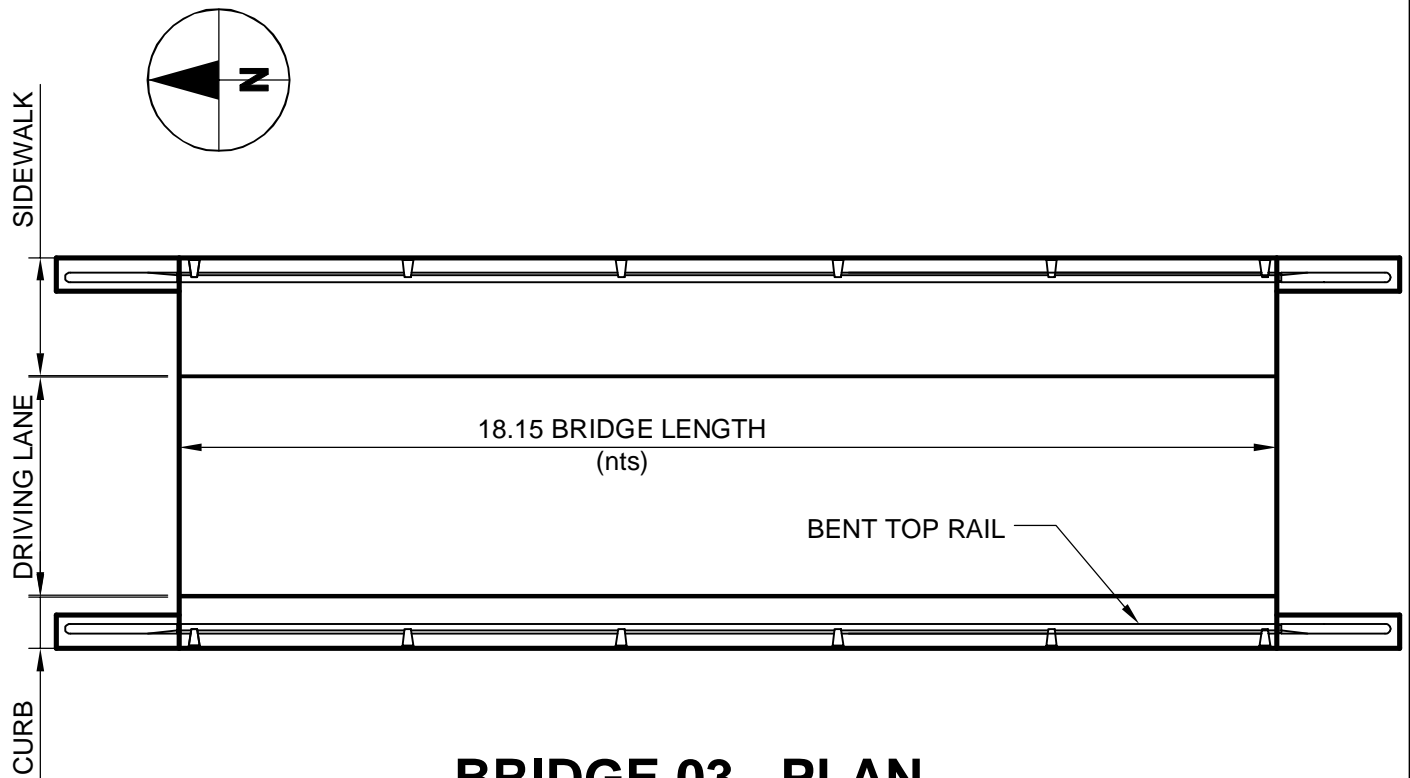
BRIDGE 03 - PLAN

Issue	Resolution	Approx. Cost
Very High (Resolve <1yr)	Tripping hazard due to unevenness between bridge sidewalk and sidewalk approaches	Regrade (asphalt) sidewalk approaches	\$1,500
High (Resolve <5yr)	Vegetation growing into abutment seats (at both abutments) with potential of growing into girder underside longitudinal joints	Remove vegetation	\$1,000
	Vegetation overgrowing ends of bridge and barriers with potential of growing (or having its roots growing) into the joints between abutment and MSE wing-walls or between MSE wall facial panels	Remove vegetation	\$1,000
	Cracked approach pavement near edge of bridge deck at northwest corner and southwest corner	Seal the crack, patch, or remove (& rebuild) the cracked portion and its adjacent areas. Remove and patch the broken deck edge. Seal the joint	\$3,000
	Vegetation growing in joints both ends of deck	Remove vegetation and dirt. Seal the joints.	\$1,000

Medium (Resolve <10yr)	Series of transverse cracks (differential shrinkage cracks) on the sidewalk and curb undersides	Locate the cracks on the top of sidewalk and curb. Seal the cracks.	\$3,000

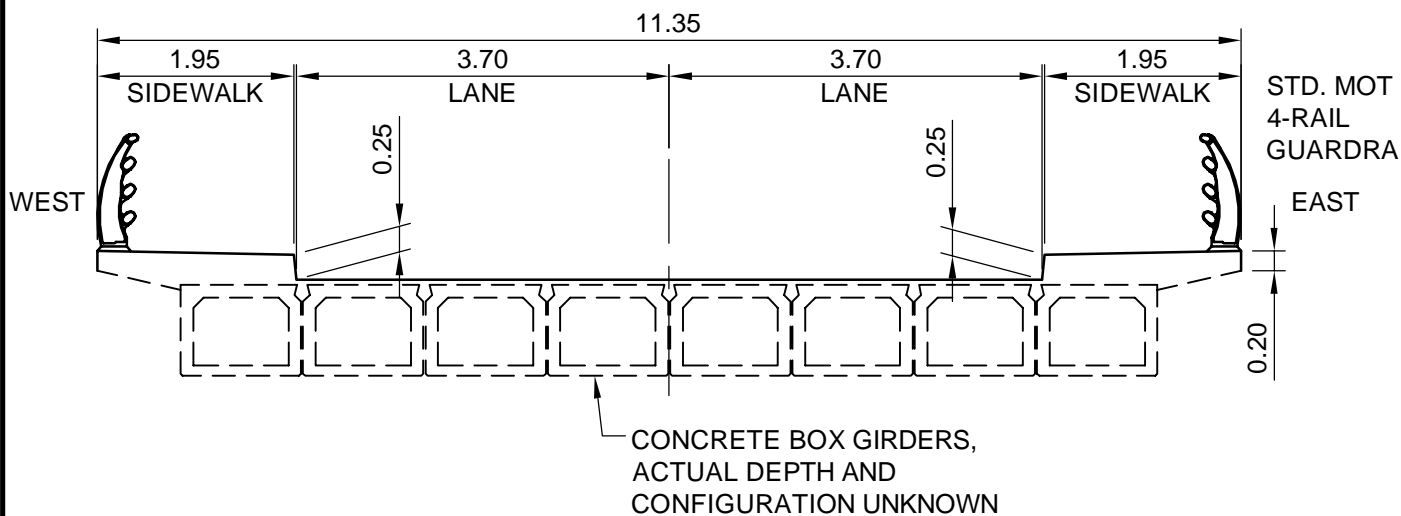
BRIDGE 04 - SECTION

FINE CRACK, LENGTH
OF BRIDGE.

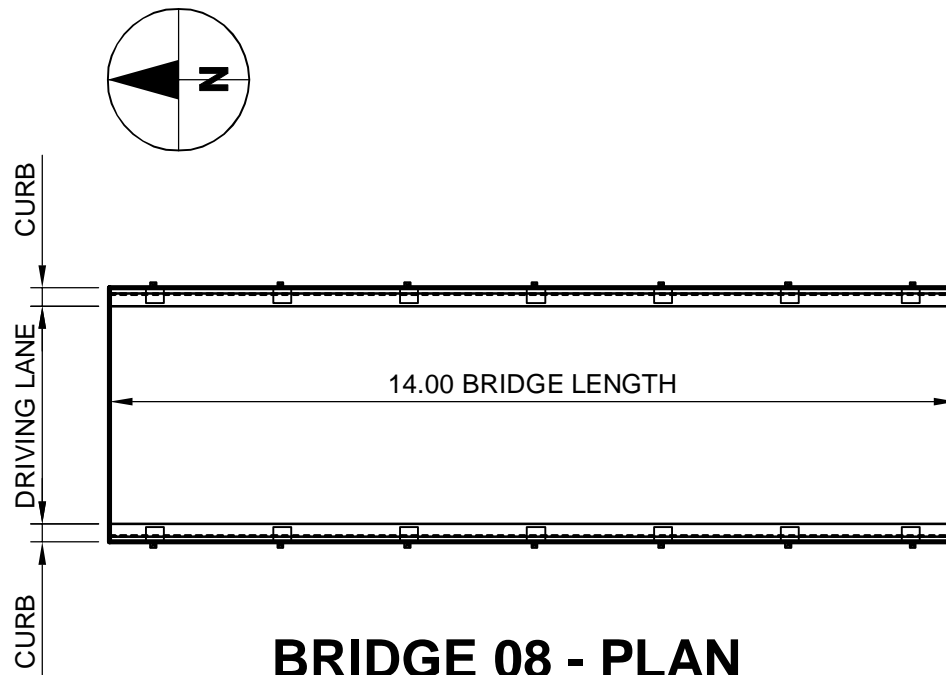
BRIDGE 08 - PLAN

Issue	Resolution	Approx. Cost
Very High (Resolve <1yr)	Vertical plank missing (west guardrail)	Install the missing plank	\$300
High (Resolve <5yr)	Vegetation encroaching (north end)	Remove vegetation	\$1,000
	Minor decay – timber curb north-west side	Check the railing condition (annually)	\$200
	Minor decay – horizontal members of wooden guardrail		
Medium (Resolve <10yr)	Allowance for complete replacement of curb and railing should the level of decaying warrant it.	Replace curbs and guardrails	\$8,000
