Village of Lions Bay

Water Storage Facilities Replacement

**Contract Documents
Issued for Tender**

**Volume 3 of 3
Appendices**

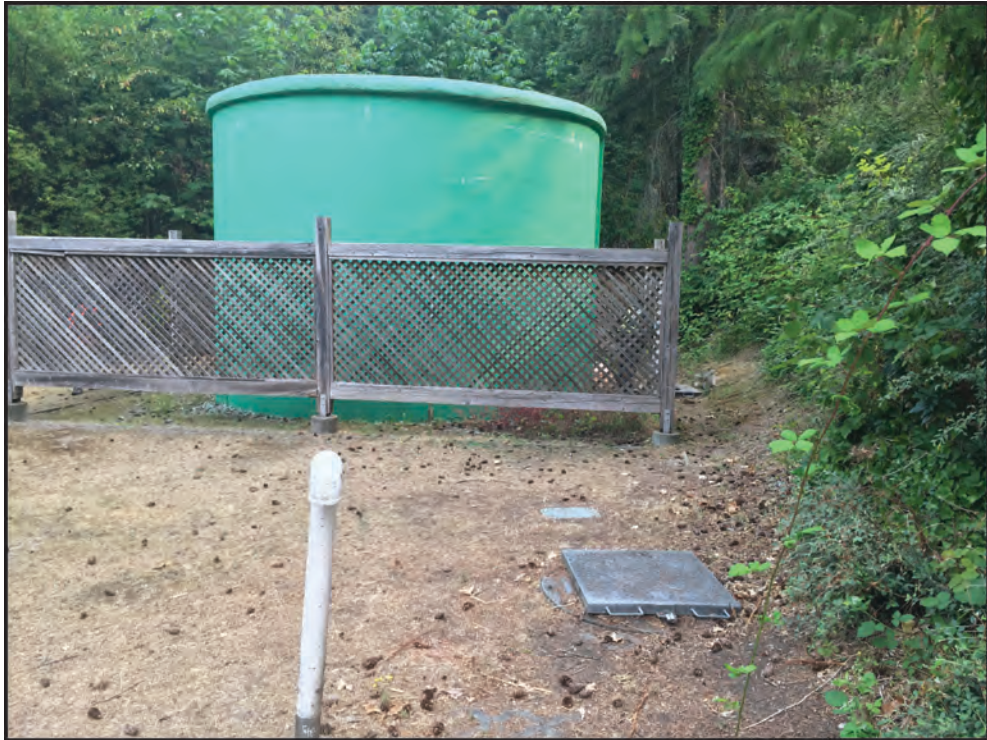
Figure 25: Highway Tank, facing north.

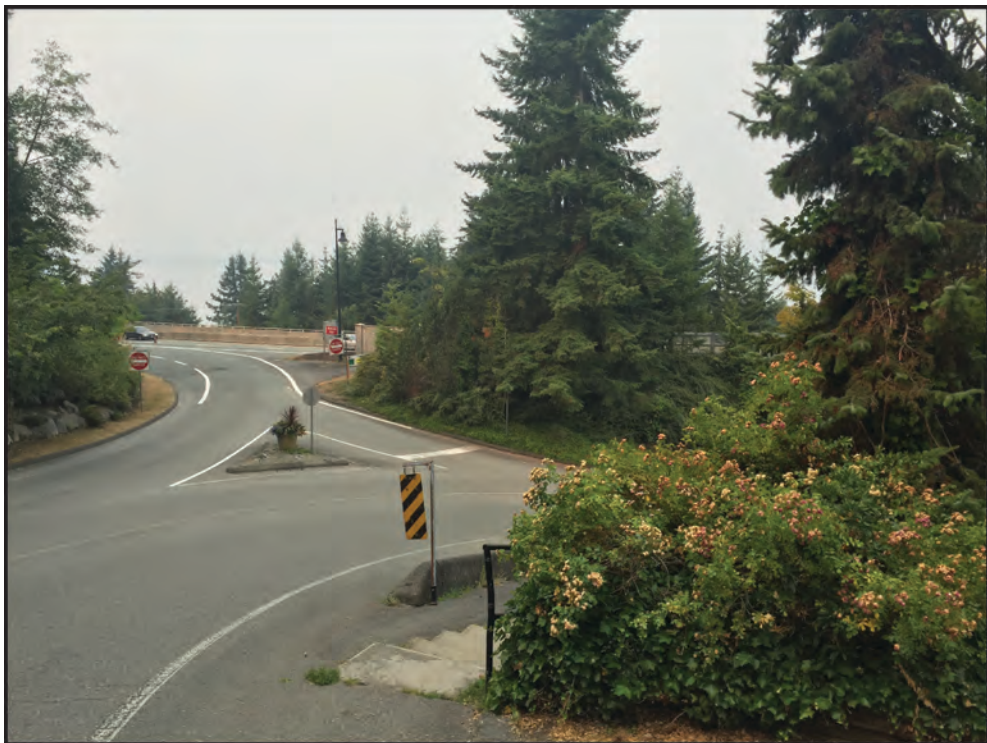
Figure 26: Looking out from the entrance to the Highway Tank location toward Highway 99, facing west.

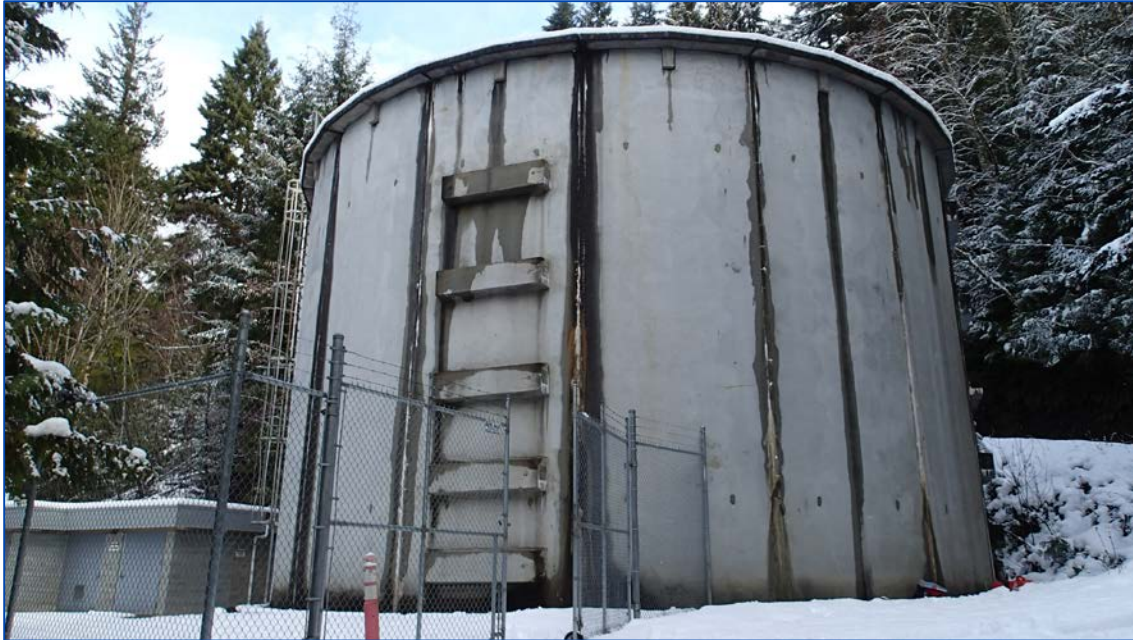
Photo1: General view of the Harvey Creek Reservoir.

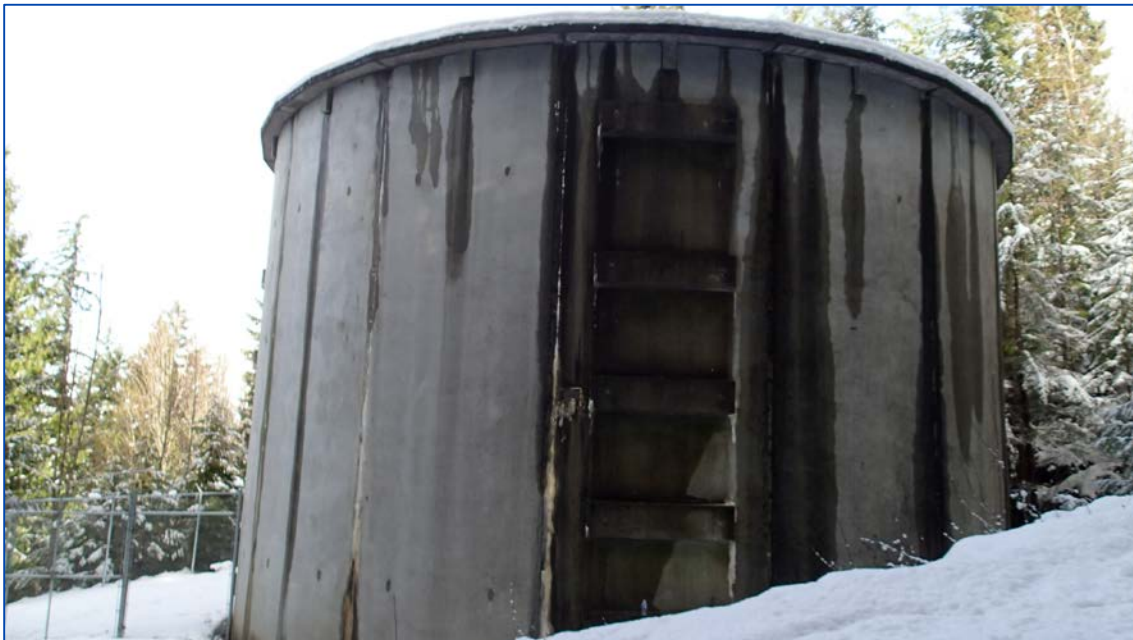
Photo 2: General view of the Harvey Creek Reservoir.

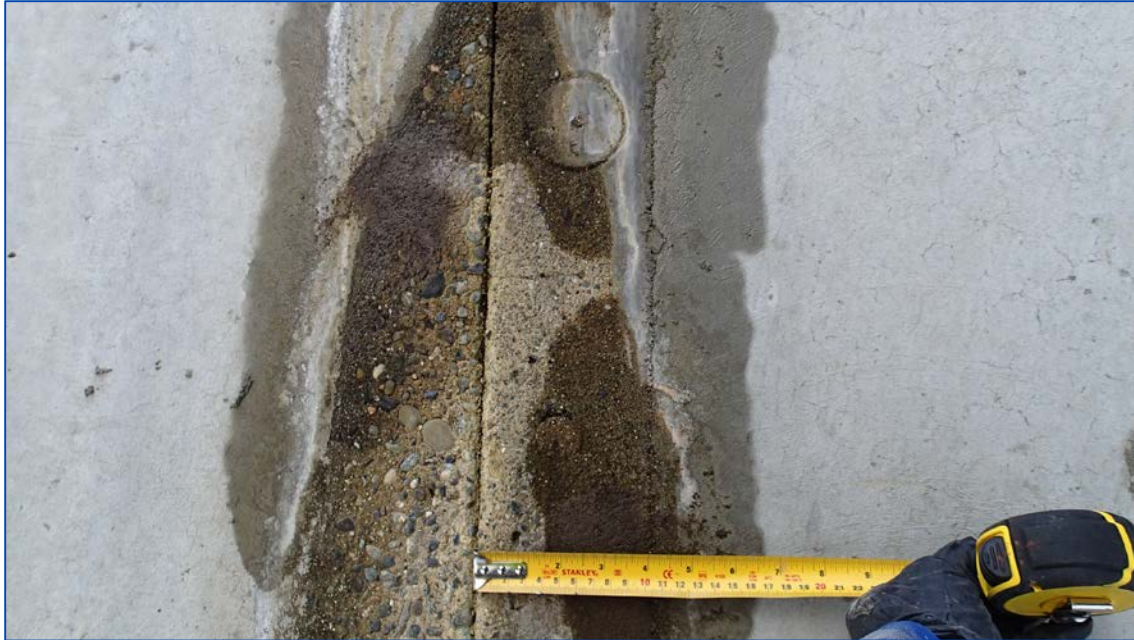
The wall of the reservoir comprises sixteen precast concrete panels. Each wall panel is joined together by approximately 100 mm wide infilled strip of concrete over its full height as part of the original construction, as shown in Photo 3. The wall is post-tensioned both in the vertical and circumferential directions.

Photo 3: Infilled concrete strip at the joint between the precast wall panels.

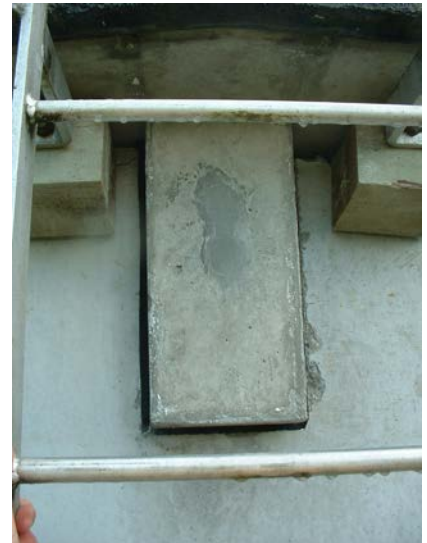
56. General view of concrete key locating roof concrete slab onto walls – NW side

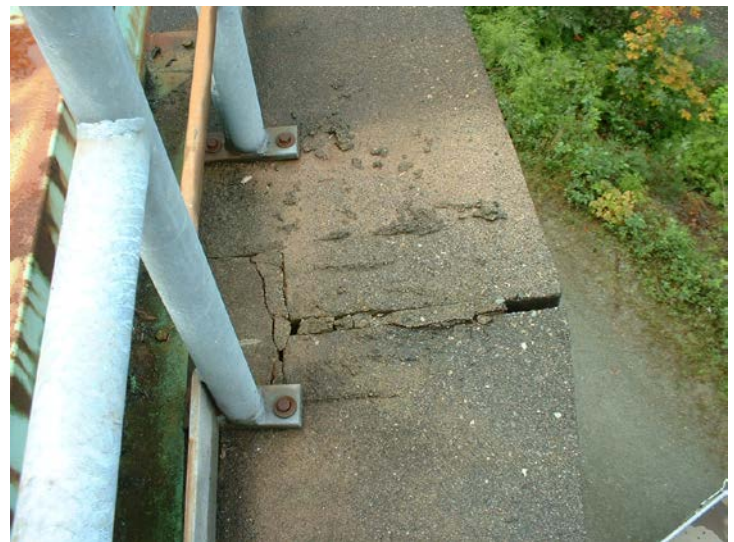
60. Joint between precast concrete roof panels at access hatch

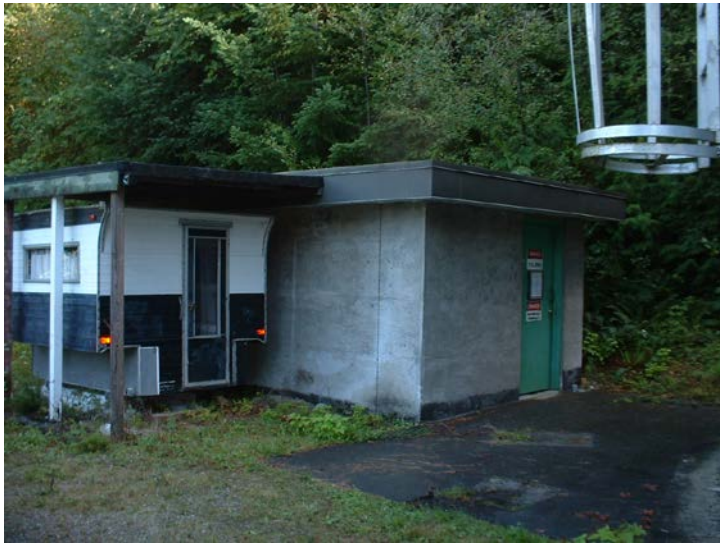
63. General view of chlorination building

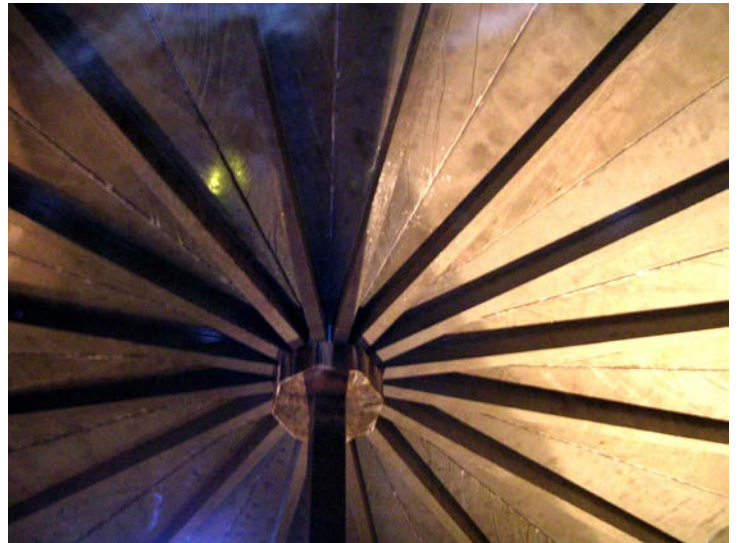
142. Underside of roof from inside of tank

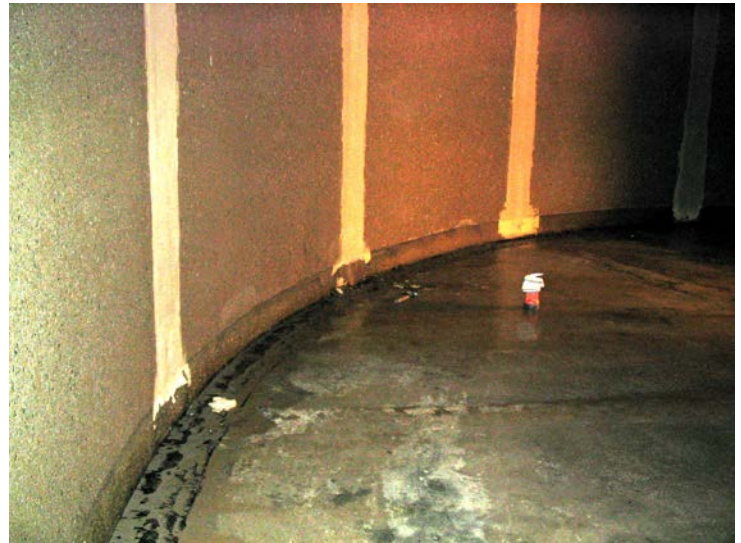
| Item | Location | Activity description | Qty | Unit | U | Make safe | Comments | Rep Photo | Mon freq |
|---|---|--|---|---|---|---|--|---|---|
| 2.3 | IS | Seal & repair crack | 50 | m | 1 | | New seal needed along circumference of tank at joint between wall and floor | 148-153 | |

148. Rubberized type of coating material used along joint between the wall and base slab

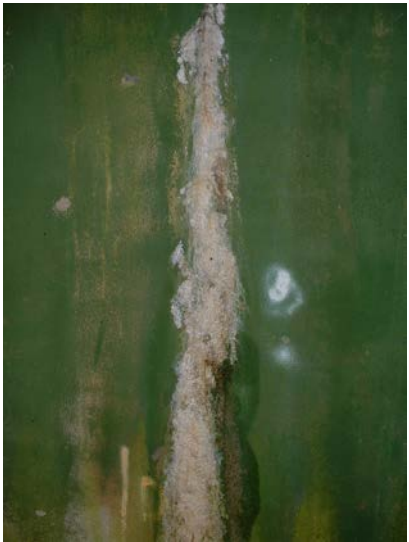
| Item | Location | Activity description | Qty | Unit | U | Make safe | Comments | Rep Photo | Mon freq |
|---|---|--|---|---|---|---|---|---|---|
| 1.1 | AS | Seal repair cracks | 35 | m | 3 | | Vertical – 25m; Horizontal – 11m | 37-39 | 3 yrs |

37. Efflorescence and corrosion stains at vertical crack

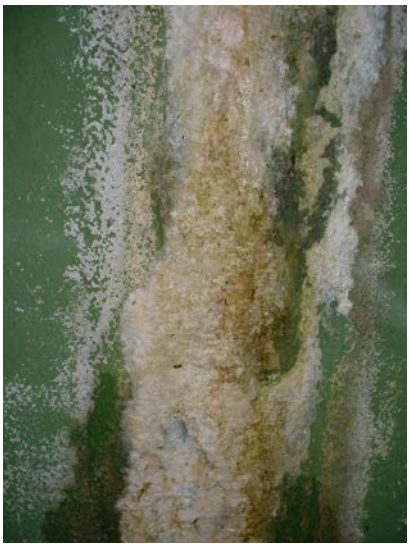
39. Efflorescence and corrosion staining at vertical crack

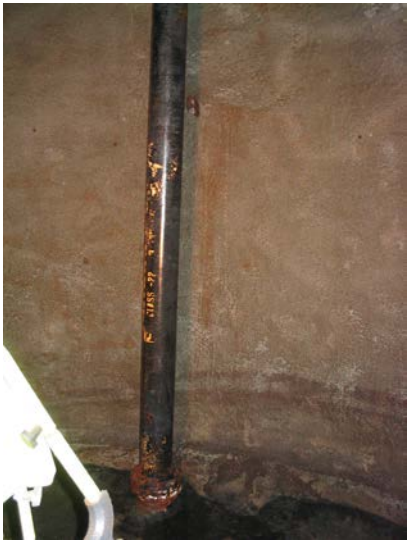
| Item | Location | Activity description | Qty | Unit | U | Make safe | Comments | Rep Photo | Mon freq |
|---|---|--|---|---|---|---|---|---|---|
| 3.5 | IS | Wire brush & Power tool - paint | 0.25 | m2 | 2 | | Corrosion evident on overflow pipe | 136 | |

136. Overflow pipe slightly corroded

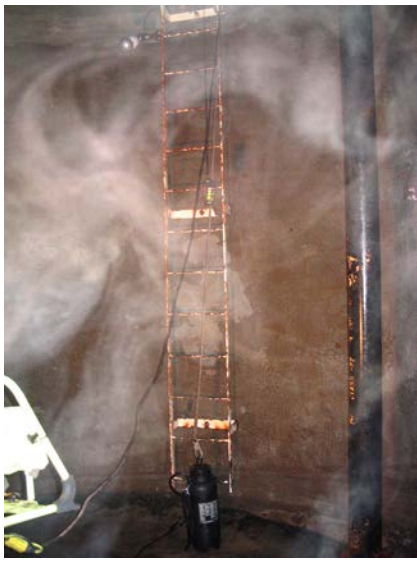
| Item | Location | Activity description | Qty | Unit | U | Make safe | Comments | Rep Photo | Mon freq |
|---|---|--|---|---|---|---|---|---|---|
| 3.13 | IS | Interior ladder - replace | 1 | No | 2 | | Ladder corroded, so should be replaced | 137,139 | |

137. Corroded interior ladder

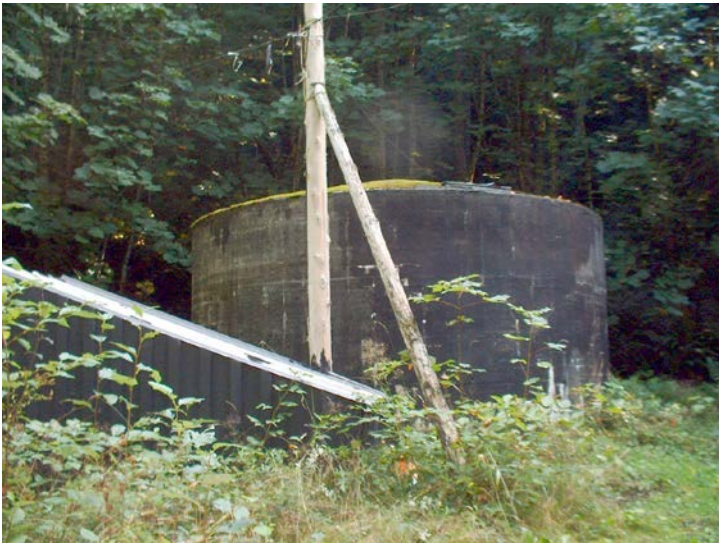
71. General view of tank

| Item | Location | Activity description | Qty | Unit | U | Make safe | Comments | Rep Photo | Mon freq |
|---|---|---|---|---|---|---|--|---|---|
| 1.12 | | Hydro poles - replace | 2 | No | R | | | 71 | |

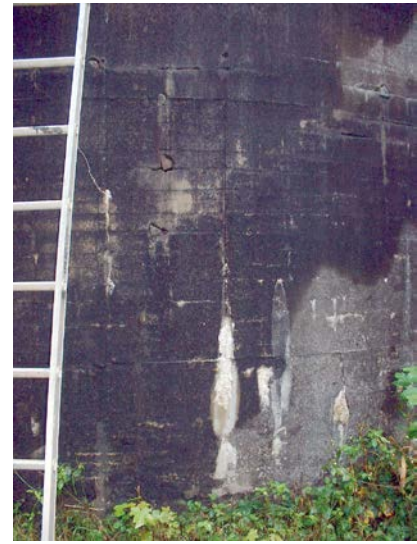
72. Vertical crack. Evidence of moisture and efflorescence

| Item | Location | Activity description | Qty | Unit | U | Make safe | Comments | Rep Photo | Mon freq |
|---|---|---|---|---|---|---|--|---|---|
| 1.1 | | Cracks - seal / repair | 4 | m | 3 | | Seal from inside with a protective and waterproofing slurry seal with glass fiber reinforcement from the inside of tank if possible (SikaTop Seal 107 or similar approved) | 72 | |

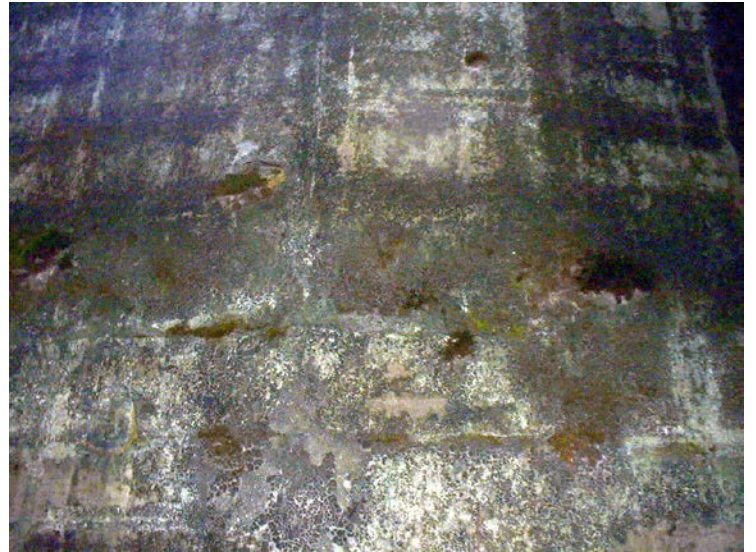
74. Algae growth on wall

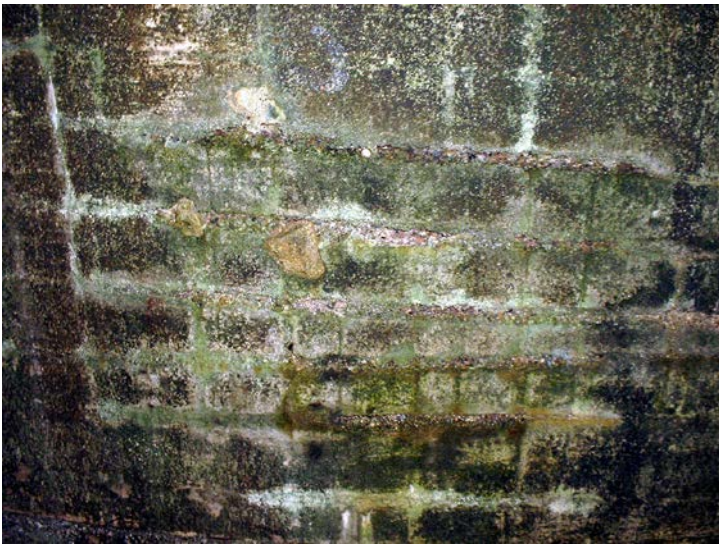
| Item | Location | Activity description | Qty | Unit | U | Make safe | Comments | Rep Photo | Mon freq |
|---|---|---|---|---|---|---|--|---|---|
| 1.1 | | Honeycombed concrete - repair | 0.05 | m3 | M | | Outer surface of wall has shallow honeycombing which is not affecting the tanks integrity | 73, 75 | 2yrs |

75. Honeycombed concrete along horizontal joints

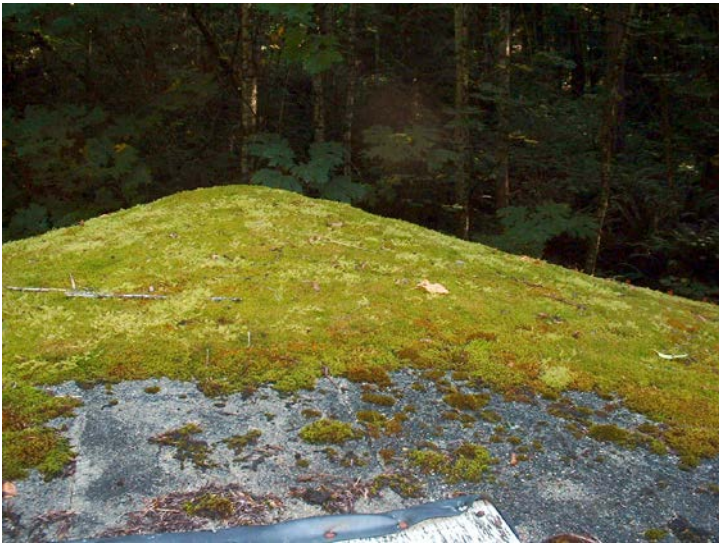
77. General photo of roof showing vegetation and algae

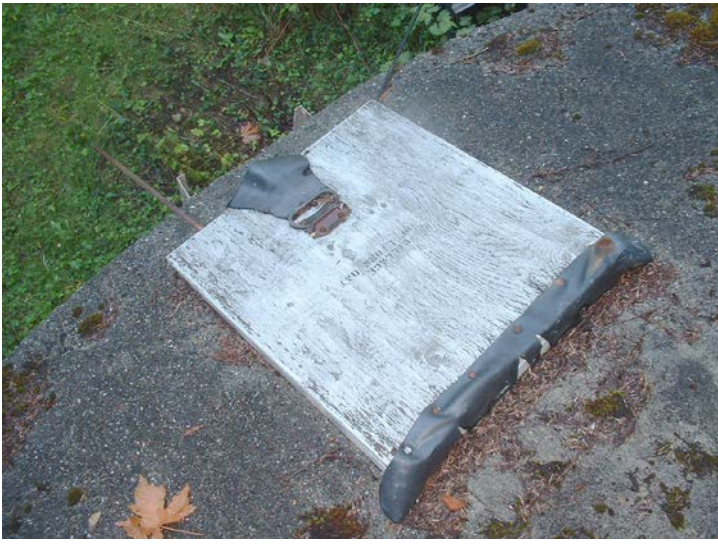
78. Roof access hatch

| Item | Location | Activity description | Qty | Unit | U | Make safe | Comments | Rep Photo | Mon freq |
|---|---|---|---|---|---|---|--|---|---|
| 1.10 | | Hatch - replace | 1 | No | 2 | | | 78 | |

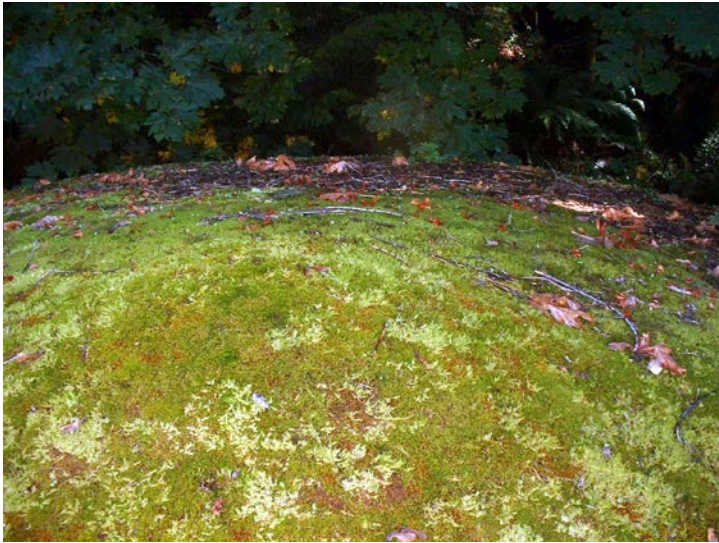
79. Vegetation and algae on roof

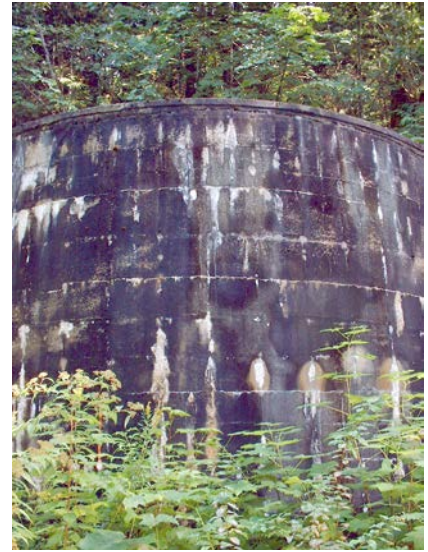
| Item | Location | Activity description | Qty | Unit | U | Make safe | Comments | Rep Photo | Mon freq |
|---|---|--|---|---|---|---|--|---|---|
| 1.1 | | Protective and water proofing slurry seal – apply to walls on inside of tank | 75 | m2 | 4 | | Many cracks are observed on the outer face of the tank wall. It is best to seal from the inside (SikaTop Seal 107 or similar approved) | 83, 92 | |

83. Vertical and transverse cracks

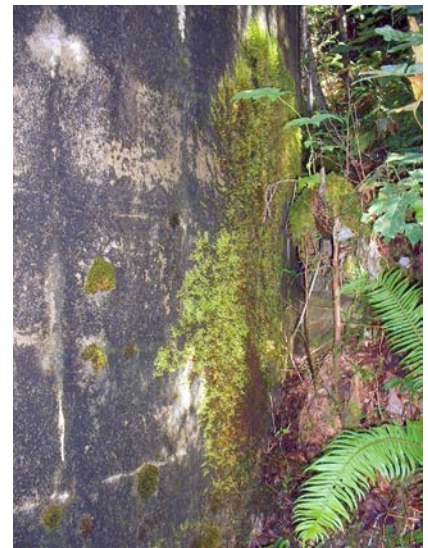
85. Algae growth on tank wall

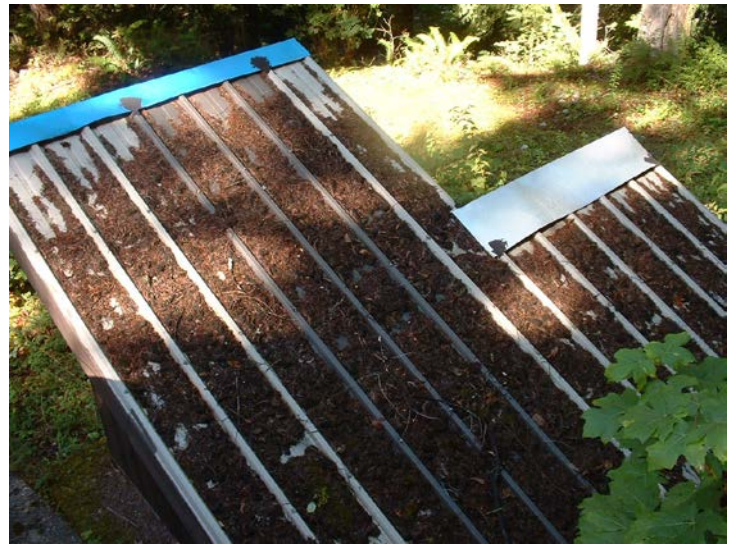
89. Debris on valve chamber roof

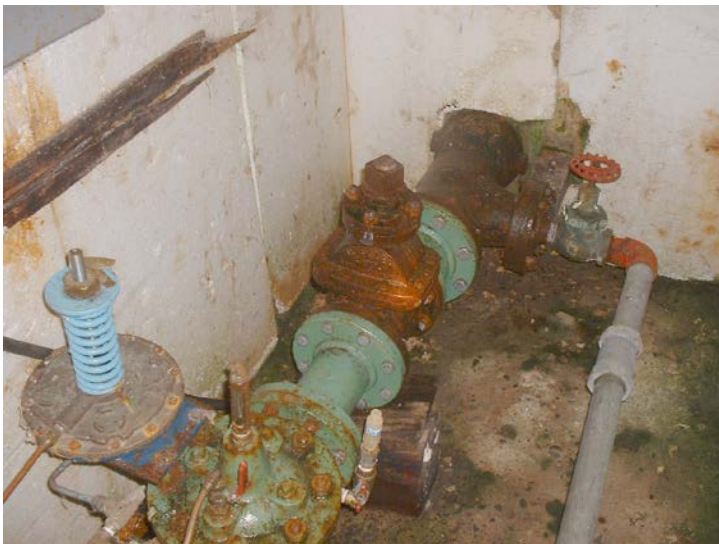
| Item | Location | Activity description | Qty | Unit | U | Make safe | Comments | Rep Photo | Mon freq |
|---|---|--|---|---|---|---|--|---|---|
| 3.3 | | Wire brush & Power tool - paint | 1 | m2 | R | | Corroded Inlet pipe in valve chamber | 90, 91 | |

90. View of inlet pipe

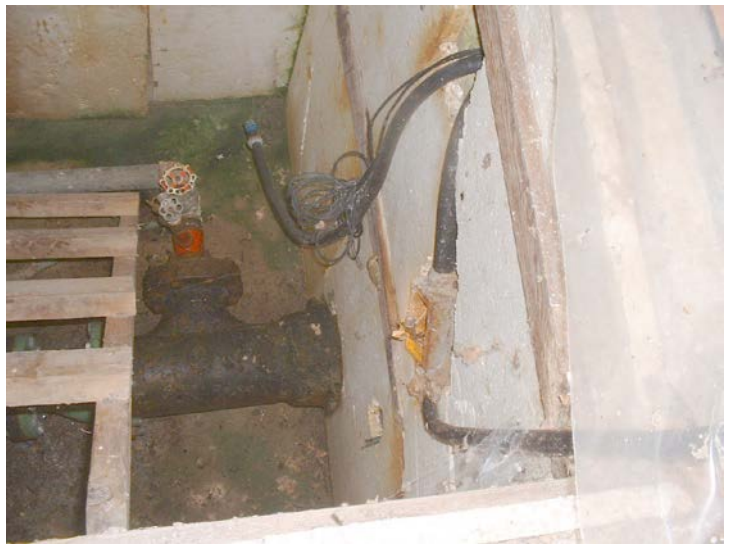
91. View of electrical box inside valve chamber

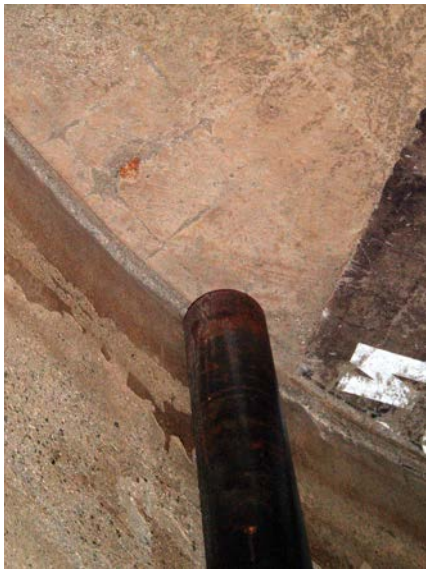
| Item | Location | Activity description | Qty | Unit | U | Make safe | Comments | Rep Photo | Mon freq |
|---|---|--|---|---|---|---|--|---|---|
| 3.3 | IS | Pipe bracket & Anchorage – install with stainless steel | 2 | No | 2 | | Overflow pipe anchorage inside the reservoir were taken out for concrete surface repair and have not been reinstated. | 167,168 | |

168. Missing anchorage at top of overflow pipe
