Village of Lions Bay

Harvey Tank Replacement Project

Contract Documents
Issued for Tender

Volume 3 of 3
Appendices

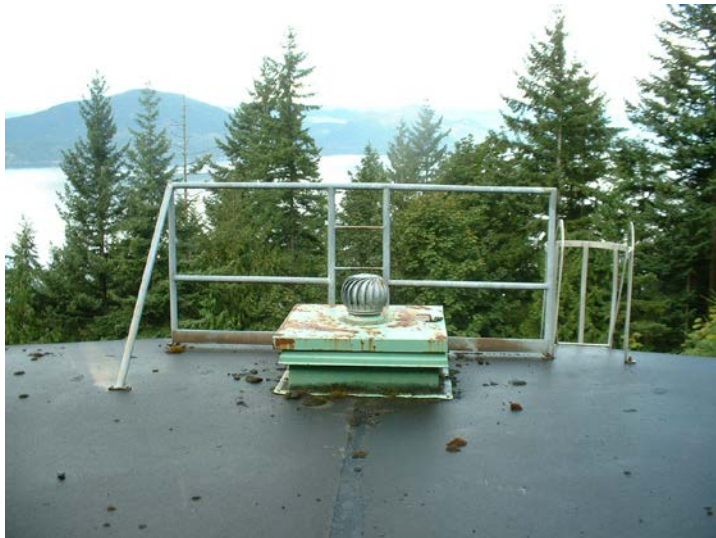
57. Roof hatch and vent

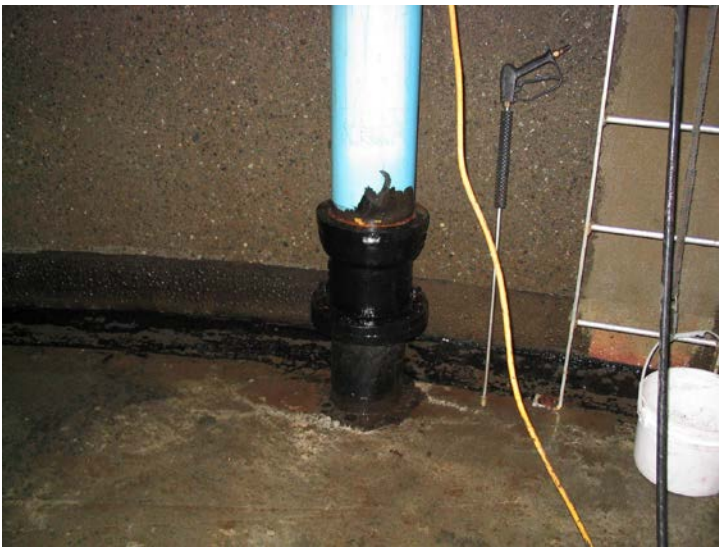
145. 200 pvc overflow pipe
