March 31, 2022

**RE:** Arborist Report #1 for tree at corner of Bayview Rd & Stewart Rd, Lions Bay

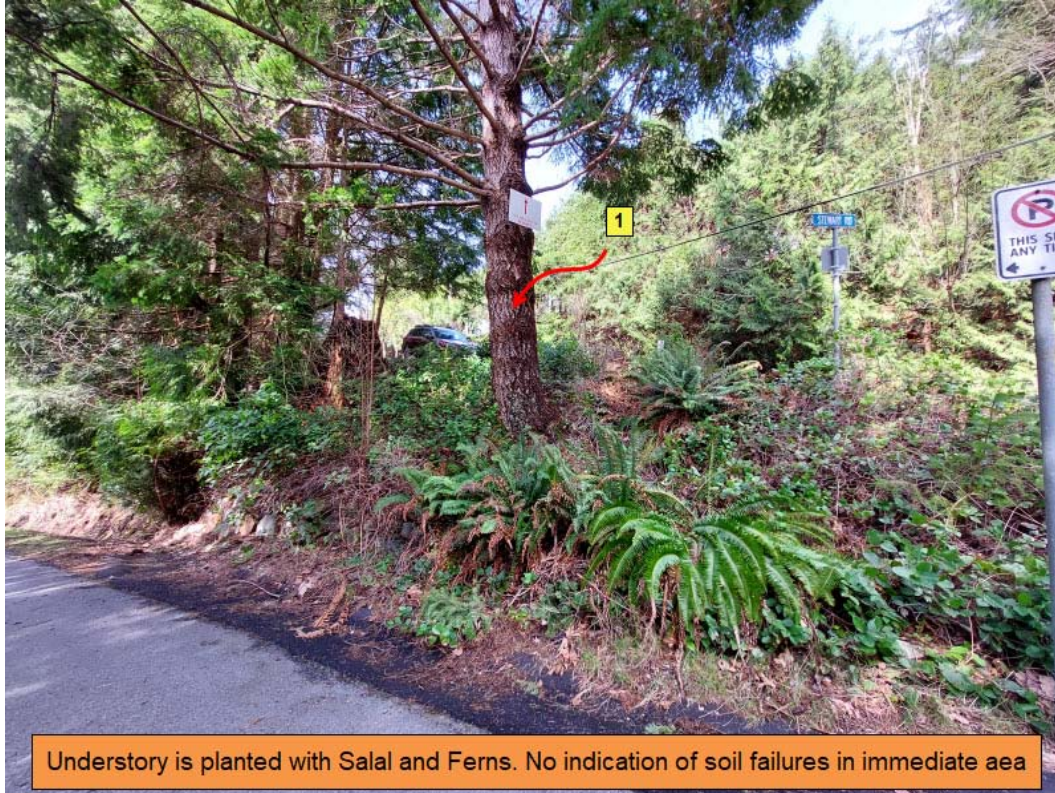
Picture 12. Tree #1 – native planting within understory

There were no significant grade or slope issues observed on the blvd where the tree is located. The understory near tree #1 is naturalized with a good population of Western Sword Ferns (*Polystichum munitum*) and Common Salal (*Gaultheria Shallon*). There appears to be no automated irrigation within the blvd however efforts have been made to redirect surface runoff from the roadway into the blvd landscape.
