THE MUNICIPALITY OF THE VILLAGE OF LIONS BAY

**INFRASTRUCTURE COMMITTEE MEETING  
OF THE VILLAGE OF LIONS BAY  
HELD ON THURSDAY, JANUARY 23, 2020 at 7:00 PM  
COUNCIL CHAMBERS, 400 CENTRE ROAD, LIONS BAY**

## 2.0 Open Channel Assessment

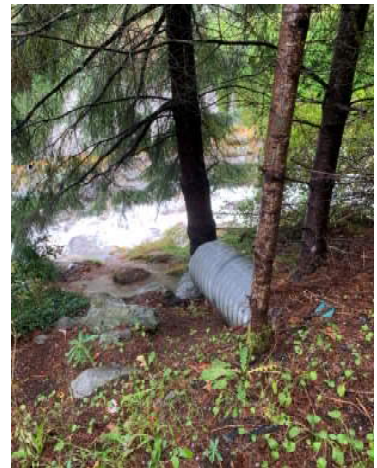
Outlet to Harvey Creek

Sta.	Culvert				Channel Cross section					Comments
	Dia. (mm)	Material	L (m)	S (%)	D (m)	W (m)	Side Slope (H:V)	S (%)	n	
1+375	-	-	-	-	0.3	0.4	1:0.8	15.3	0.05	Channel consisted of cobbles and vegetation, no presence of water
1+394	450	Corrugated Steel	5.0	13.2	-	-	-	-	-	Poor Condition, corroded bottom, outlet not visible due to vegetation cover, no presence of water
1+429	-	-	-	-	0.5	0.5	1:0.8	15.4	0.05	Channel consisted of cobbles and vegetation, no presence of water
1+465	525	Corrugated Steel	150	10.7						Inlet in poor Condition, corroded bottom, no presence of water
1+615	Outlet to Harvey Creek
