**BOARD OF VARIANCE MEETING  
OF THE VILLAGE OF LIONS BAY  
THURSDAY, MARCH 4<sup>TH</sup>, 2021 at 6:30 PM  
VIA ZOOM VIDEO CONFERENCE**

**Village of Lions Bay  
Board of Variance Application Form**

<b>LAND SUBJECT OF THE APPLICATION</b>	
Street Address: 105 Kelvin Grove way,	
Legal Description: Lot 53, Block 'B' District Lot 1575 Group One, New Westminster District Plan 18530	
Zoning: RS-1	
<b>OWNER/CONTACT INFORMATION</b>	
Full Name(s) of Property Owner(s): arya121holdings Ltd	
Full Name of Owner's Authorized Representative (if applicable): Hadi Khakpouri & Mohammad Dadashzadeh	
Address to Which Notices Should be Mailed: 407-837 west Hastings, Vancouver, V6C-1B6	
Daytime Phone # of Owner or Authorized Representative: 778-707-3391 604-913-6121	
Name of Person Who Will Represent Applicant at the Hearing: Hadi Khakpouri	
<b>TYPE OF APPLICATION (Complete Applicable Section)</b>	
<input checked="" type="checkbox"/>	A. VARIANCE OF BYLAW RESPECTING SITING, SIZE OR DIMENSION OF A BUILDING OR STRUCTURE [s.540(a)(i)]
Bylaw Name/Number & Section(s) from which relief is sought: zoning and development bylaw No.520/2017 zone Rs-1 siting

This document reports on the results of the site reco

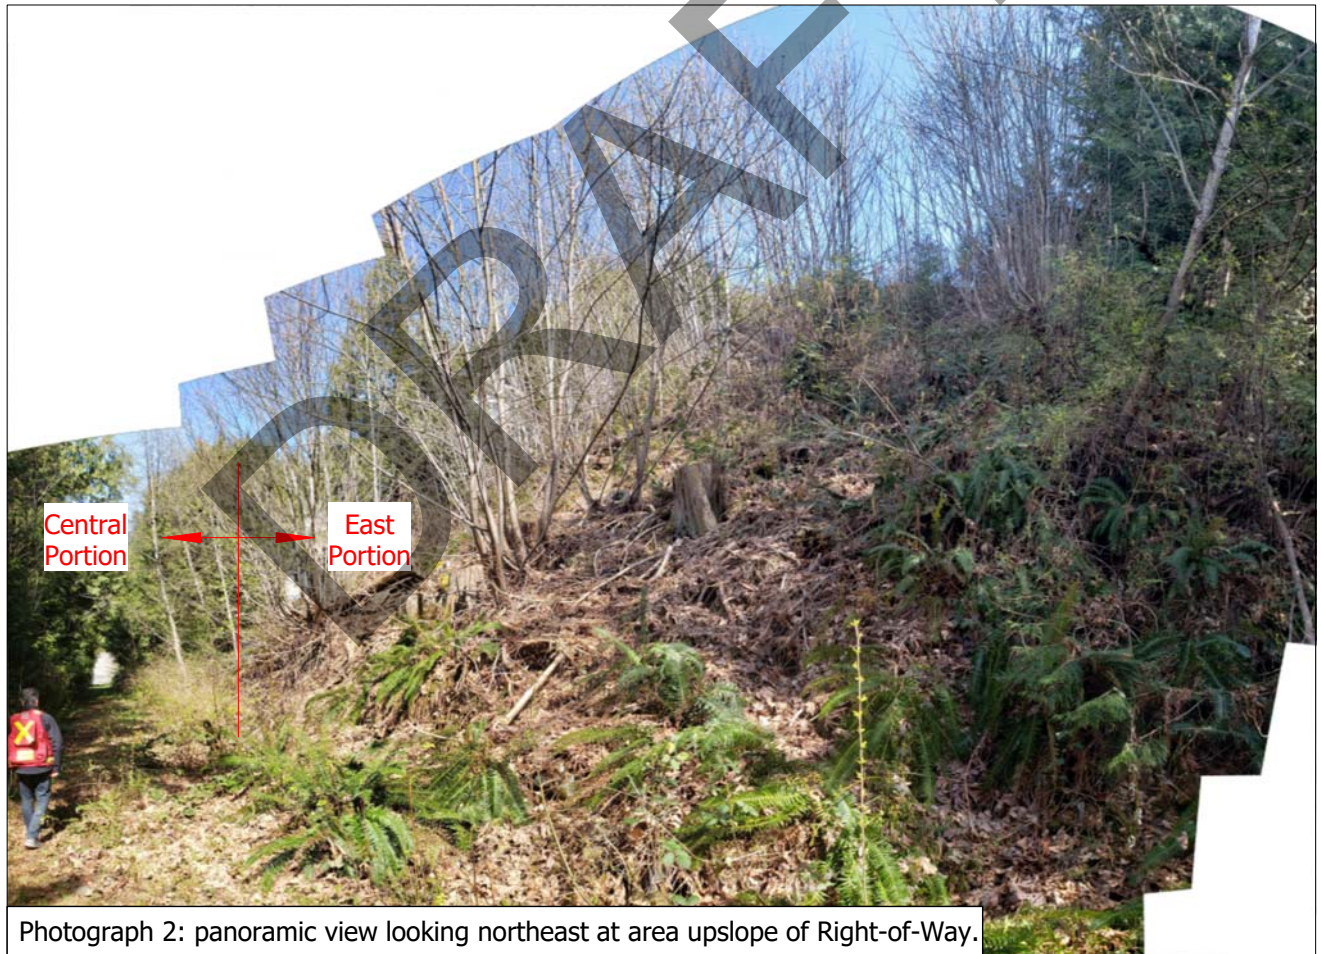
Photograph 2: panoramic view looking northeast at area upslope of Right-of-Way.

At the time of our 2020 site visit, the coniferous trees were removed from most of this mid to upper elevation slope area as shown in Photograph 2 and Photograph 3 on Figure 4, attached. The conifers that remain along the north and south edges of this portion of the site appear to have vertical growth. With an exception of potential isolated rockfalls, no obvious indicator signs of recent or past, slow or rapid, mass movement was noted at the sloping terrain and within the subject property. More specifically, no landslide scarps, debris deposition lobes, tension or settlement cracks, jackstrawed or pistol butted coniferous trees, or other indicator signs of landslide activity were noted. It should be understood that leaning and/or pistol butted deciduous trees observed in the local and general vicinity of the site are not considered reliable slope stability indicator signs.

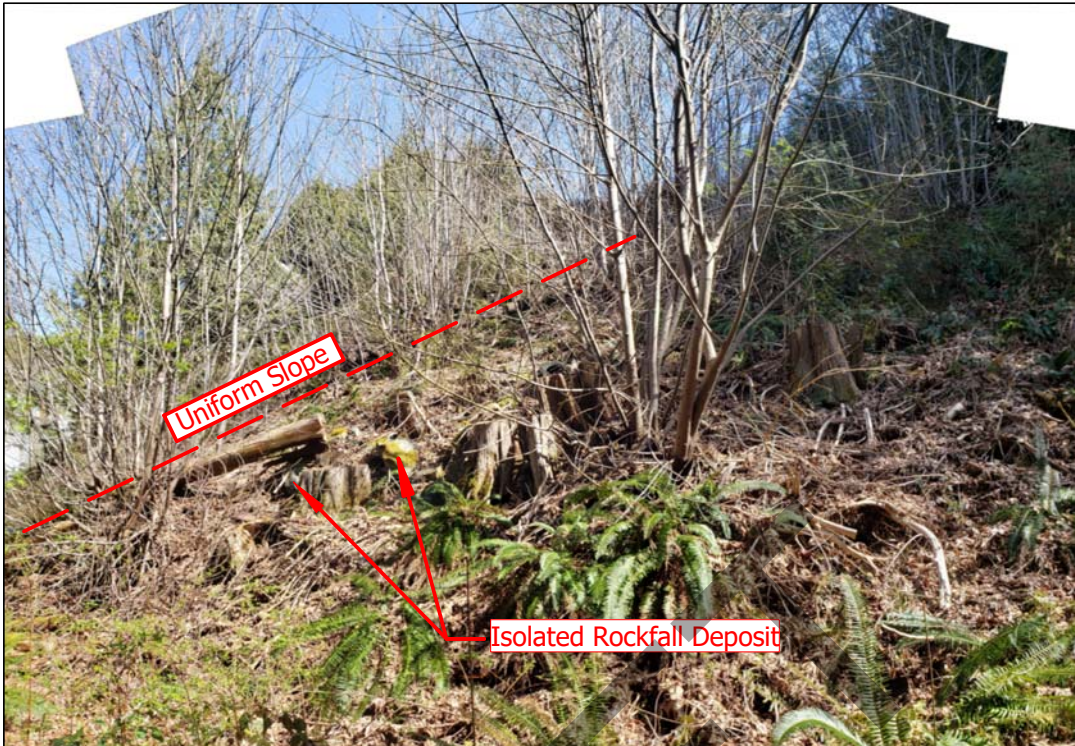
Photograph 3: panoramic view of vegetation covered slope at east portion of site.

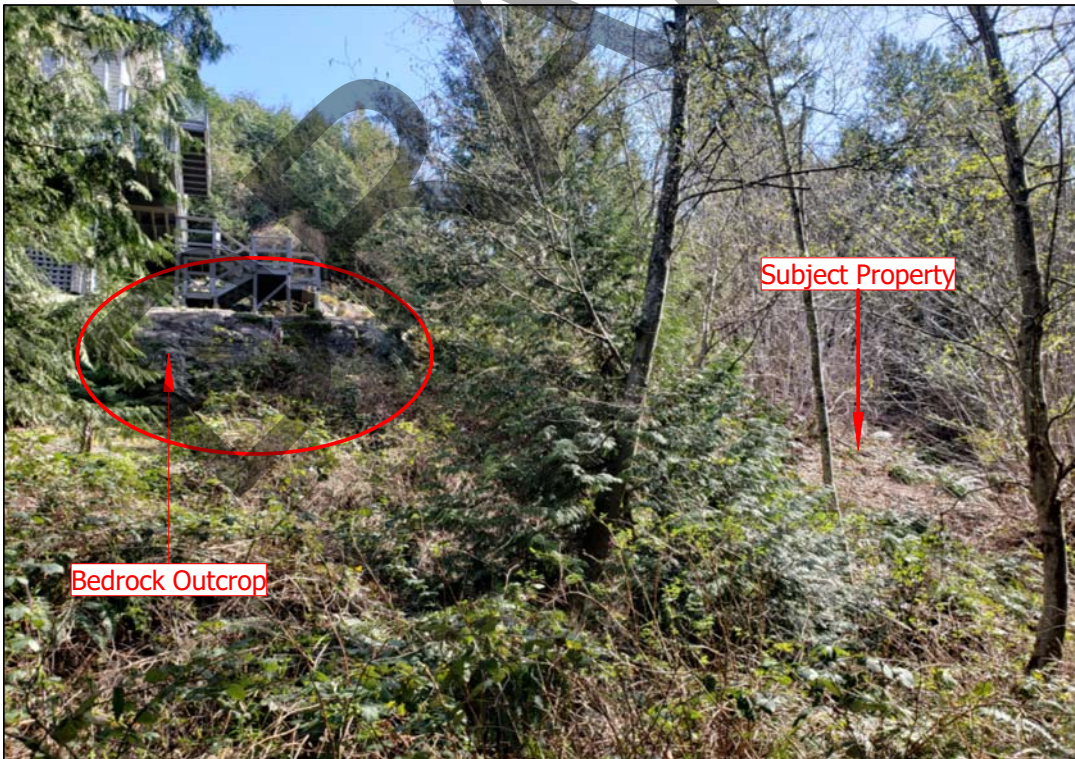
Photograph 4: bedrock outcrop at mid-slope elevation in north neighbouring property.

Although bedrock outcrops within the subject property were obscured by the overlying colluvium and organic matter, there were bedrock outcrops located at approximately mid-slope elevation in the neighbouring property to the north as shown in Photograph 4 on Figure 4 and at the east side of Kelvin Grove Way as shown in Photograph 5 on Figure 5, attached. These bedrock outcrops would be expected to be representative of bedrock conditions within the subject property. The exposed bedrock material was consistent with the published information from the Geological Survey of Canada. The intact bedrock was estimated to be strong to very strong.

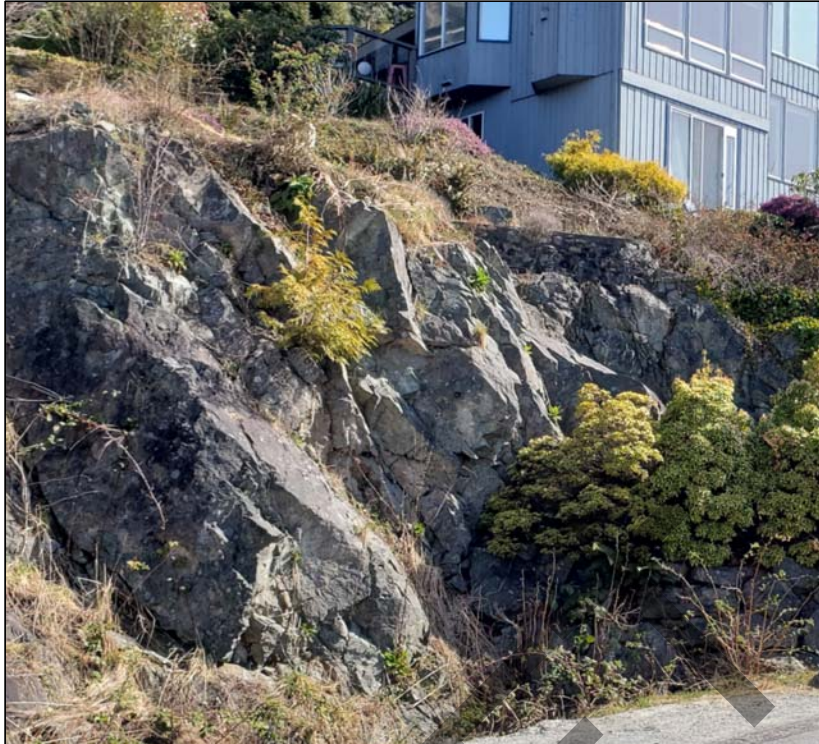
Photograph 6: closer view of exposed bedrock discontinuities.

It was noted that the bedrock had an approximately blocky fracture pattern and the discontinuities were attributed to joints and fractures in the rock mass. A number of the discontinuities including a dominant joint set are highlighted in Photograph 5. This dominant joint set dips steeply down towards the west and forms potential planar failure surfaces in the rock mass as shown in Photograph 5 and Photograph 6 on Figure 6, attached. It is estimated that potential wedge type failures are also kinematically permissible. The joints were estimated to be persistent with spacing that varied from close to wide. Joint apertures were estimated to vary from closed to open and there was evidence of past water flow at some of the gapped to open joints. No infilling was noted in the rock mass joints.

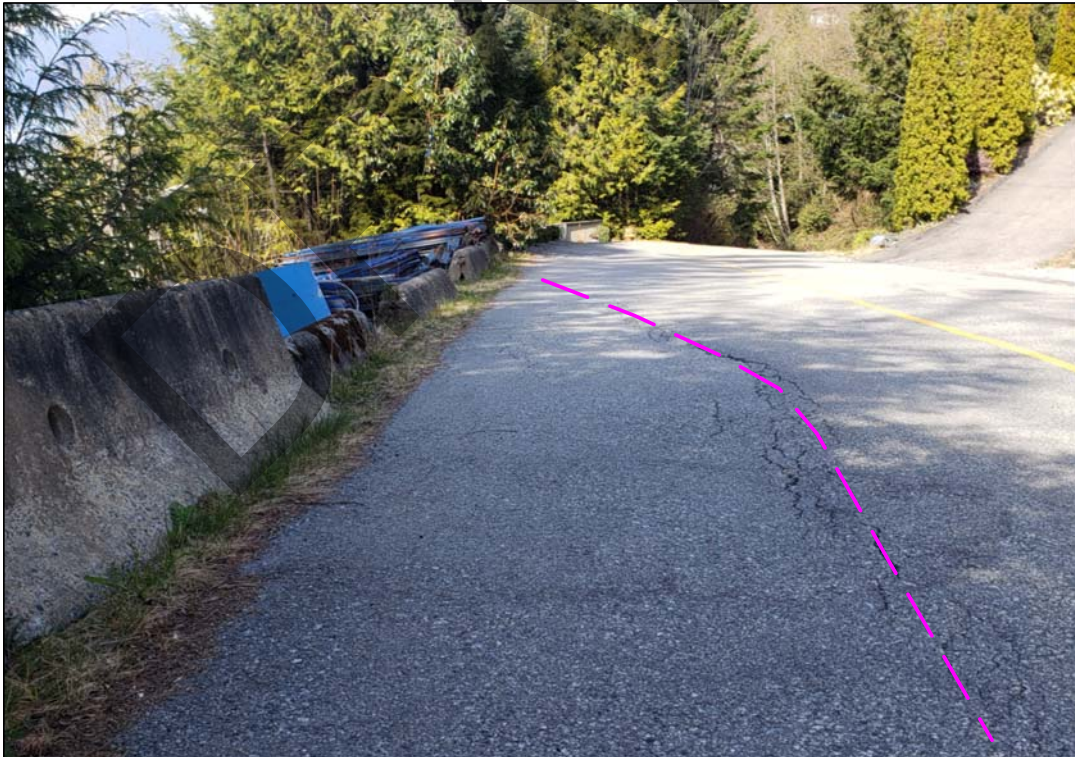
Photograph 7: view looking north showing cracked pavement beside slope crest.

As shown in Photograph 5 and Photograph 7 on Figure 6, the pavement along Kelvin Grove Way has significant cracks. These pavement cracks were generally estimated to be associated with differential performance of subgrade materials in underground utility trenches that follow the road alignment. However, it was noted that there were also cracks in the pavement surface that coincided with the slope crest area adjacent to the subject property as highlighted in Photographs 5 and 7. More specifically, these specific pavement cracks appeared to form a broad arc in plan that terminated at the approximate north and south ends of the sloping terrain at the subject property. Although these cracks in the pavement are present at local areas adjacent to the slope crest, it should be emphasized that the cracks did not have significant vertical or horizontal ground displacement which would be an indicator sign of active ground displacement and soil movement. It was estimated that these cracks may be attributed to localized settlement or small displacements that have occurred in the fill materials forming the road prism and likely a portion of the slope crest in the subject property.
