## Village of Lions Bay

Final Report

Bridge Inspection Program

June, 2018

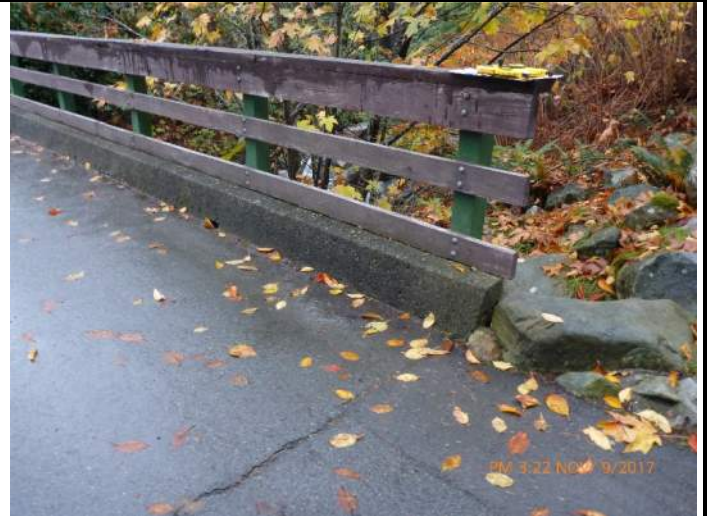
002 – Delamination area at SE corner of the deck

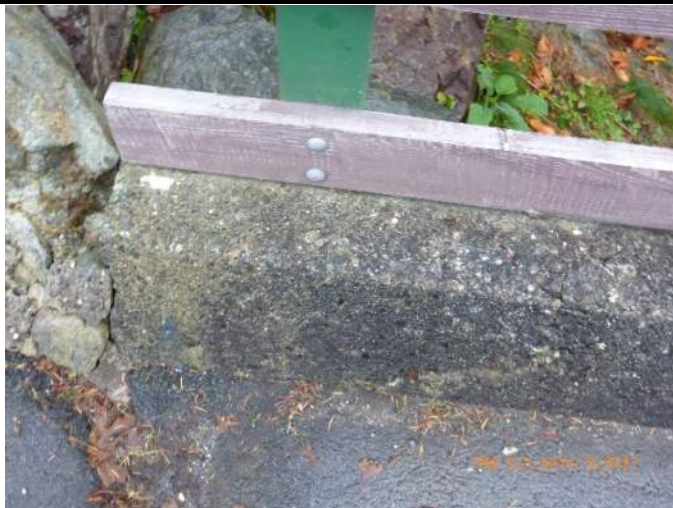
005 – 0.8m long delamination at North end of East side curb

- Repair delaminated NE end of the curb.

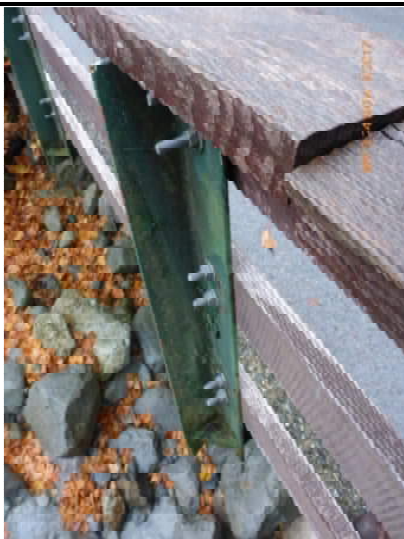
007 – Top rail misalignment; deformed post (5<sup>th</sup> from North on East side)

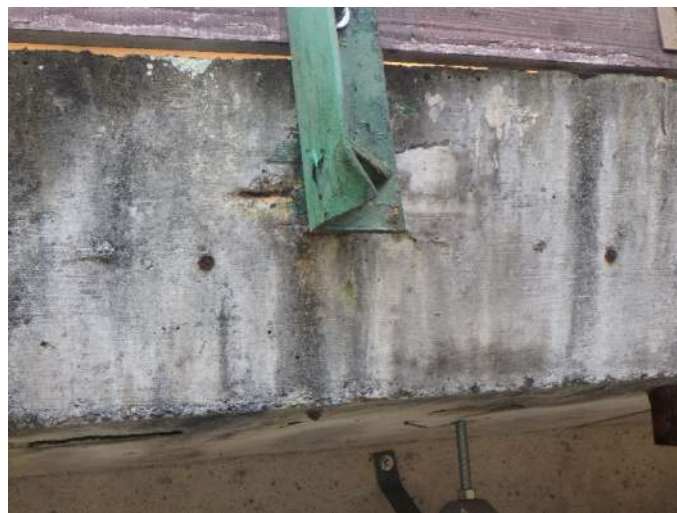
008 – Deformation at the bottom of the post (5<sup>th</sup> from North on East side)

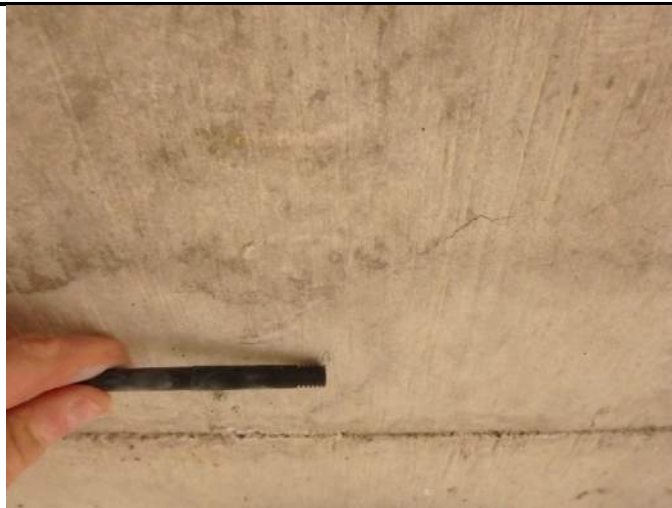
013 – Hairline cracks at soffit, typical

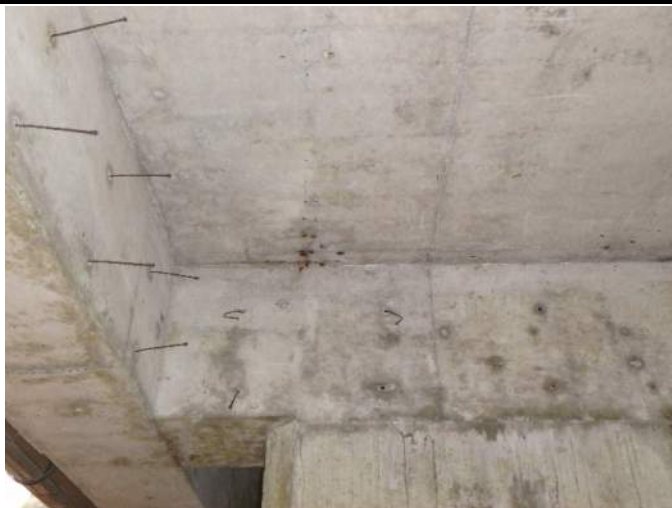
015 – Pier 1, typical delaminations at Pier to Soffit interface with rust staining.

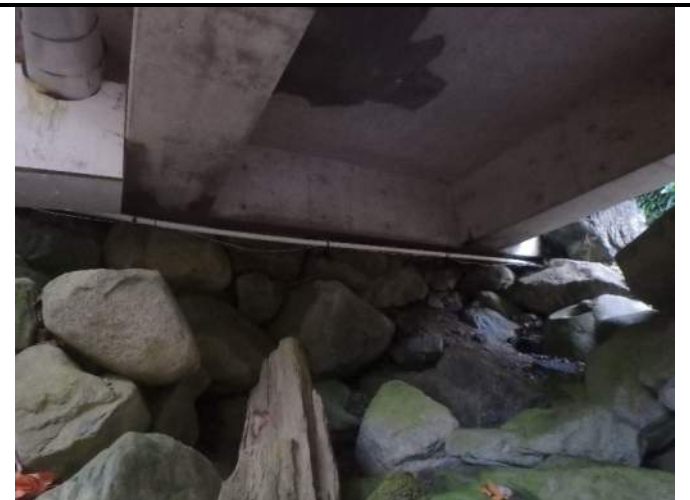
018 – Scour at North Abutment

- Recommend regrading embankments and installing suitable slope protection beneath bridge.

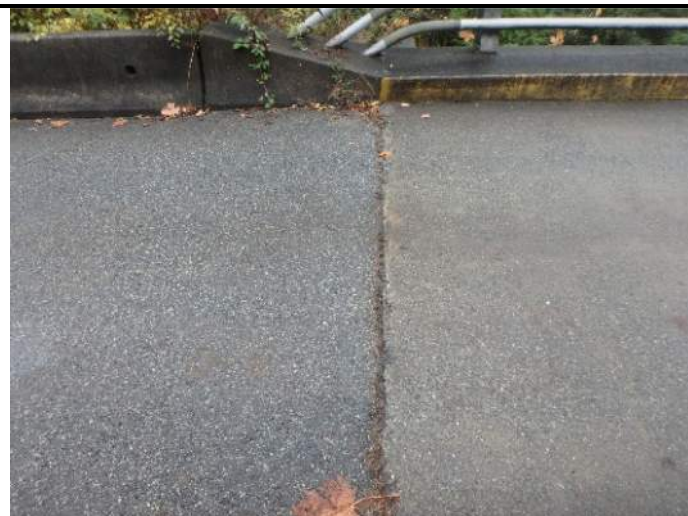
002 – Typical gap between deck and approach

- Clear vegetation and debris in gaps between deck and approaches, fill the gap to eliminate grade differential.

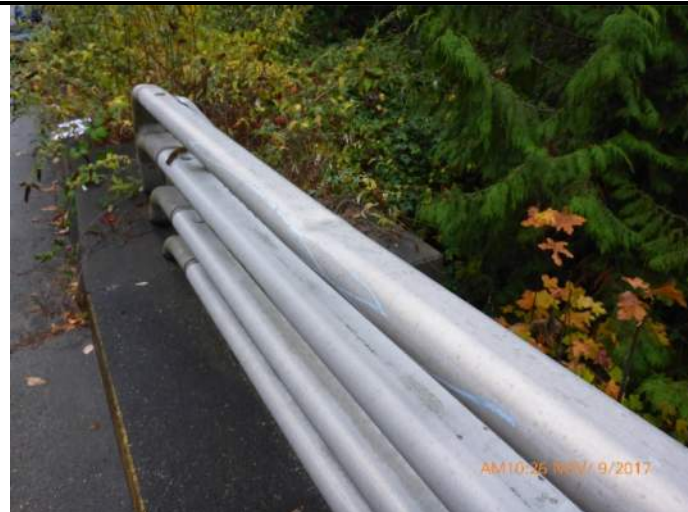
006 – Deformed rail on West side

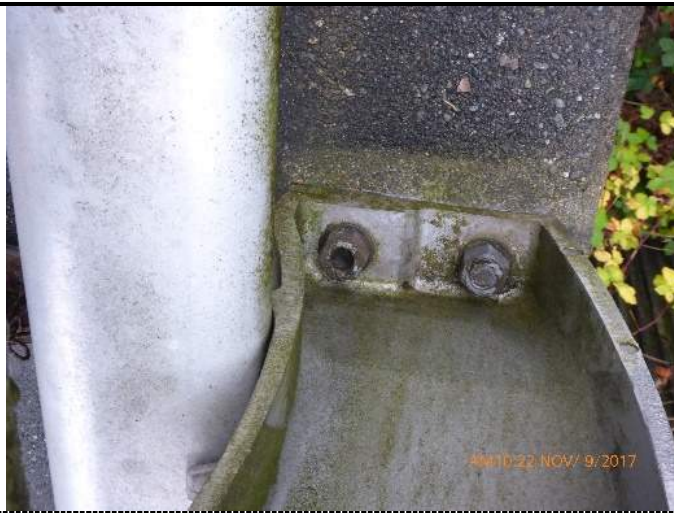
007 – Anchor bolts of insufficient length (2 locations)

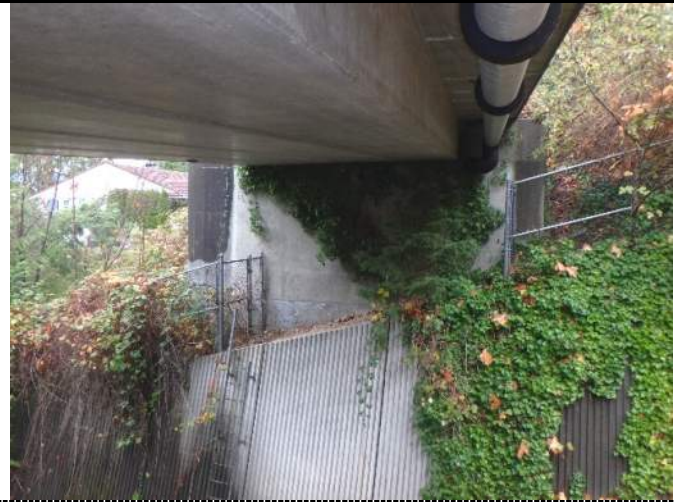
009 – North Abutment. Note vegetation growth.

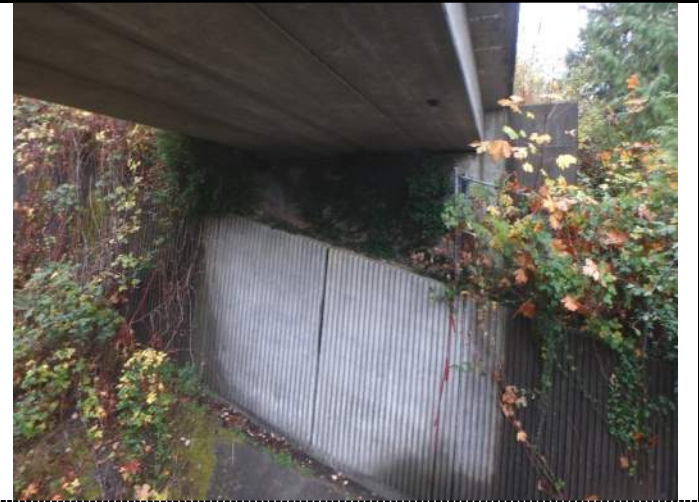
010 – South Abutment. Note vegetation growth.

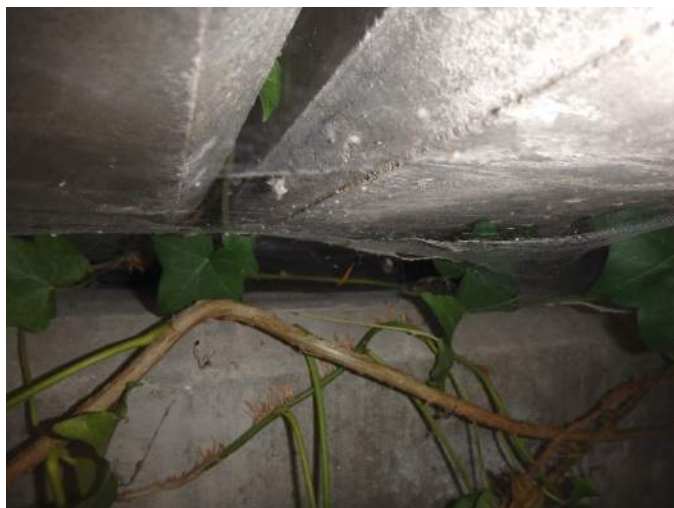
011 – Vegetation is growing between girders and abutments

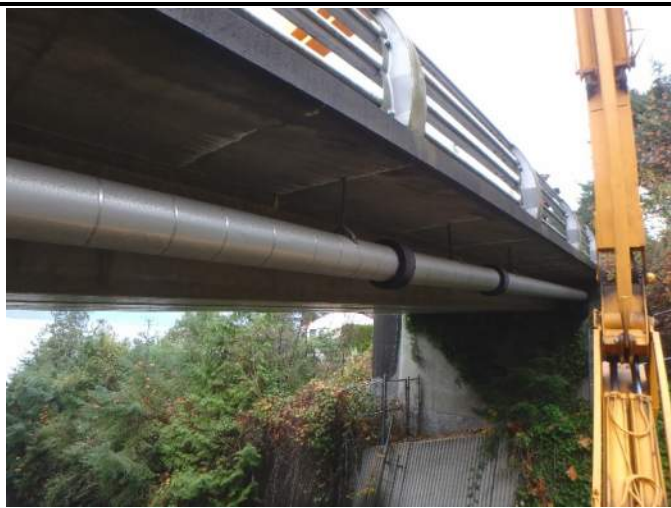
013 – Transverse cracks with efflorescence at the underside of sidewalks typical.

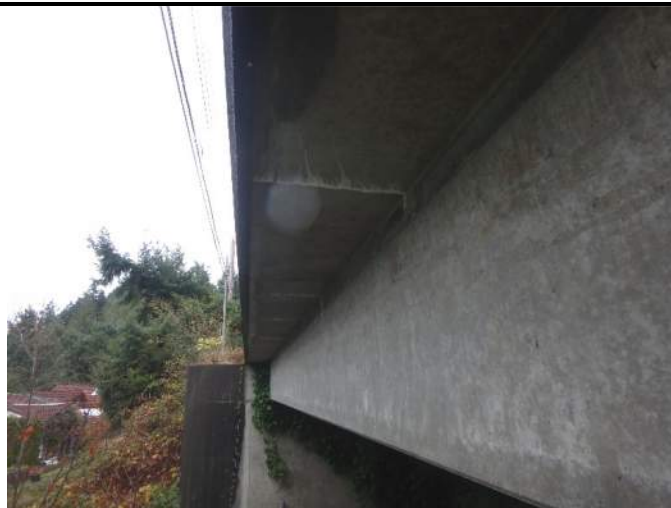
014 – Transverse cracks with efflorescence at the underside of curb typical.

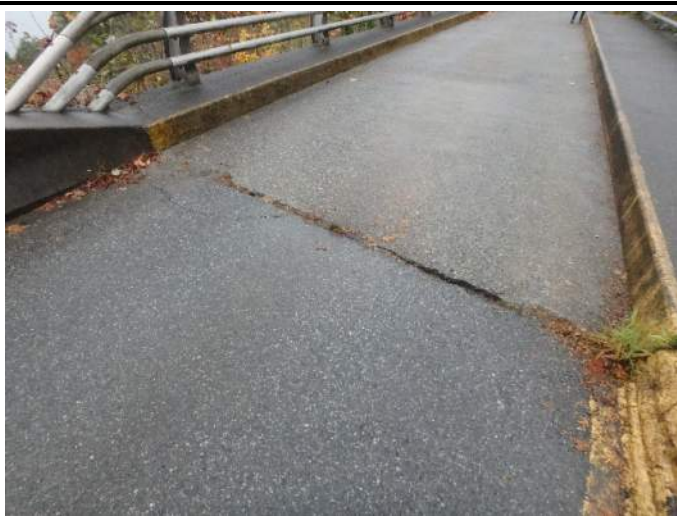
003 – South Approach – Gap between deck and approach

- Repair debonded asphalt and seal the crack at approaches.

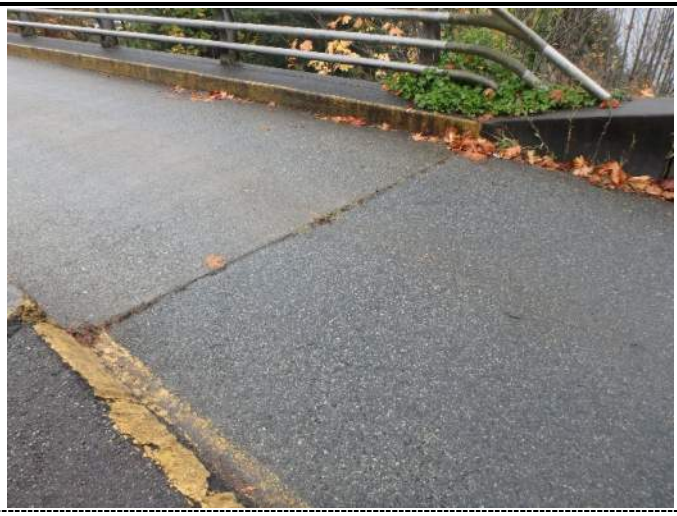
005 – North Approach – Gap between deck and approach

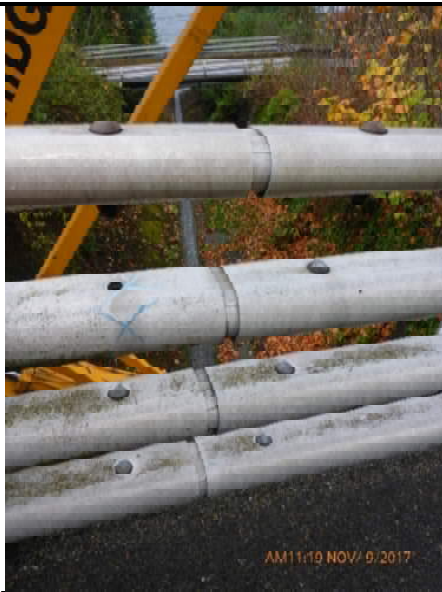
007 – Missing splice bolt at West side railing

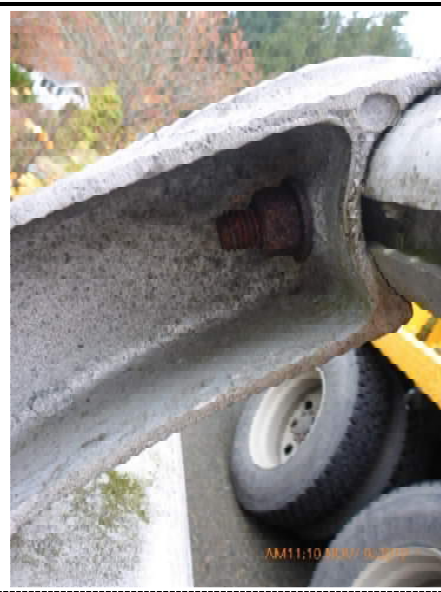
008 – Rusting bolt at the railing post

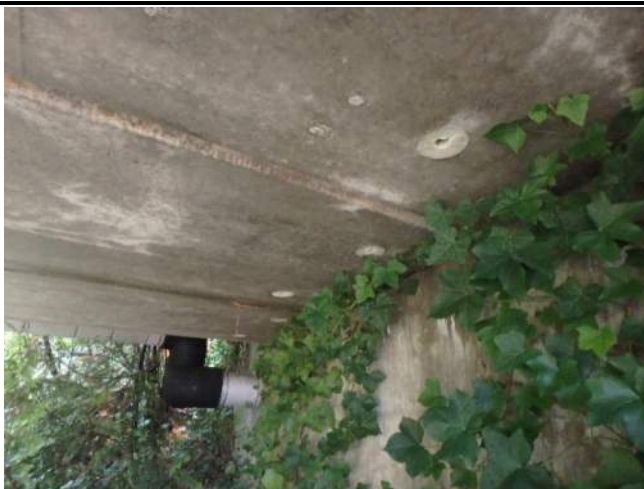
011 – Vegetation at S approach, evidence of water leaking between girders

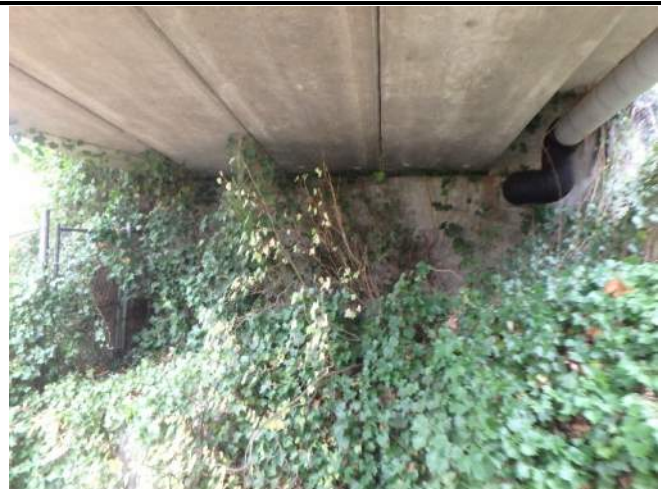
012 – North Abutment. Note vegetation growth.

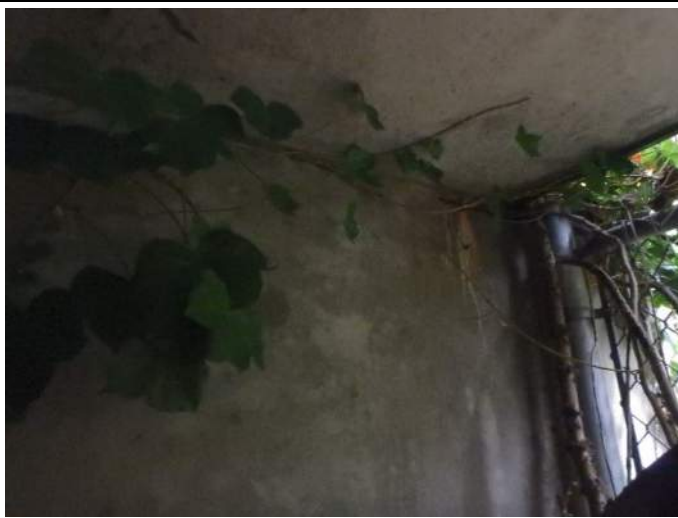
013 – Vegetation growth between abutment wall and underside of girders.

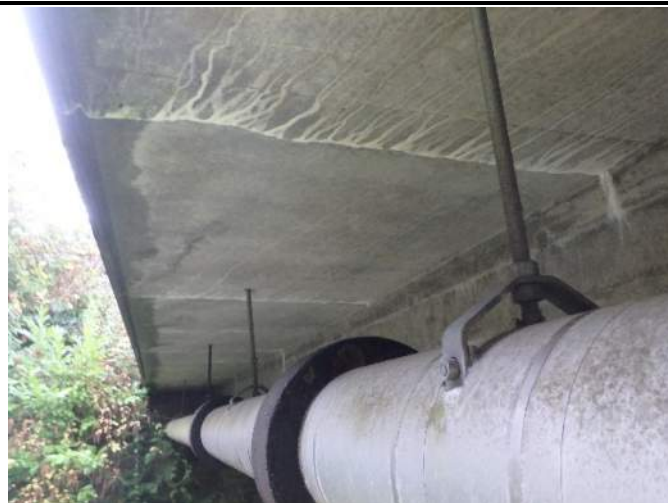
015 – Transverse cracks with efflorescence on the underside of sidewalk typical

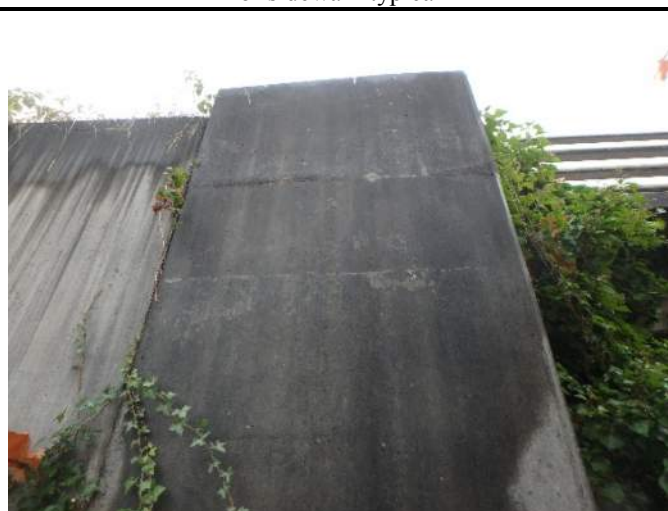
017 – Hairline cracking at North Abutment wall

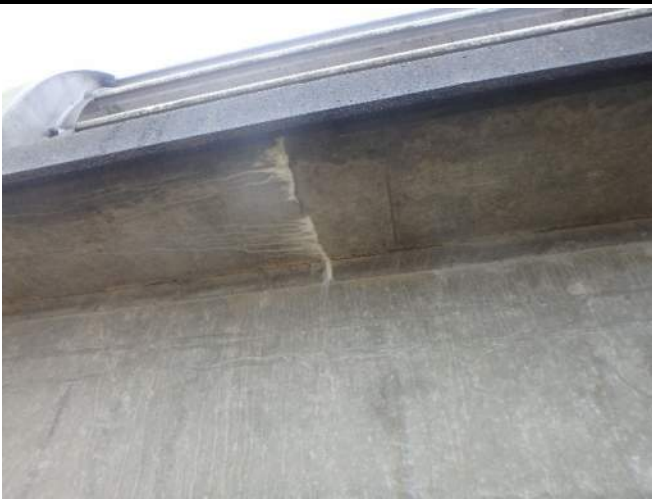
019 – Transverse cracks with efflorescence on the underside of curb typical.

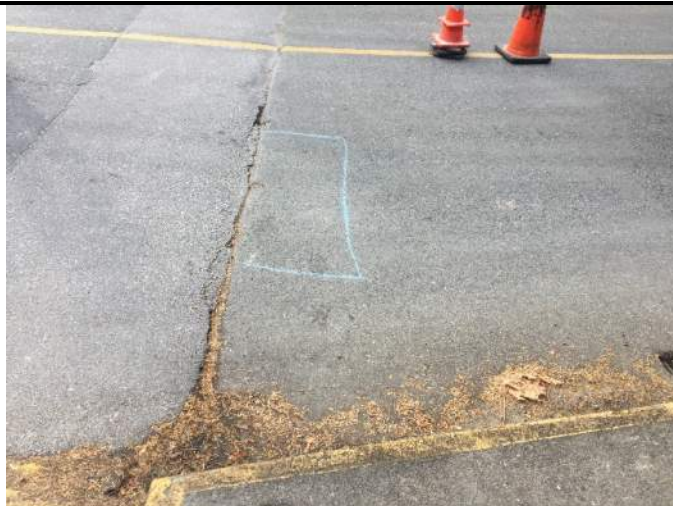
005 – Delamination area at South-East side of deck

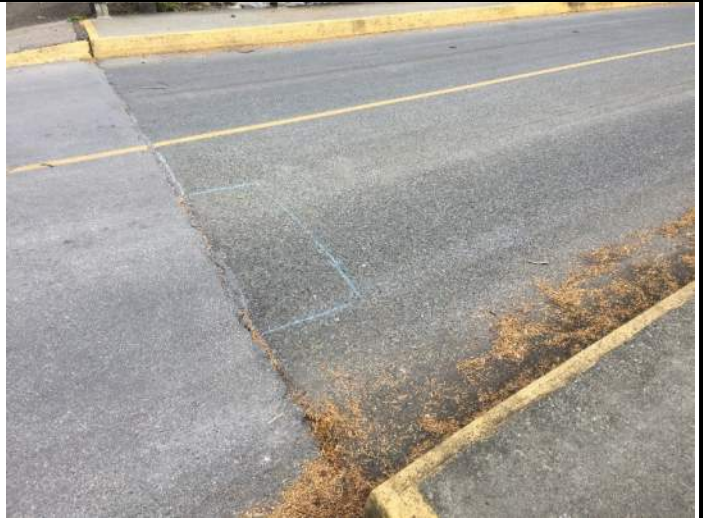
008 – Delamination area at North-West side of deck

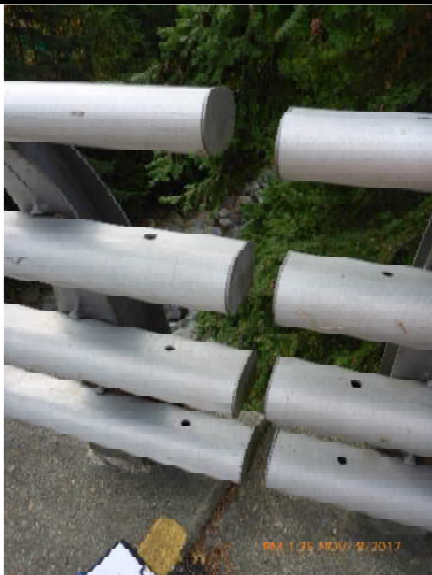
011 – Misalignment of railings at North-West corner

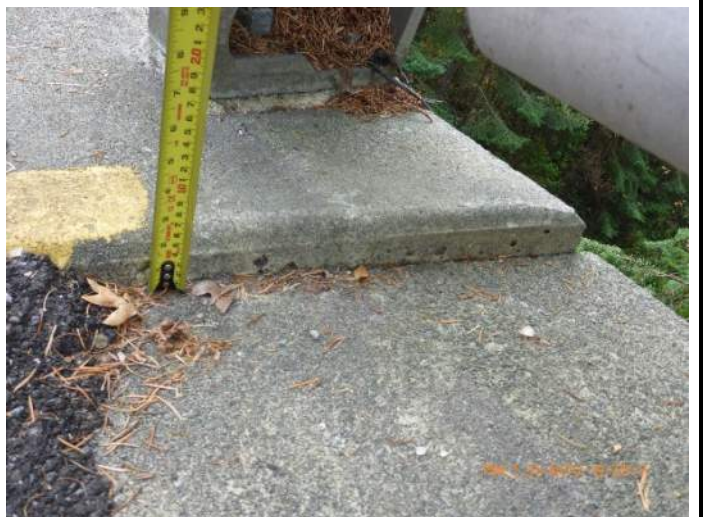
012 – Misalignment of deck and retaining wall North of bridge at West side

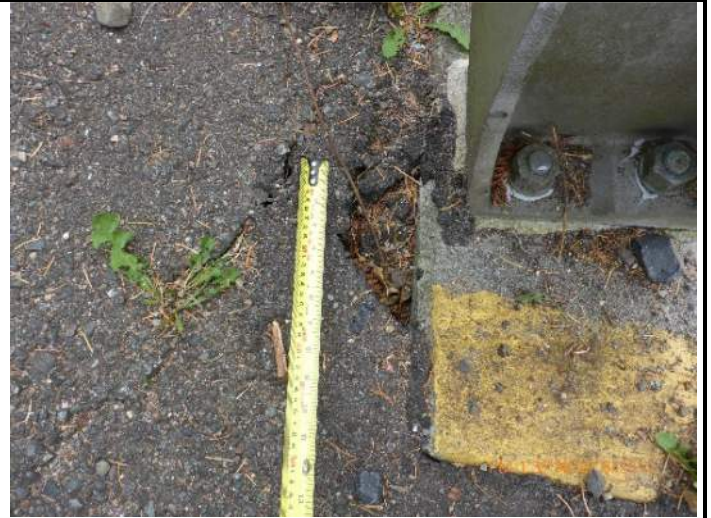
014 – Settlement at the North-East corner

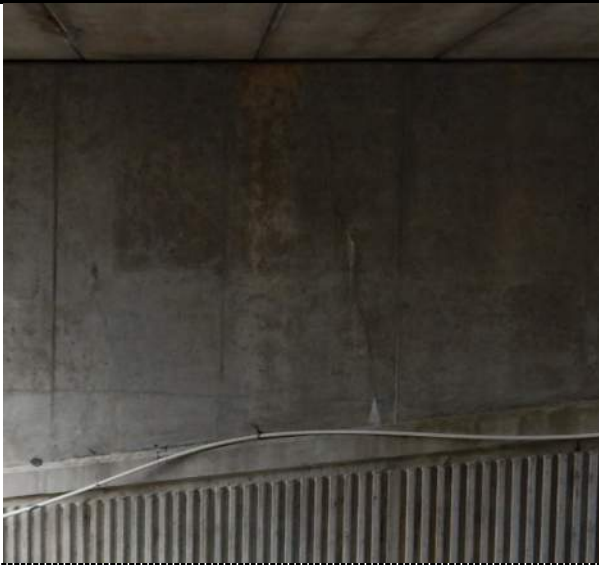
021 – North Abutment: vertical hairline crack with efflorescence, localized rust staining

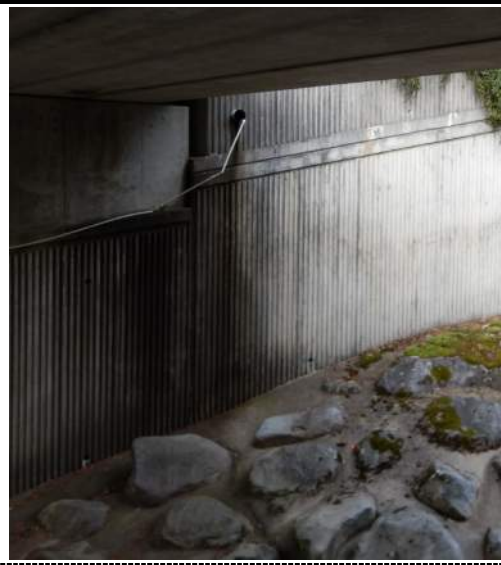
022 – Evidence of leaking at North Abutment

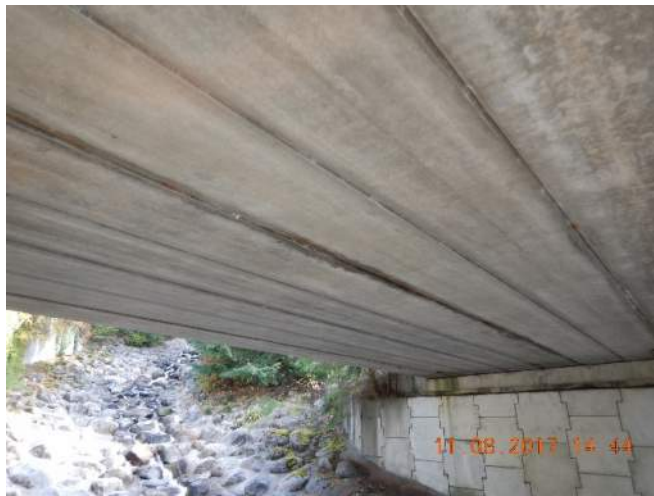
027 – Leaking through Girders 5 and 6 with efflorescence

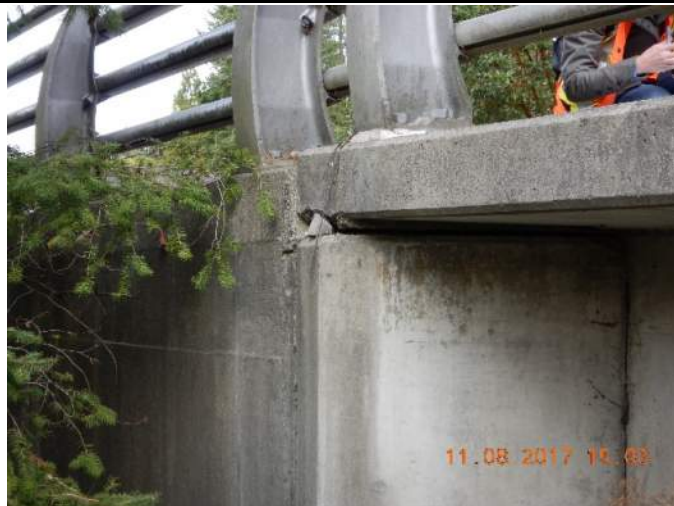
029 – North corner of West sidewalk – minor spall

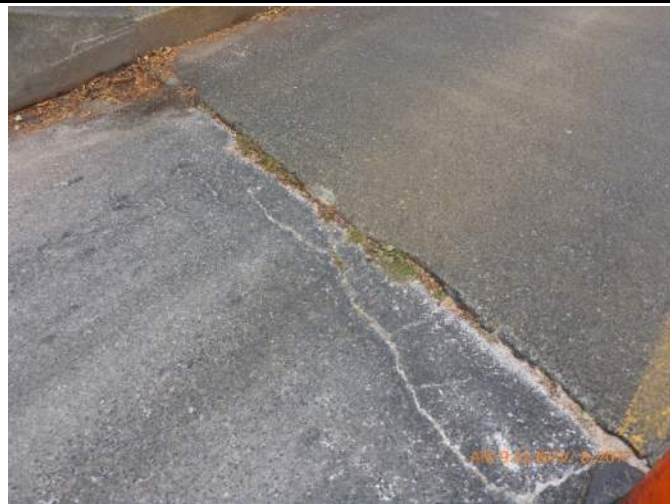
003 – Asphalt cracking at South Approach

Urgency Rating Notes:  
- Remove vegetation from abutment. Repair delaminated concrete.  
- Seal sidewalk, curb, and deck  
- Repair broken up asphalt at South approach, regrade to eliminate grade differential.

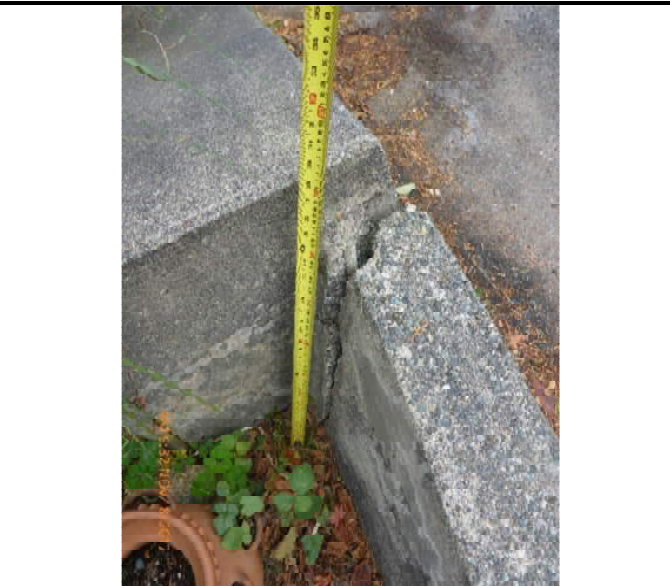
005 – Barrier detached at South-West corner

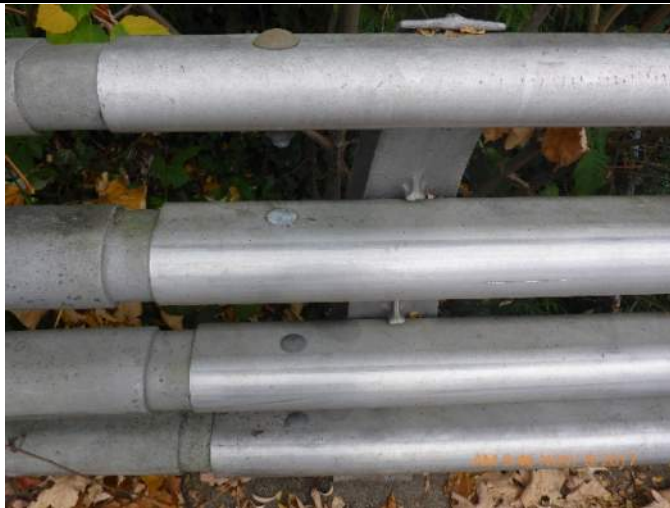
009 – Typical Railing with minor corrosion on top bolts

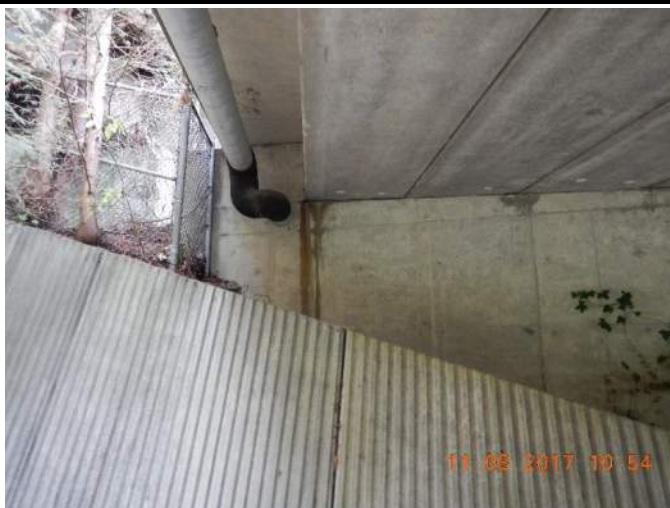
011 – South Abutment: evidence of leaking at East side

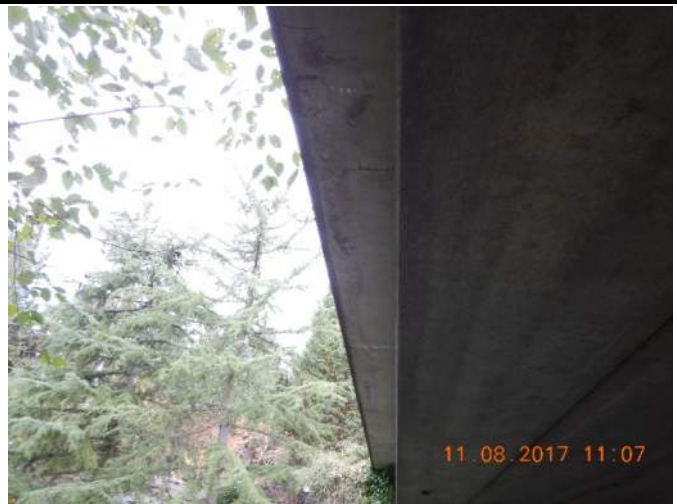
017 – Curb underside. Note transverse cracks with efflorescence.

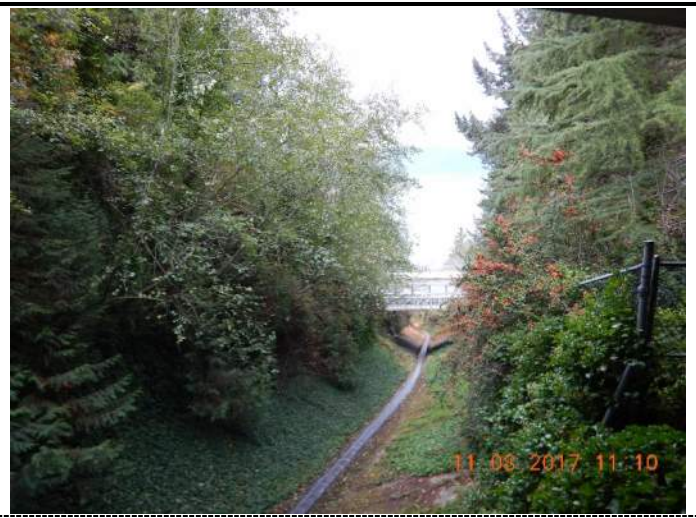
020 – View downstream

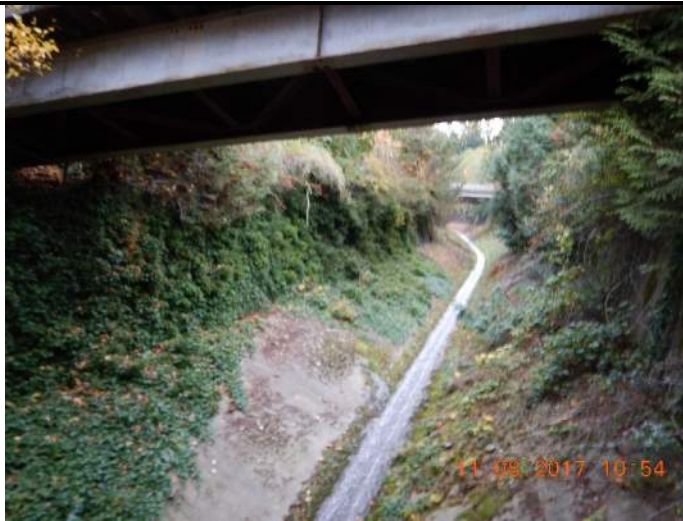
021 – View upstream

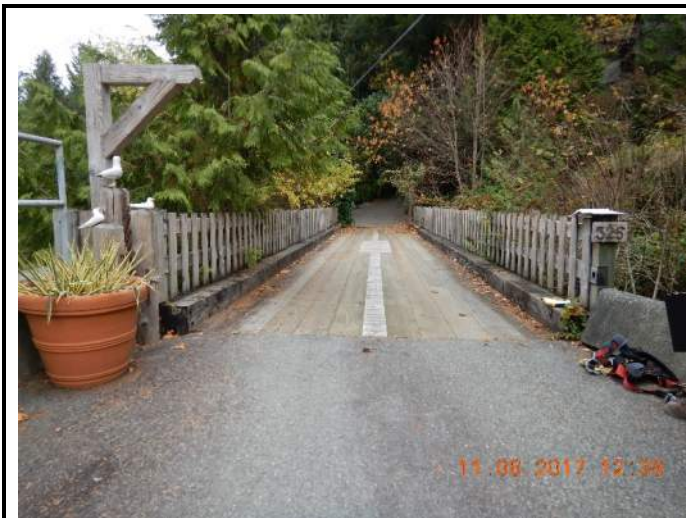
001 – View of Bridge looking North

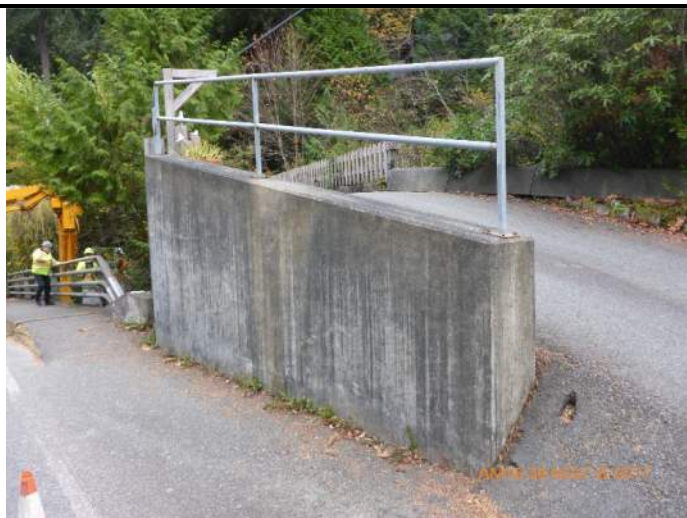
002 – Retaining wall at South Approach

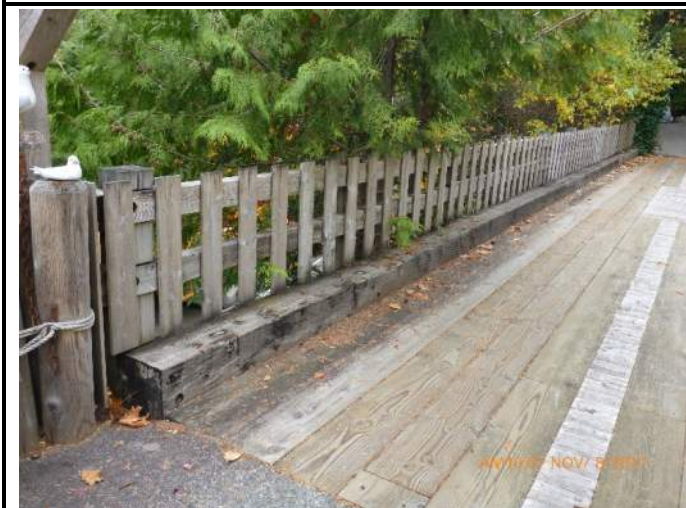
003 – Typical Railing

- Recommend replacing guardrail system.

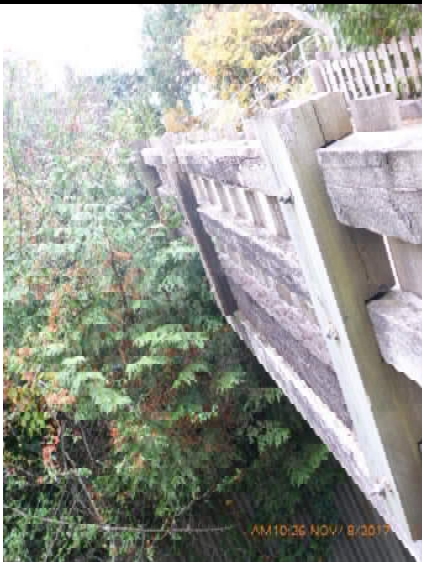
007 – Typical Post connection to wheelguard

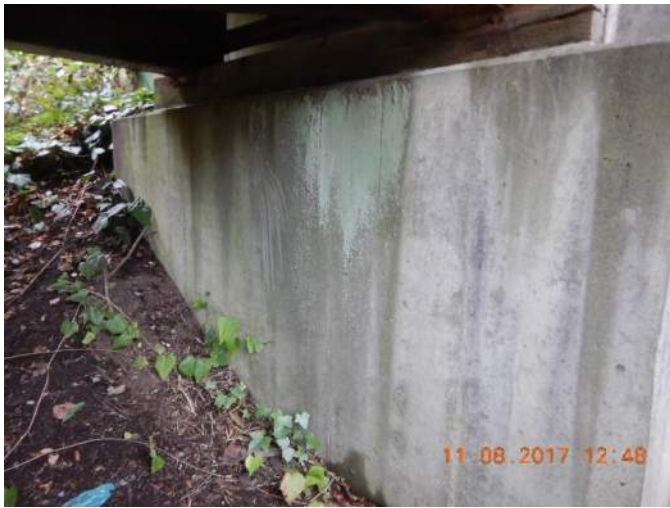
009 – South Abutment

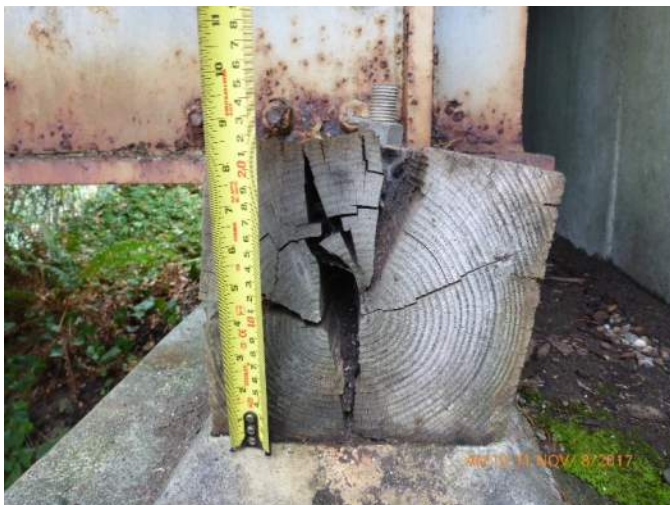
011 – Bearing at South Abutment. Note severe cracks and crushing.

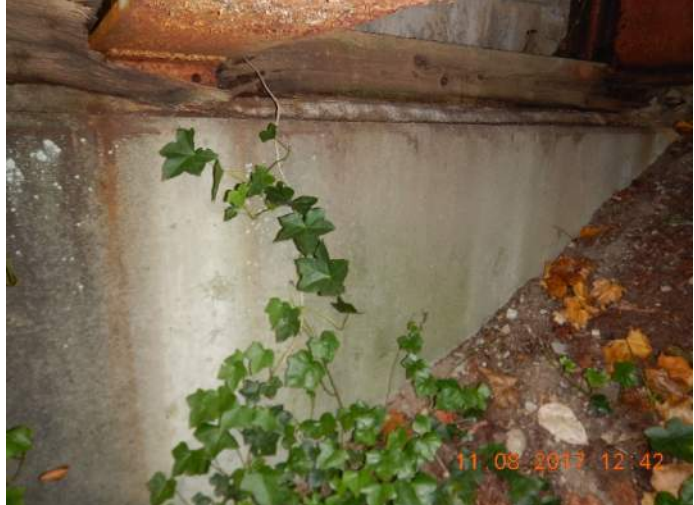
012 – North Abutment

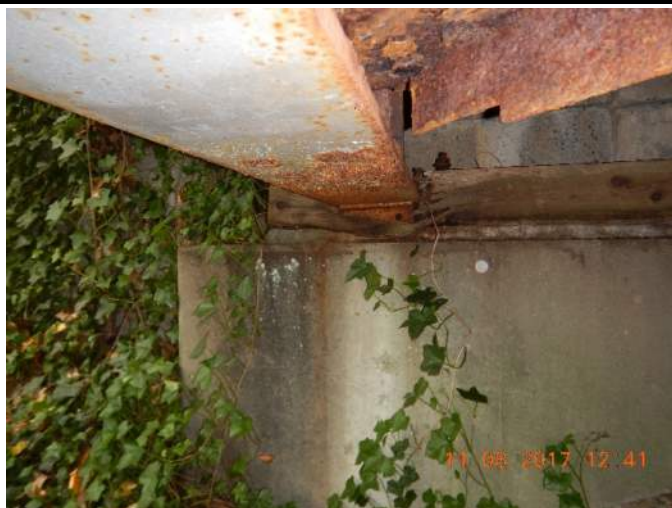
013 – North Abutment Bearing. Note severe crushing.

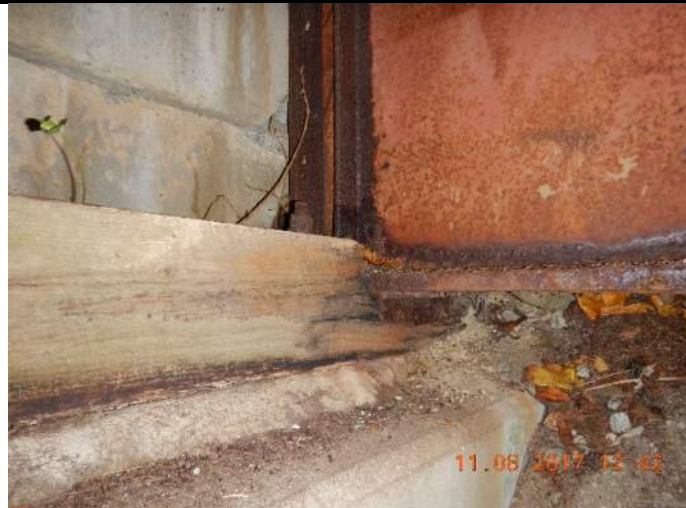
014 – Bearing at North Abutment. Note severe crushing.

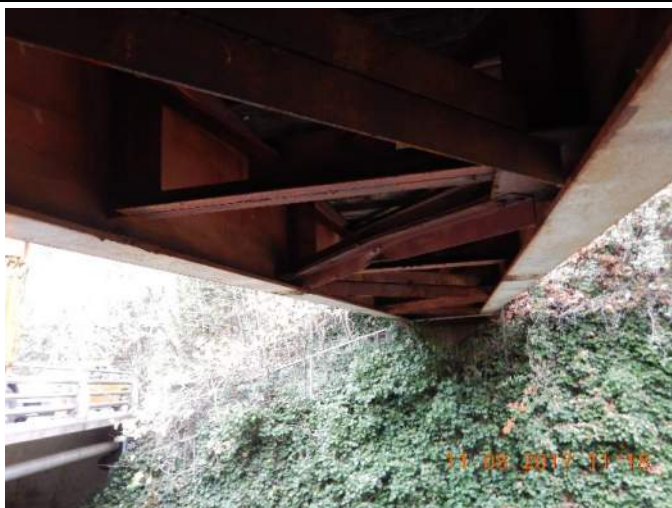
015 – Girders and diaphragms overview – medium corrosion on flanges and light corrosion on web. Note permanent deformation on cross bracing.

- Recommend recoating steel superstructure.

- Recommend repairing connection at Diaphragm 3 and deformed secondary members.

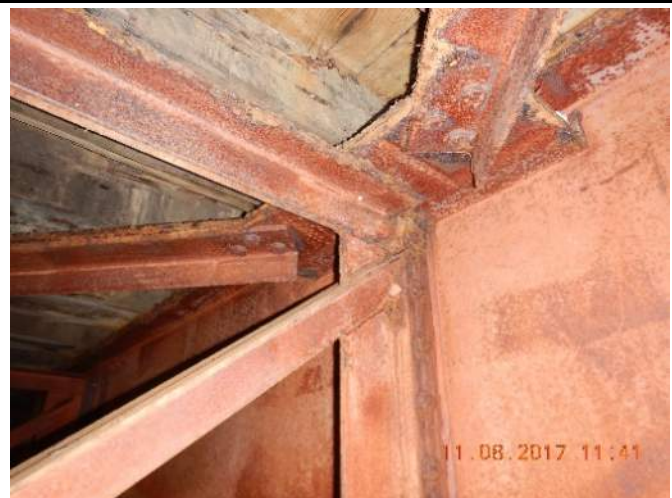
017 – Typical Connection – medium corrosion

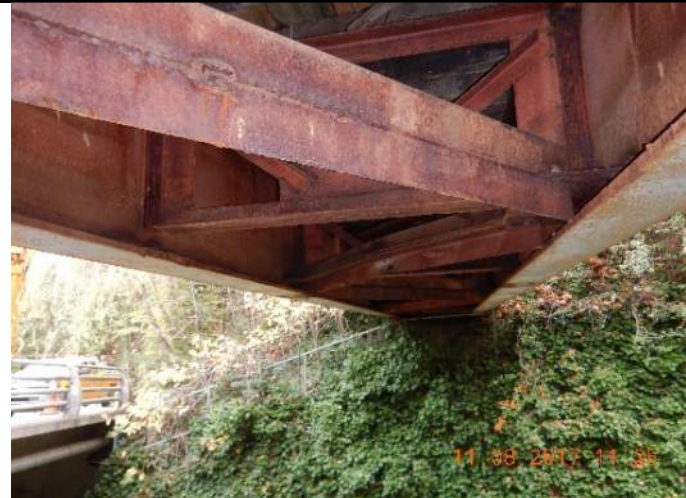
018 – Medium corrosion on all bracing/diaphragm members

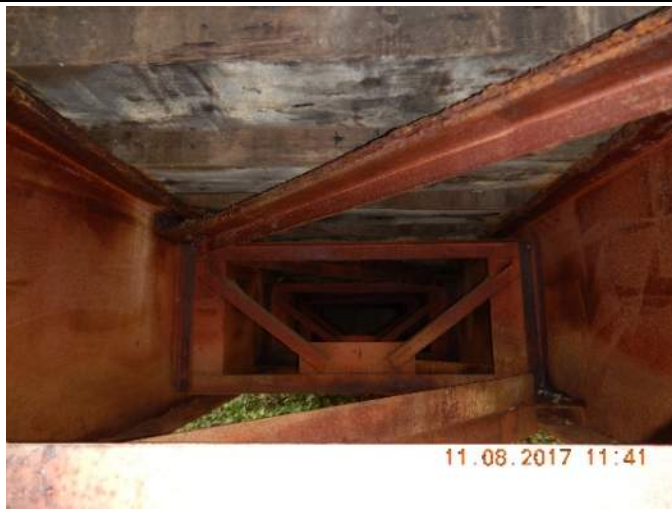
019 – Typical Diaphragm

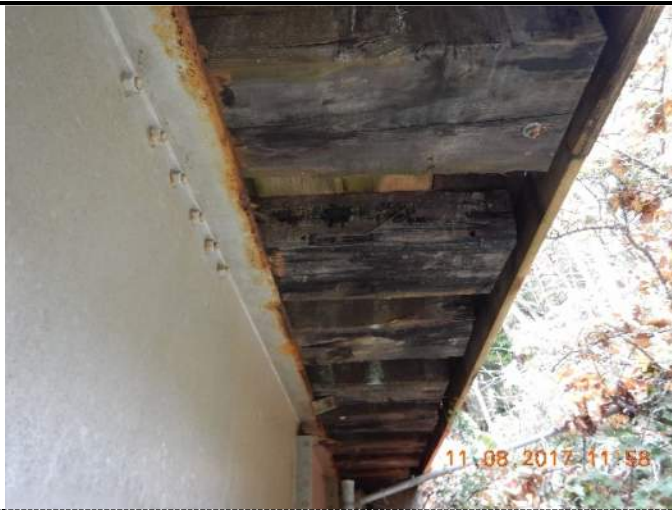
C. SUPERSTRUCTURE:						
1 Floor Beams/Transoms (P)			79	21		Extensive checks/splits and light weathing typical throughout each floor beam. Suspected severe rotting in Floor Beam 13, 15, 17, 18, 20. Splitting on Floor Beam 5.
2 Stringers (P)					N	
3 Girders (P)				100		Medium corrosion typical on top and bottom flangers with section loss of < 15%. Light corrosion typical on web.
4 Portals (P)					N	
5 Bracing/Diaphragms (S)				68	32	Medium corrosion typical on all members. Permanent deformation on multiple diaphragms (D3, D7, D9). Permanent deformation on multiple cross bracings (CB2, CB4, CB6, CB7, CB8).
6 Truss Chords/Arch Ribs (P)					N	
7 Arch Ties (P)					N	
8 Truss Diagonals (P)					N	
9 Truss Rods/ Verticals (P)					N	
10 Cables (P)					N	
11 Panels (S)					N	
12 Pins/Bolts/Rivets (P)					N	
13 Camber/Sag (S)					N	
14 Live Load Vibration (S)					N	
15 Coating (structure) (P,S)			20	80		Coating has failed on interior faces of Girders and all diaphragms and cross bracing. Bottom face of the flange and exterior face have Category 4 surface rusting and pinholing typical throughout.

021 – Suspected rotting at floor beams

- Recommend replacing floor beams

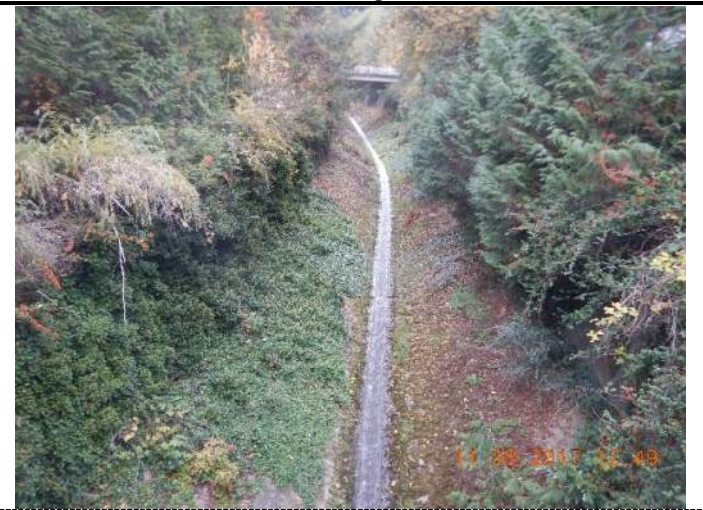
022 – View upstream

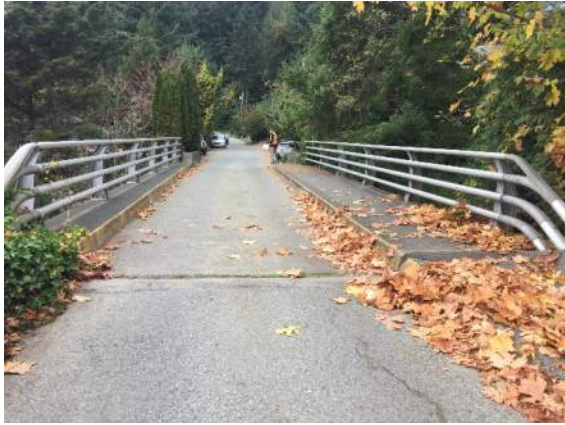
001 – View of Bridge looking North

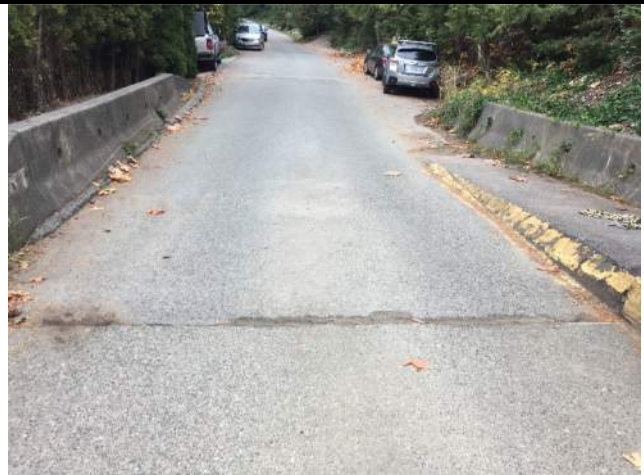
002 – View of North Approach

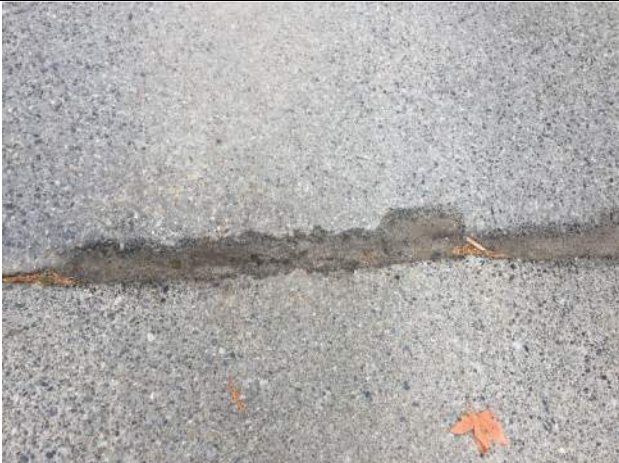
003 – Gaps between deck and asphalt at North Approach

- Clear gaps between approaches and deck, regrade to eliminate grade differential.

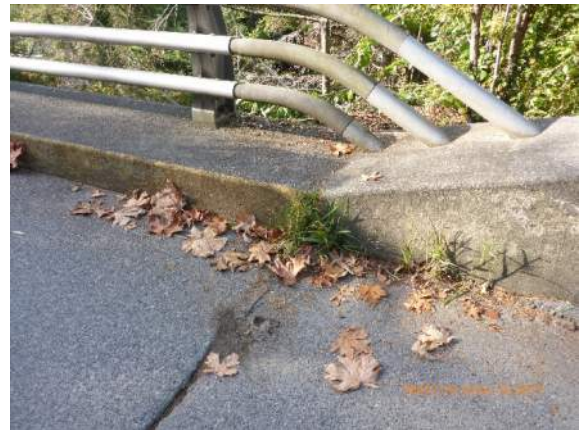
004 – Scaling on deck NW corner

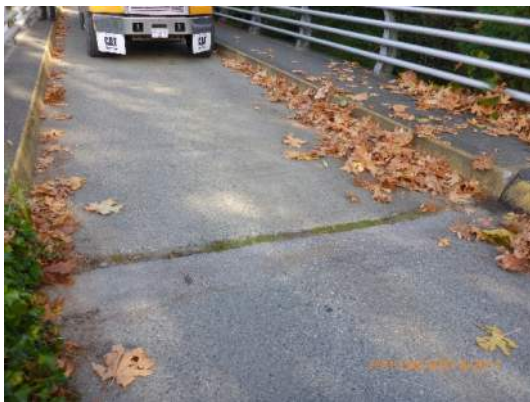
005 – South Approach gap between deck and asphalt

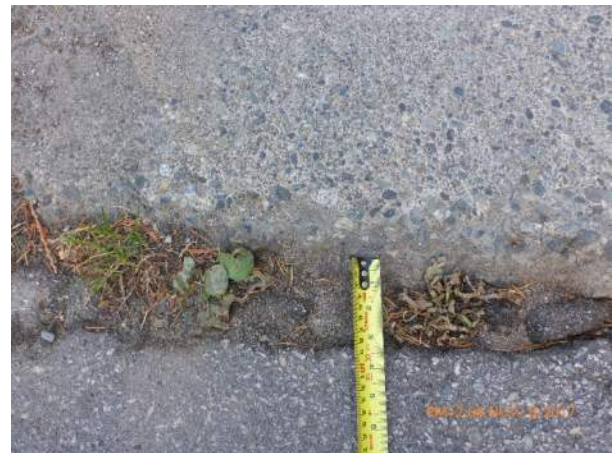
006 – Vegetation in the gap and abrasion at the deck due to uneven elevation at South Approach

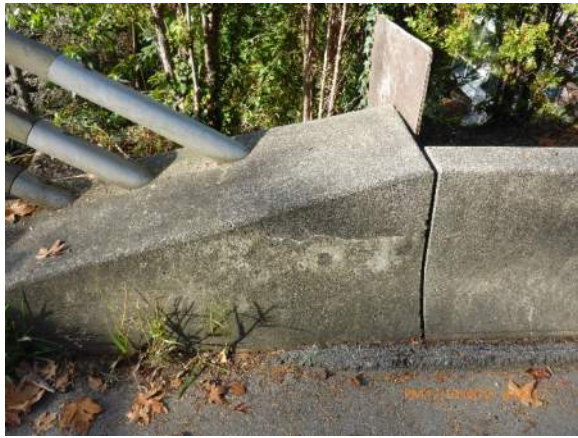
007 – Efflorescence at the curb at North-West end

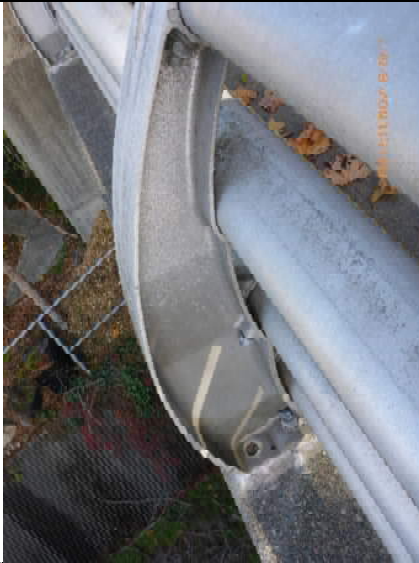
009 – Missing anchor bolt at 3<sup>rd</sup> post from North on West side

- Install/repair missing anchor bolt at the post.

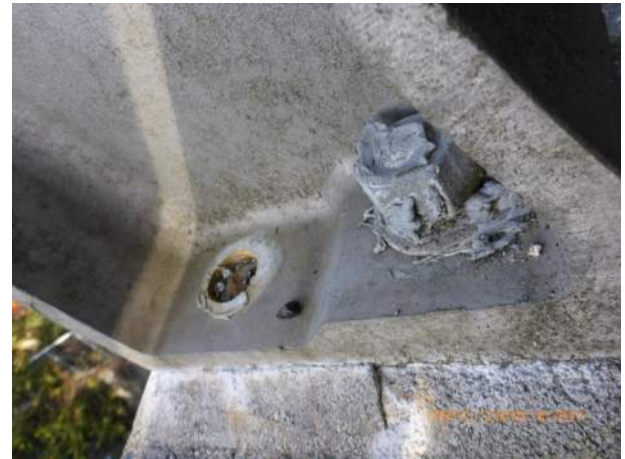
010 – Close up of missing anchor

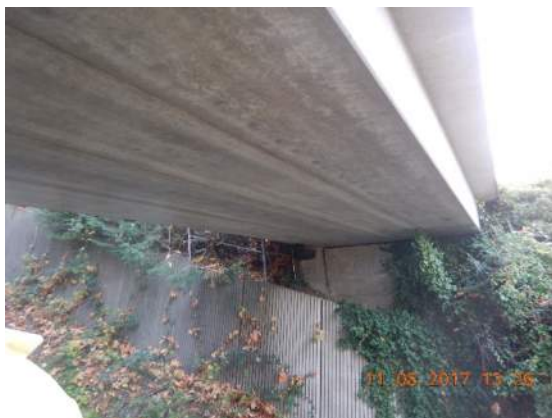
011 – South Abutment

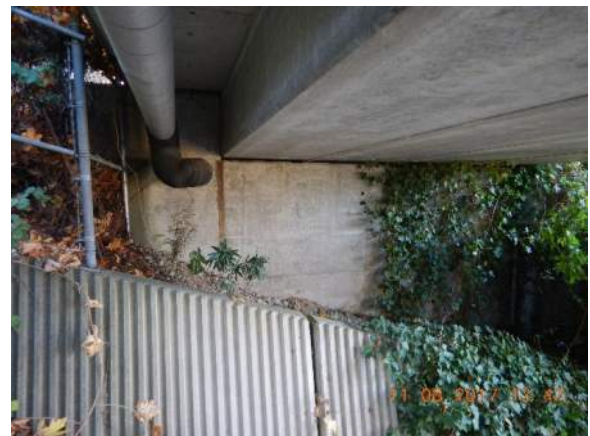
012 – Leaking at exterior girder units at South Abutment
