## Village of Lions Bay

Final Report

Bridge Inspection Program

June, 2018

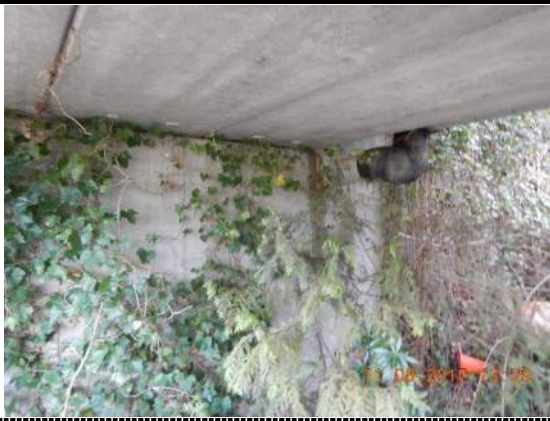
013 – Leaking at exterior girder units at North Abutment

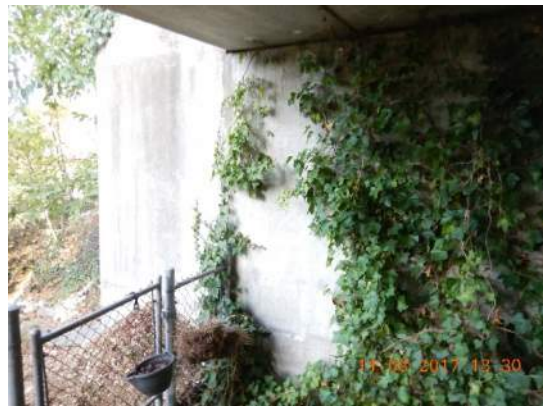
014 – Vegetation growth at North Abutment

- Remove vegetation growth on abutments and between girder units. Repair delaminated concrete on abutment.

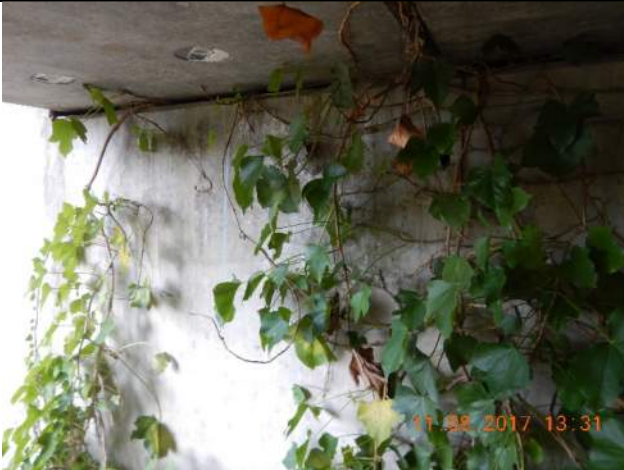
B. SUBSTRUCTURE:							
1 Foundation Movement (P)		100					Settlement at approaches.
2 Abutments (P)		97	1.5	1.5			Light scaling typical with localized hairline cracks. Very severe delamination under G4 at the top of the wall and localized efflorescence under G4 on North Abutment. Localized efflorescence under G1 on South Abutment. Evidence of leaking at exterior girder units. Vegetation growth typical.
3 Wing/Retaining Walls (S)						x	Unable to inspect due to access/vegetation.
4 Footings/Piling (P)						x	
5 Pier Columns/Walls/Cribs						N	
6 Bearings (S)	100						Limited inspection due to visibility. No material defects noted.
7 Caps (S)						N	
8 Corbels / Bridge Seats (S)						N

015 – Severe delamination area at North Abutment, West side

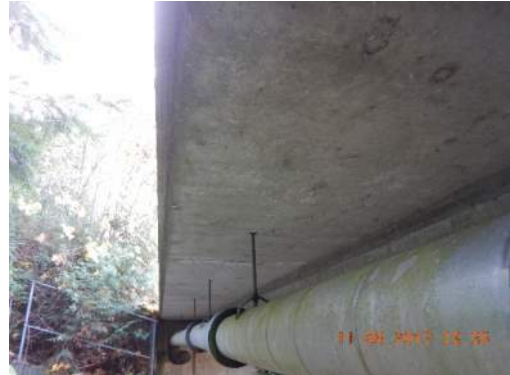
016 – Main at East side

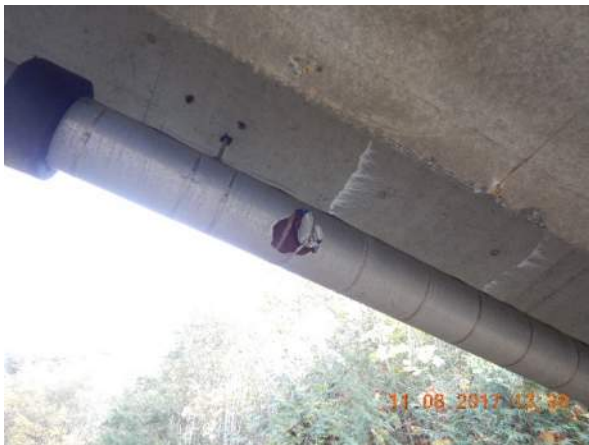
017 – Damage at watermain cover

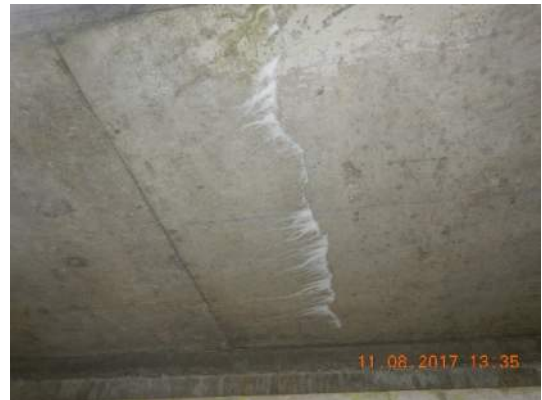
018 – Transverse cracks with efflorescence on underside of sidewalk and curb typical.

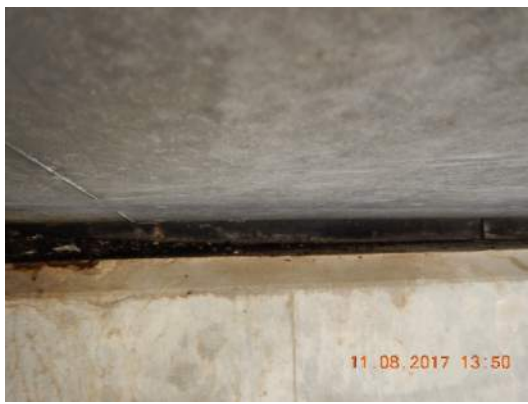
019 – Typical bearing

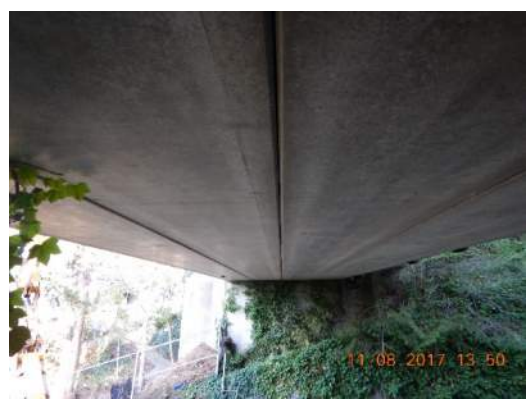
020 – Underside of girders - overview

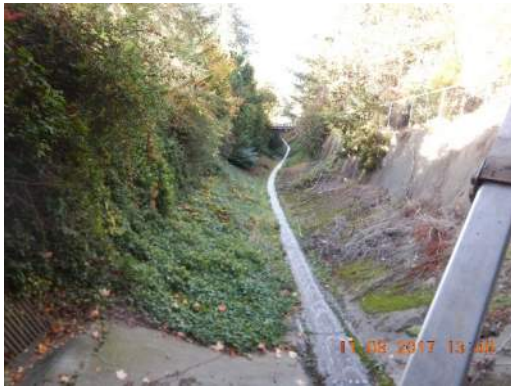
021 – View downstream

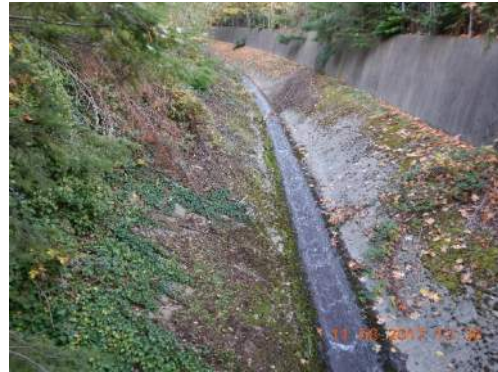
022 – View upstream

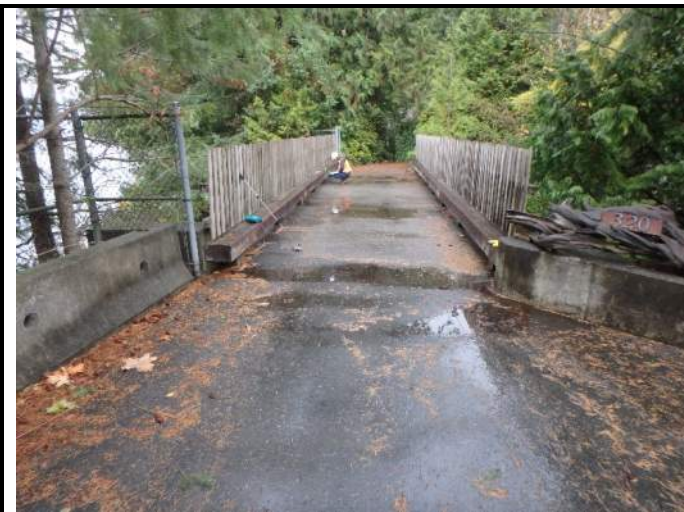
001 – View of Bridge looking North

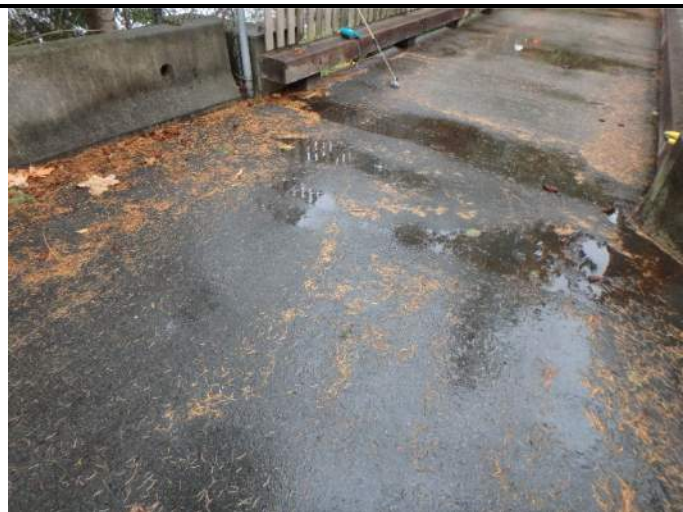
002 – South Approach

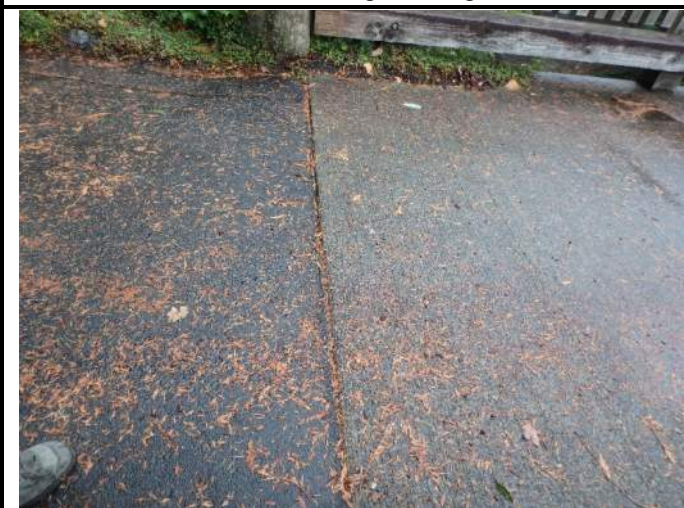
003 – Minor gap between deck and asphalt at South approach

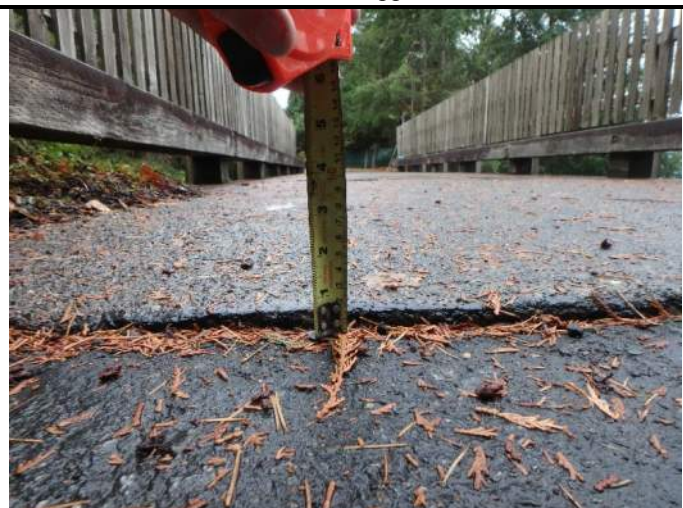
004 – 15mm difference in elevation between deck and asphalt at North approach

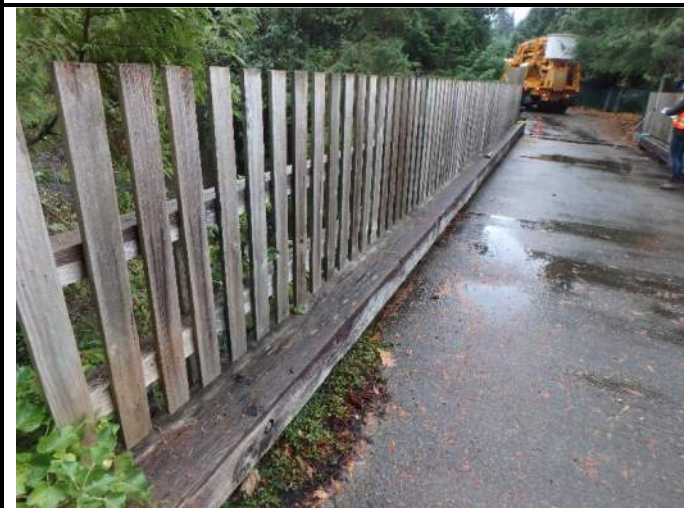
005 – Typical railing

- Recommend replacing guardrail system.

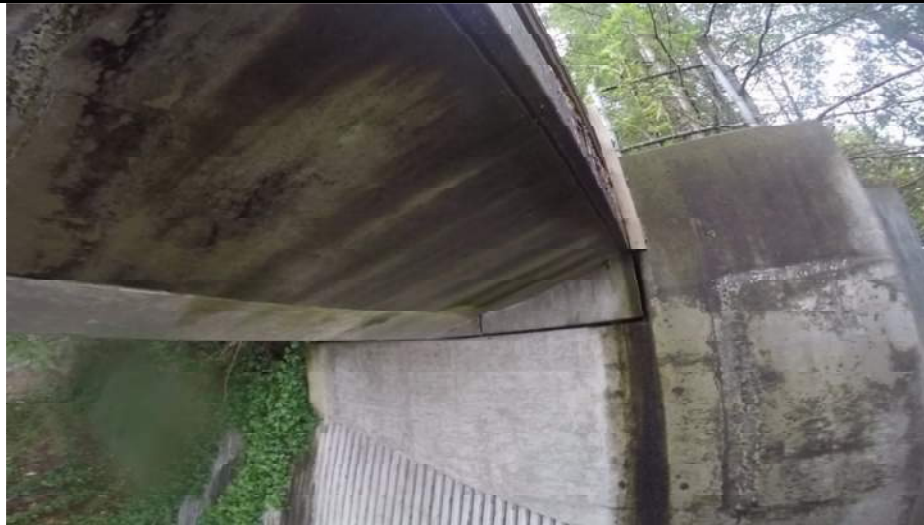
009 – South Abutment Overview

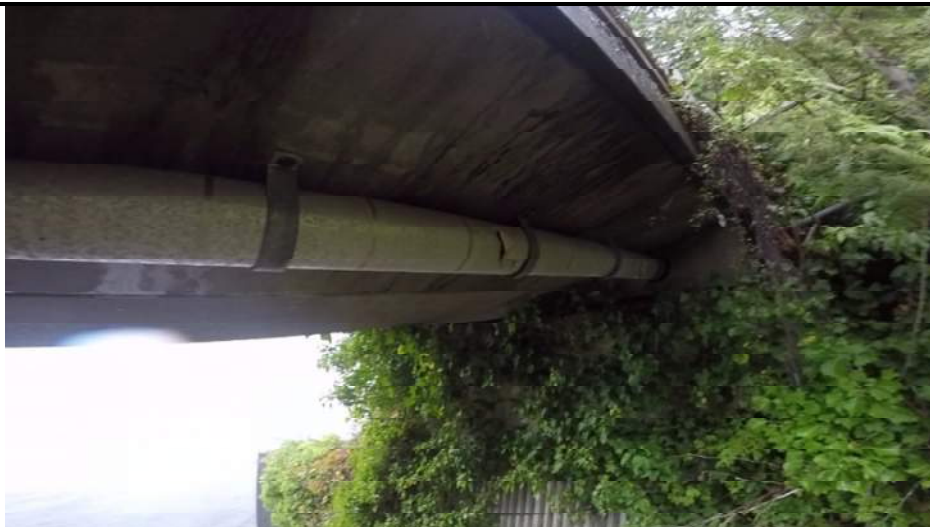
010 – North Abutment Overview – vegetation overgrowth; water main on the East side of the bridge

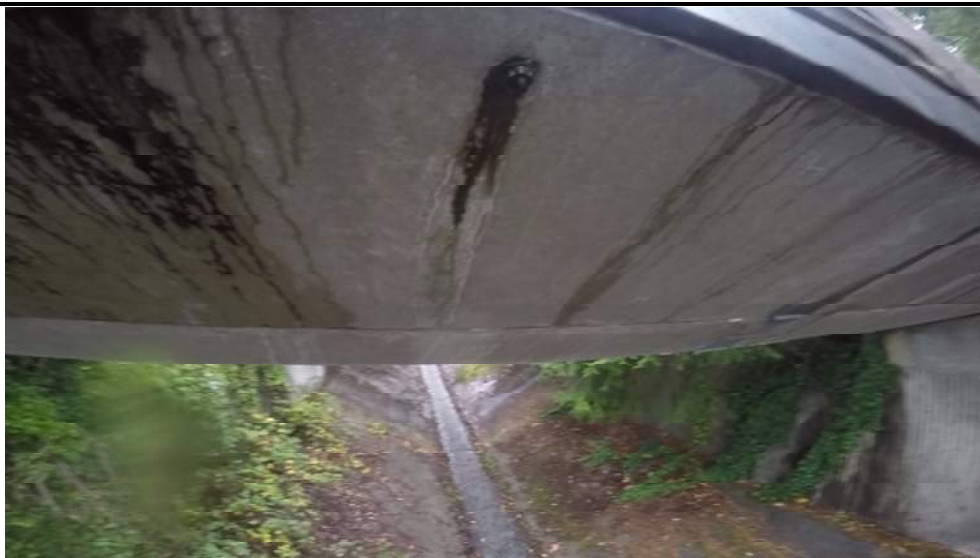
013 - Soffit and bolt close up

- Recommend inspection of soffit and abutments with rope access or drone.
