Village of Lions Bay

Water Storage Facilities Replacement

Contract Documents
Issued for Tender

Volume 3 of 3
Appendices

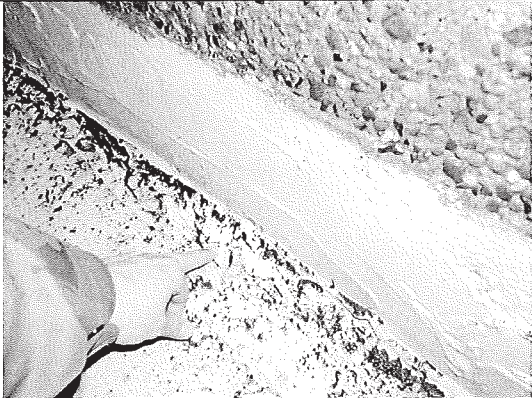
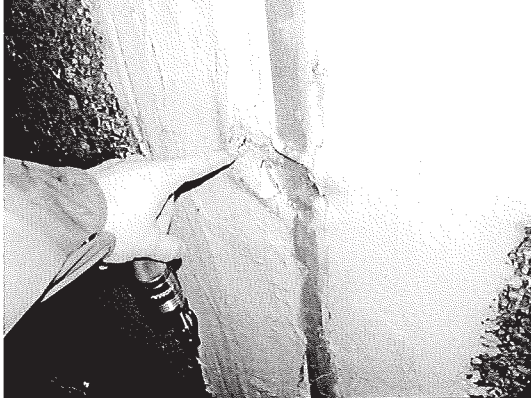
<p>1. A number of tears were found in the hypalon material. The above photo shows one such tear. This was located in the hypalon along the base of the wall</p>	<p>2. A large hole sufficient to push a pen through was observed at one of the vertical joints between precast panels</p>

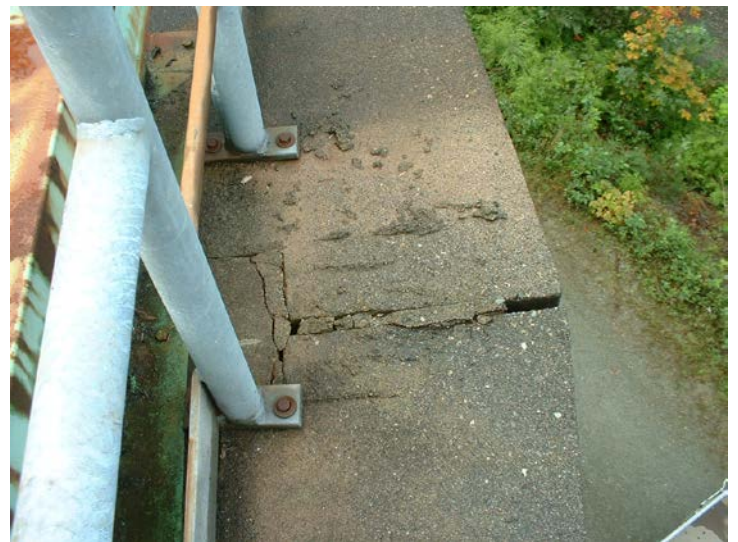
60. Joint between precast concrete roof panels at access hatch

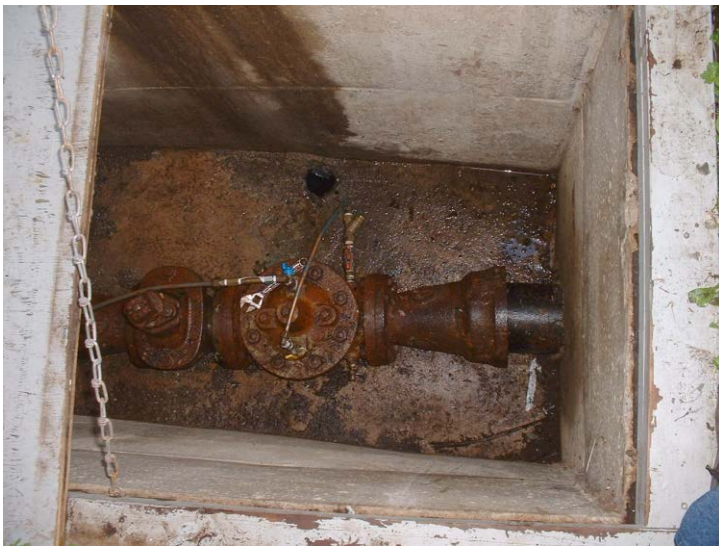
32. Valve chamber
