Village of Lions Bay

Water Storage Facilities Replacement

**Contract Documents
Issued for Tender**

**Volume 3 of 3
Appendices**

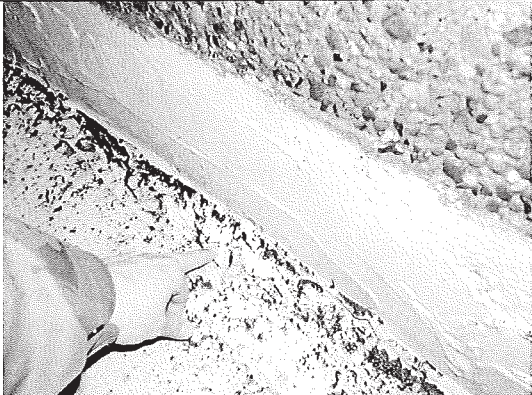
| <p>1. A number of tears were found in the hypalon material. The above photo shows one such tear. This was located in the hypalon along the base of the wall</p> | <p>2. A large hole sufficient to push a pen through was observed at one of the vertical joints between precast panels</p> |

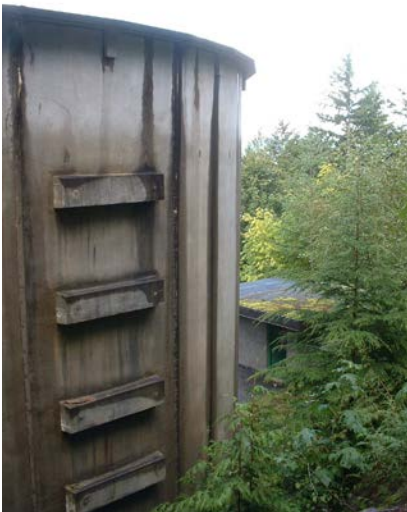
51. General view of anchor blocks. Note algae growth on chlorination building roof

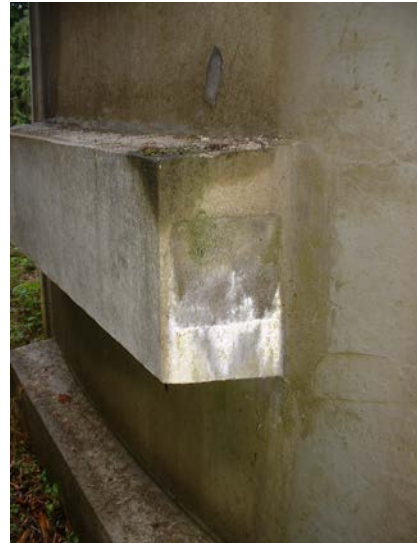
52. Note efflorescence at SE anchor block

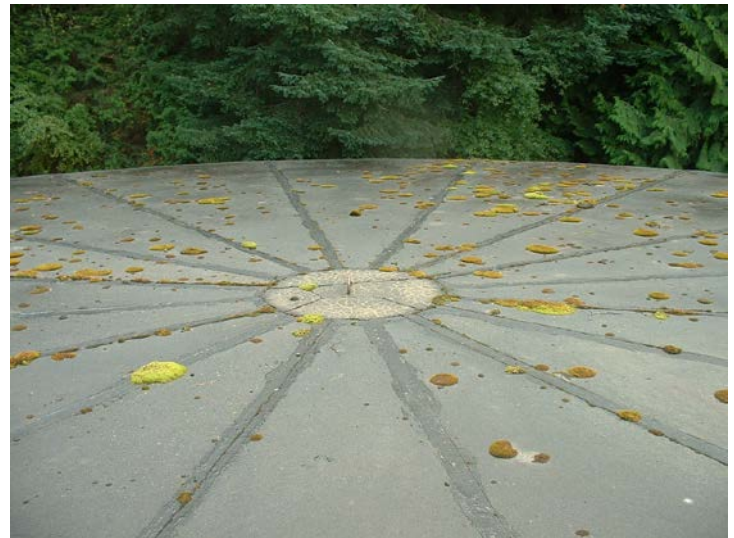
58. Note concrete precast panels making up the roof structure

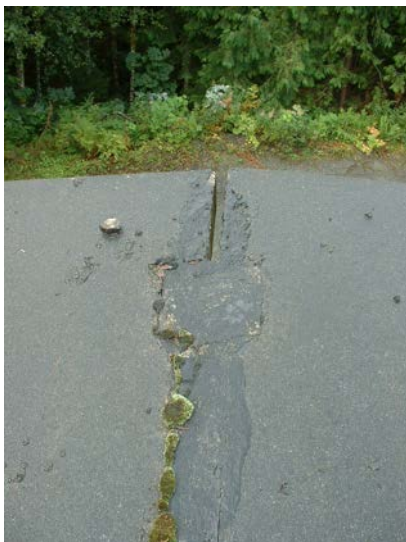
59. Concrete filler section has fallen out from between two precast concrete roof panels

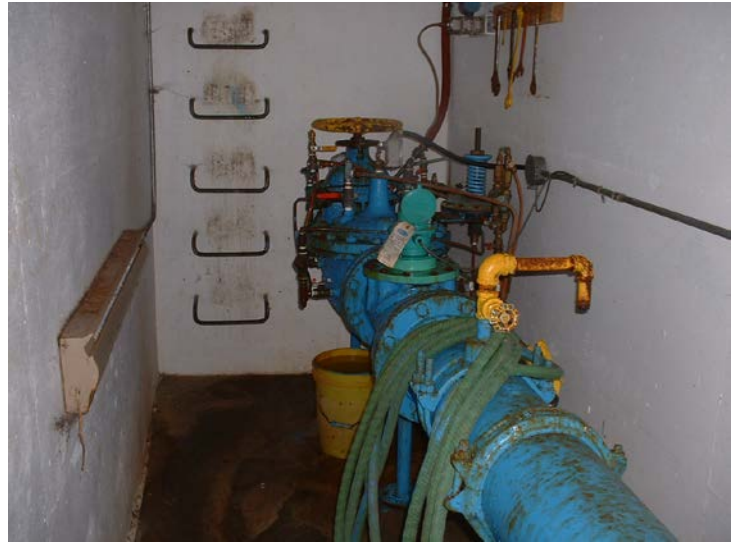
62. General view of inlet pipe in chlorination chamber

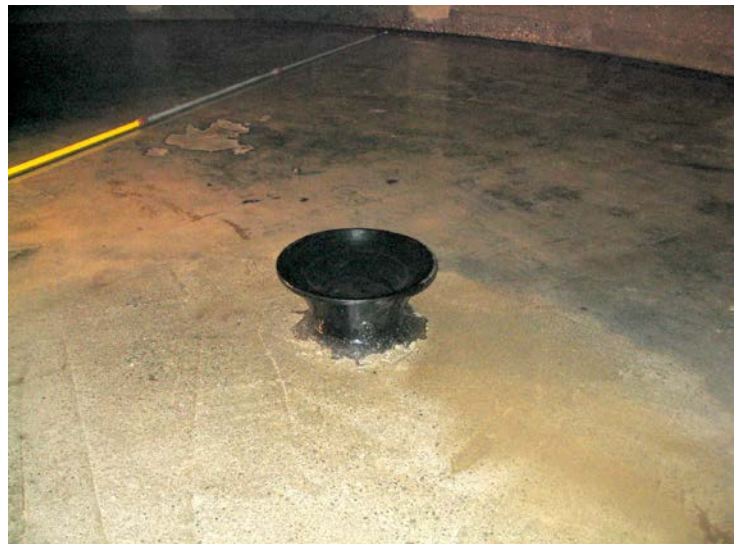
144. 250 Φ bellmouth inlet drain

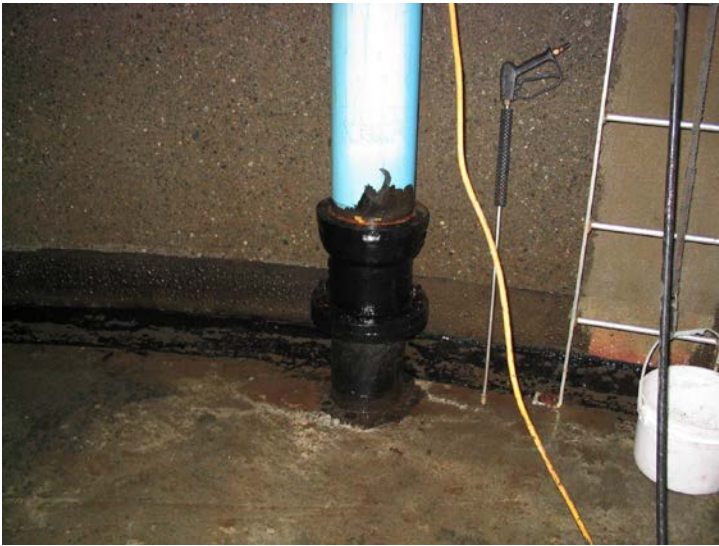
145. 200 pvc overflow pipe

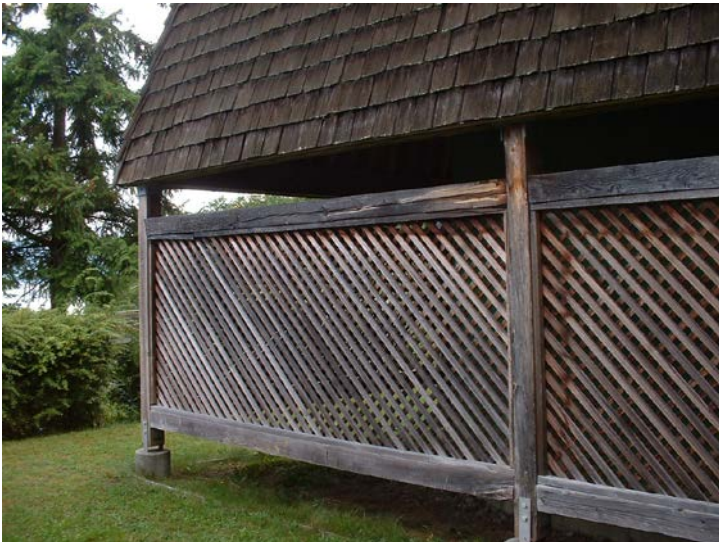
| Item | Location | Activity description | Qty | Unit | U | Make safe | Comments | Rep Photo | Mon freq |
|---|---|--|---|---|---|---|---|---|---|
| 1.12 | WS | Shakes – replace | 20 | No | 2 | | Roof structure on top of reservoir consists of a timber structure and shakes | 34, 36 | |

36. Lattice wall

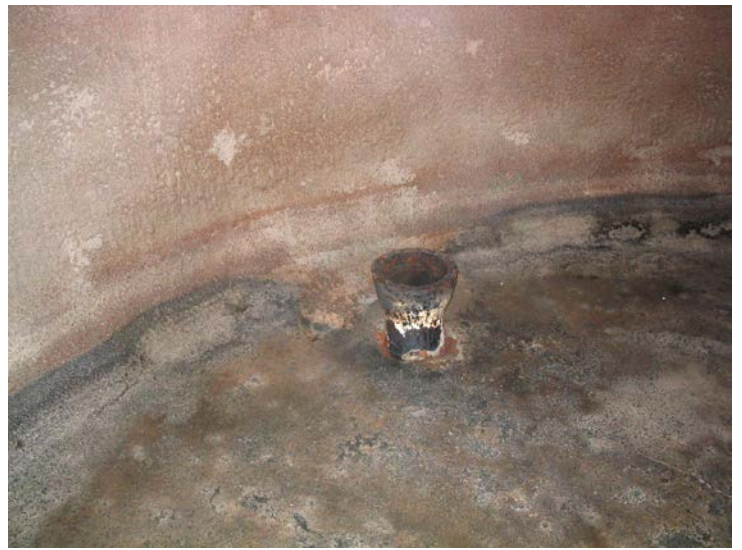
| Item | Location | Activity description | Qty | Unit | U | Make safe | Comments | Rep Photo | Mon freq |
|---|---|--|---|---|---|---|---|---|---|
| 3.4 | IS | Wire brush & Power tool - paint | 0.5 | m2 | 2 | | Corrosion evident on outlet pipe | 138 | |
| 3.3 | IS | Wire brush & Power tool - paint | 0.5 | m2 | 2 | | Corrosion evident on inlet pipe | 138 | |

138. Inlet pipe

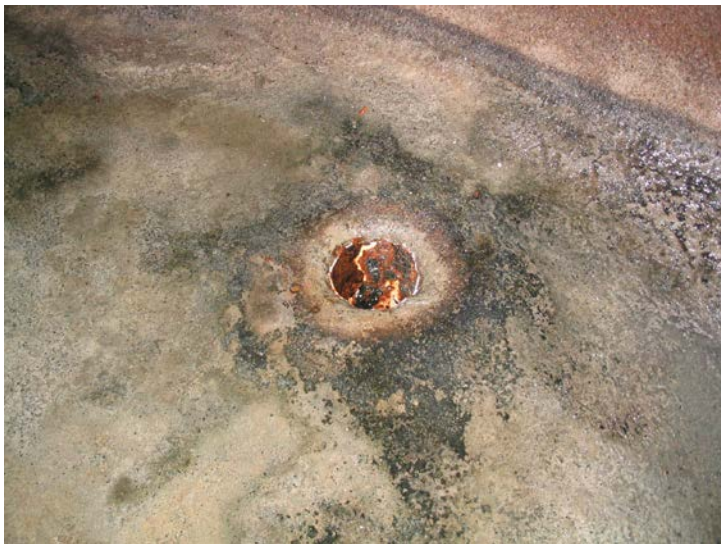
| Item | Location | Activity description | Qty | Unit | U | Make safe | Comments | Rep Photo | Mon freq |
|---|---|--|---|---|---|---|---|---|---|
| 3.6 | IS | Wire brush & Power tool - paint | 2 | m2 | 2 | | Corrosion evident on drain pipe | 141 | |

141. Drain
