Village of Lions Bay

Harvey Tank Replacement Project

Contract Documents
Issued for Tender

Volume 3 of 3
Appendices

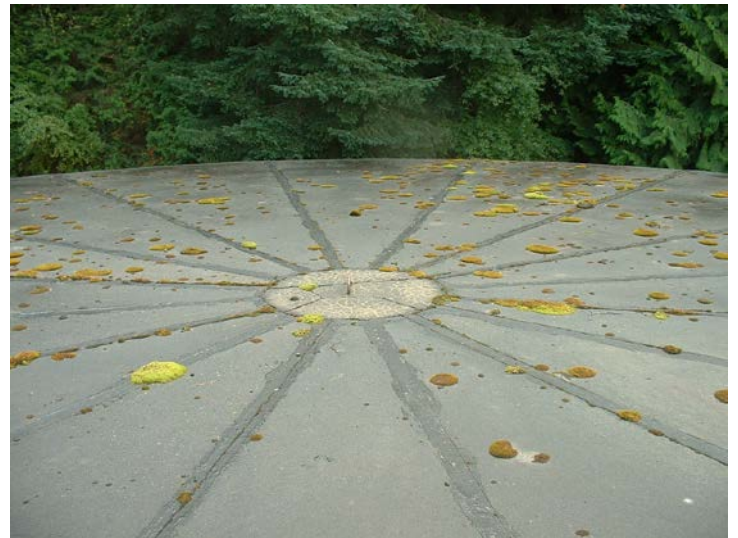
58. Note concrete precast panels making up the roof structure

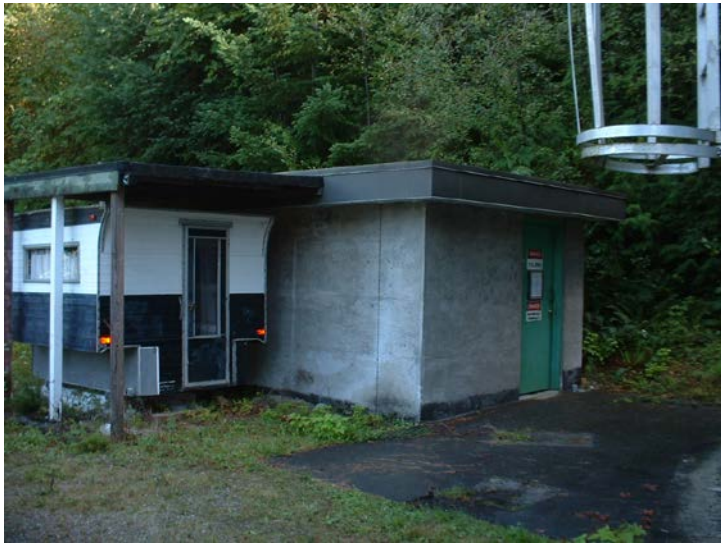
63. General view of chlorination building

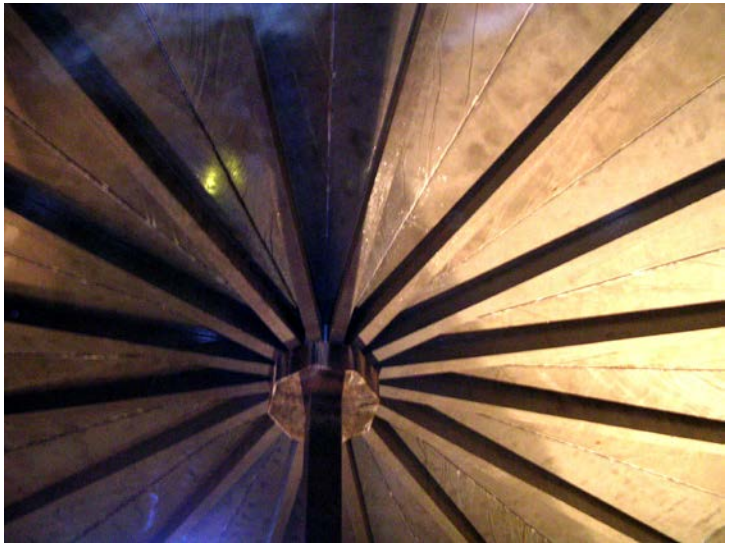
142. Underside of roof from inside of tank

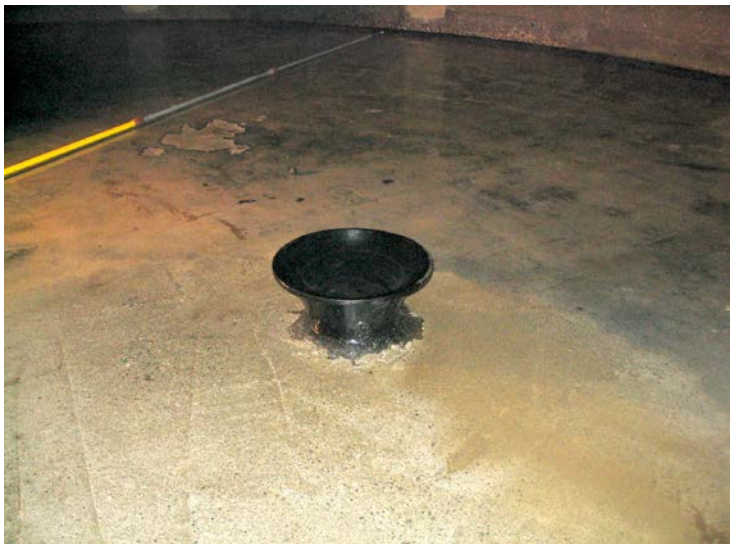
144. 250 Φ bellmouth inlet drain

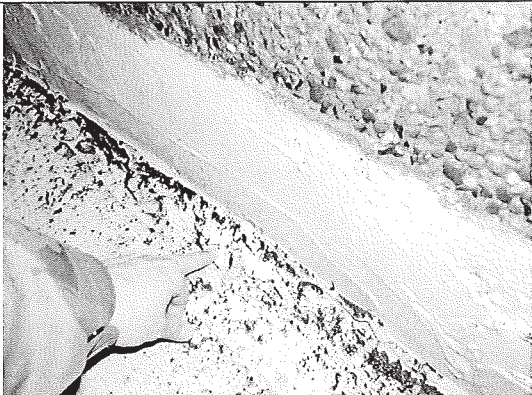
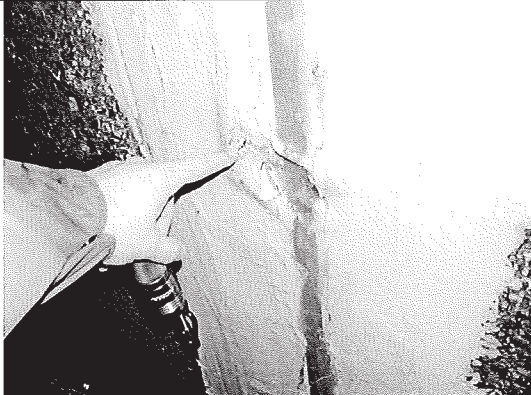
<p>1. A number of tears were found in the hypalon material. The above photo shows one such tear. This was located in the hypalon along the base of the wall</p>	<p>2. A large hole sufficient to push a pen through was observed at one of the vertical joints between precast panels</p>

It is suggested that the contractor carry out a further more detailed inspection of the whole area of repair and positively identify all defects and propose a procedure for remedial work to reinstate the integrity of the Combiflex System.
